A CASE STUDY ON CORROSION OF STAINLESS STEEL IN FIREWATER MAINS

L. Carpén¹, T. Ohligschläger²

¹VTT Technical Research Centre of Finland, Finland, ²Outokumpu Stainless Oy, Finland

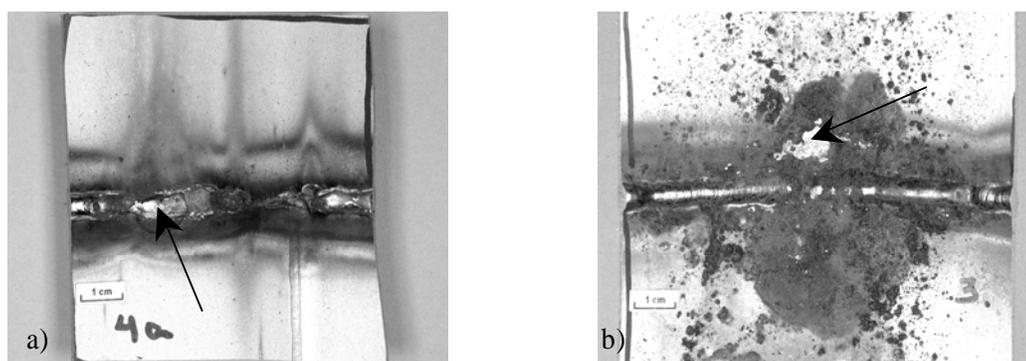
The failures of the removed metal pipes (EN 1.4301) occurred in less than three years of usage. Some pits already perforated the pipe wall. Most of the corrosion attacks detected were either in the fusion line or in the heat affected zone, Figure 1. Although the weld itself was uneven and partly incomplete in some cases, the corrosion did not occur especially in those areas. Instead, colourful heat tint areas could be seen on the failed pipes. The heat tint colours ranged from very dark blue to dark brown.

Figure 1. Pits (black arrows) a) in the fusion line and b) in the heat-affected zone of the weld.

For the common stainless steels types EN 1.4301 and 1.4401, it is usually considered that a slightly straw-yellow heat tint and otherwise clean weld indicate that the shielding gas protection has been satisfactory. All other colours indicate significant decrease in corrosion resistance [5]. In Figure 1a, also multicoloured areas linked to corrosion besides the heat tint areas can be seen. Iron, oxygen and carbon were the main elements of the EDS-analyses of the deposits on the inner surfaces. Moreover, chromium and nickel as components of stainless steel as well as

manganese, sulphur and occasionally also phosphorus and chlorine originating from the environment were detected. High amounts of iron, manganese and chlorine had been detected earlier in deposits of MIC failure cases of stainless steels. Also the presence of sulphur and phosphorus can be regarded as an indication of bacterial involvement. Microbiological results taken from the failure area of one of the samples showed signs of bacteria. From this sample, bacterial DNA was isolated and multiplied with PCR using eu-bacteria primers. However, it was not possible to identify the different species without sequencing. The metallographic examination did not reveal any abnormalities in the normal austenitic microstructures of the studied samples.

The best way to prevent the formation of deleterious oxide layers is to remove oxygen from the piping by shielding gas flushing before welding and using backing gas during the whole welding process and some time afterwards. The oxidation of the weld root can be reduced also by using root paste. This paste reacts with the welding heat and forms a slag layer on the root side of the weld. However, the results achieved with root paste are not anywhere near the results achieved by using backing gas. Alternatively, heat tints can be removed by pickling after welding. However, this is not always possible when considering the welding of piping containing natural waters. To avoid this kind of failures one should use water as clean as possible with low amounts of solids, chlorides, manganese and iron as well as a low amount of organic substances. Additionally, stagnant conditions or very low flow rates should be avoided as well. If continuous flow is not possible, the water should be changed frequently enough and the amounts of bacteria should be checked regularly. When necessary, the water should be treated to minimise bacterial activity. In Case 1, no failures had been detected in the system using the same water with regular use (once a week). In Case 2, the problems had been solved by using very clean demineralised water and circulation.

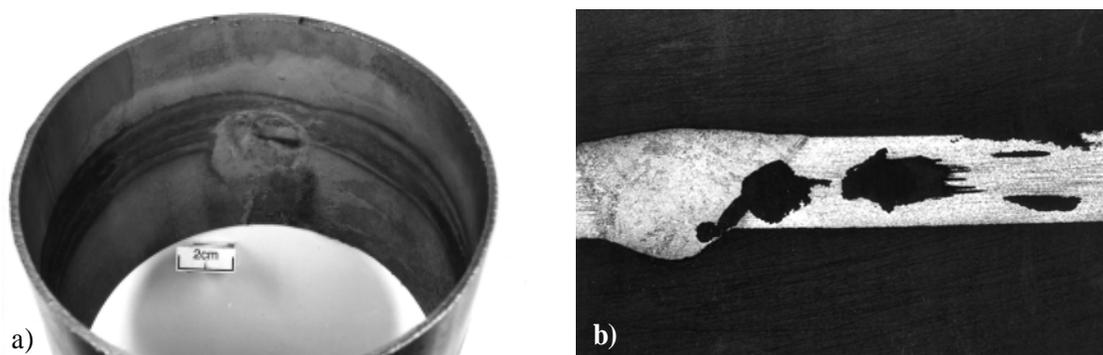
The first perforating pits in this fire extinguishing system were observed in a type EN 1.4401 stainless steel pipe with a diameter of 140 mm and a wall thickness of 3 mm. The leaks were situated near a girth weld. Visual inspection of the pipe sample revealed two perforations that were located in the heat-affected zone close to the fusion line of the on-site weld. Plenty of reddish brown deposit was found on the opposite inner side (Figure 2a). Similar reddish brown deposits and deposit rings were observed on the inner surfaces of type EN 1.4301 stainless steel pipes removed from the fire extinguishing system later. Typically, the openings of the pits were very small having large subsurface cavities (Figure 2b). The chemical compositions of the type EN 1.4301 stainless steel samples were according to the specifications within the ASTM standard boundaries except for some of the samples, which contained less than 18 % Cr (17 and 17.7 %). The microstructure of both materials was normal austenitic. The pits were typically situated close to or in the transversal on-site welds. There were clear signs of oxidation of heat-affected zones (heat tints) but no other signs for welding defects were found in the failure areas.

Figure 2. a) Reddish brown deposit on the inner surface of a stainless steel type EN 1.4401 pipe section removed from the fire extinguishing system. b) Optical micrograph of a trough-wall, mainly subsurface corrosion pit in an EN 1.4401 type of stainless steel pipe after two years of service in fire extinguishing water.

The pits were typically surrounded by dark brown circular deposit rings and the inner surfaces of the pipes were mostly covered with a thin and rather smooth layer of yellowish brown deposit. Sulphur and occasionally also high amounts of manganese as well as small amounts of phosphate were detected in the deposits in or surrounding the pits.

The total count of aerobic bacteria in samples taken directly from the surfaces of the opened system was clearly higher (from 1.1×10^3 to 7.3×10^3 cfu/ml) than in the water sample (32...50 cfu/ml). SBRs could be detected from the pipe sample, which had been delivered to the laboratory with a moist deposit still on its surface. Also the amount of aerobic bacteria in this sample was rather high, namely 4.3×10^6 cfu/cm², which was clearly higher than that in the pipe sample with dried deposit (20 cfu/cm²). Both samples contained through-wall pits. The presence of iron bacteria was verified from the sample delivered to the laboratory and the water taken simultaneously from the fire extinguishing system under consideration. The amount of heterotrophic aerobic bacteria was quite high (4.3×10^5 and 2.4×10^5 cfu/ml respectively). Plenty of individual rod-shaped bacteria as well as cell aggregates and starting biofilm formation on the stainless steel coupons incubated six days in an iron bacteria culture medium could be seen under the epifluorescence microscope. The presence of manganese oxidising bacteria was not checked.
