Baltica X

International Conference on Life Management and Maintenance for Power Plants

7–9 June, 2016

VTT Technology 261

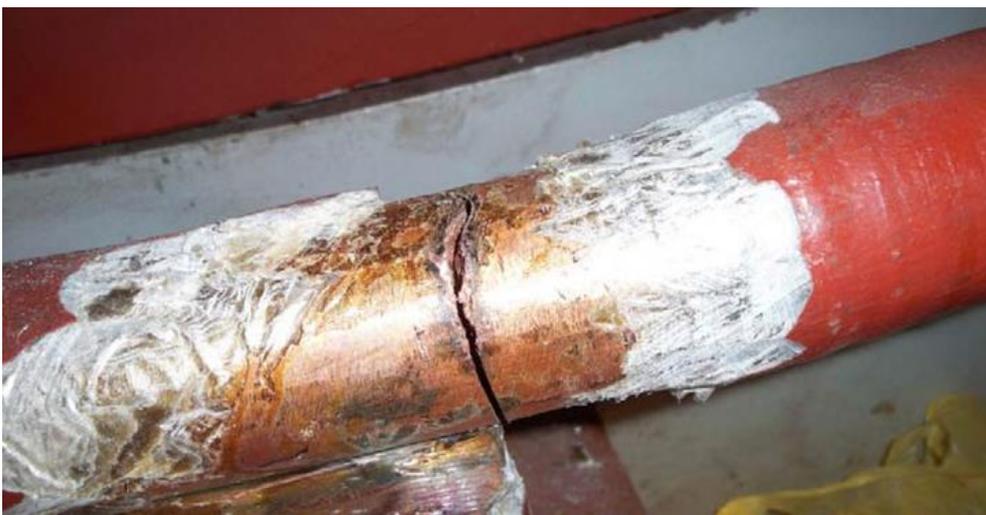
A fault was detected by stator winding resistance measurement during a yearly inspection of a 276 MVA steam turbine generator. The DC resistance was increased by 30% compared to initial values due to a crack in a winding lead. A repair was executed before recommissioning.

Figure 2. Crack in the stator winding lead.

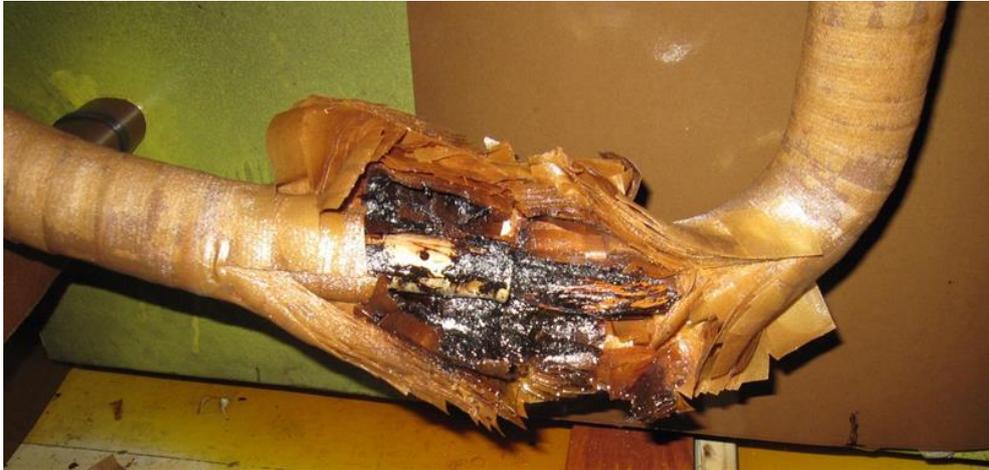
Fault was detected by resistance measurement in a generator transformer. Phase resistance of the faulty phase was appr. 7 % higher than in the other phases. The fault was at first not detected by visual inspection of the opened transformer in scheduled overhaul, because it was hidden under thick insulation layers. In this case there was no clear indication of the problem in the dissolved gas analysis results either.

Figure 3. Overheated connection in a transformer.

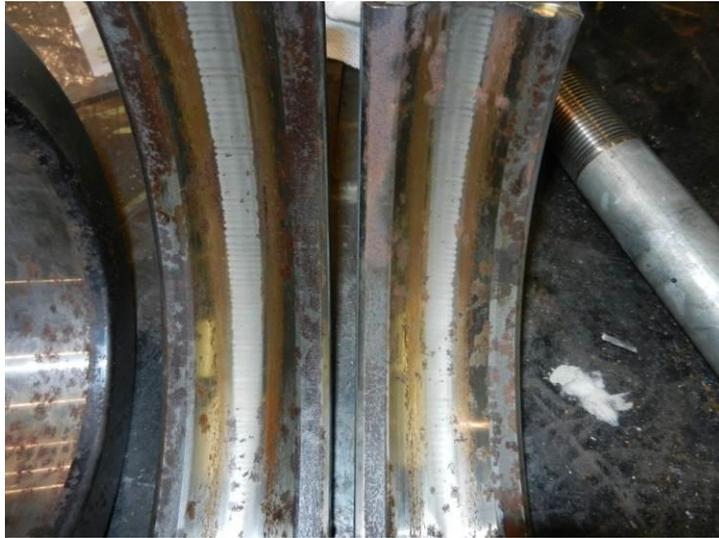
Figure 5. Bearing current damage in the outer rings of the bearings.

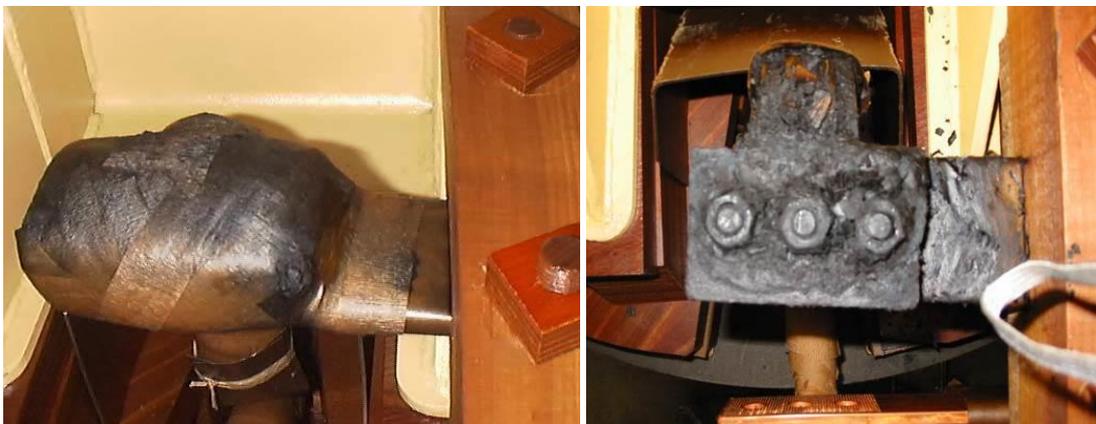
Figure 6. Overheated connection in a transformer. Left: wrapped in insulation paper. Right: revealed.

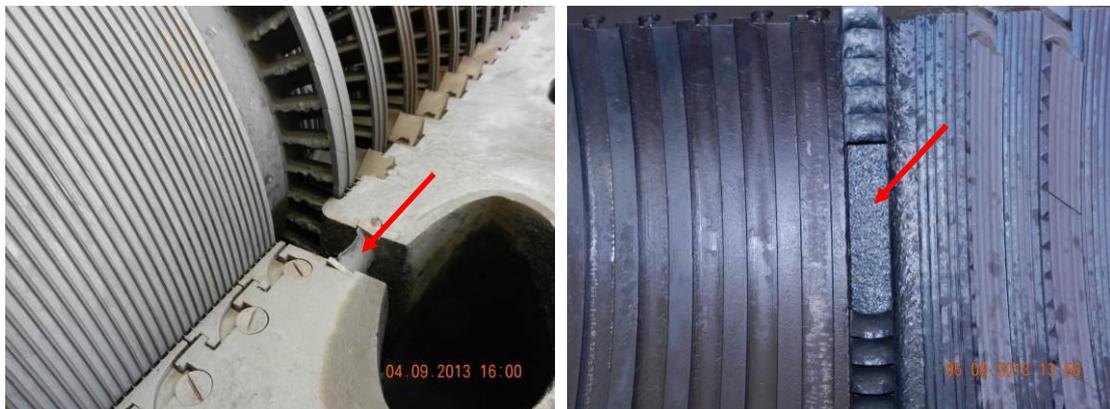
Figure 8. Six blades in Radax-stage were broken (arrow).

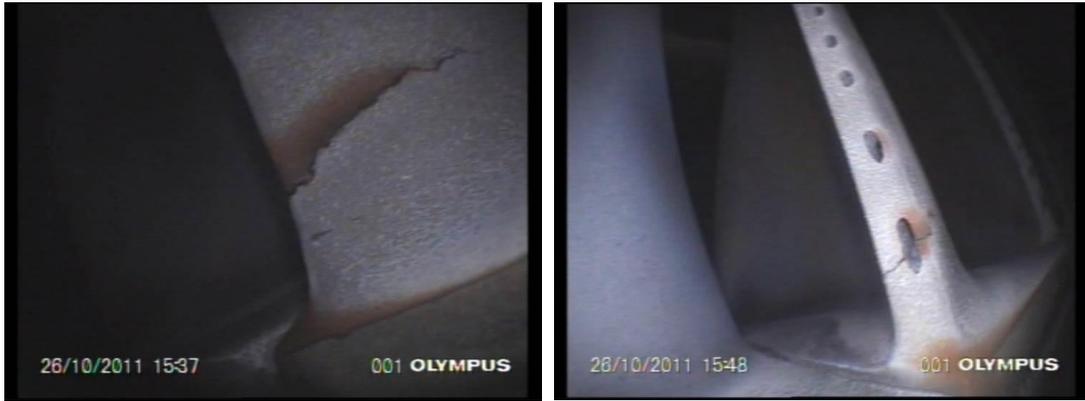
During the combustion inspection of a gas turbine quite severe coating failures in some areas of the 2nd stage nozzle in certain vane leading edges were detected. It was recommended to follow up the progress of the failure with borescope inspection in every 2000 EOH. In the first follow up inspection the progress of the coating failure was detected to be rather limited, but much more severe defects were found in several turbine first stage rotating blades. Cracks with length of 2-20 mm located in the first cooling holes counted from the shank. The whole turbine section was earlier visually inspected and none of the 1st stage rotating blade cracks was observed at that time. It is obvious that the progress of the cracking has happened during the 2000 EOH follow up period. Without this observation with borescope, which led to opening of the unit for 1st stage replacement, the downstream consequences could have been fatal due to further progress of 1st stage cracking until liberation of air foil.

Figure 9. Borescope view of 1st stage blade cracking, convex side (left) and cooling hole area (right).

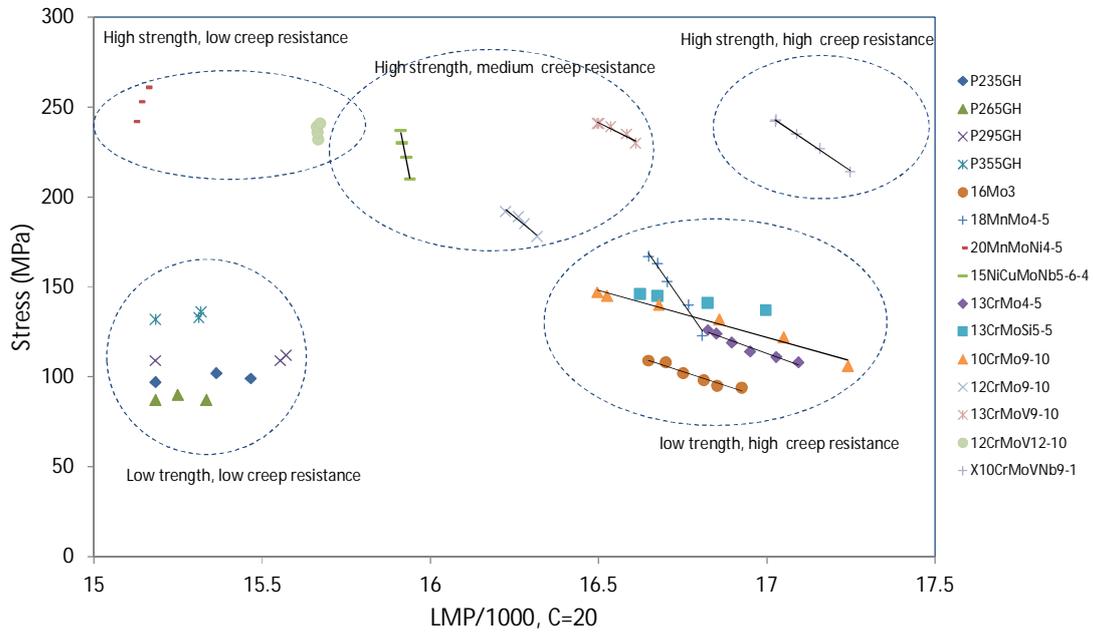
Figure 6. The F/M steels of EN10028-2 plotted as reference stress vs. the time-temperature parameter LMP.

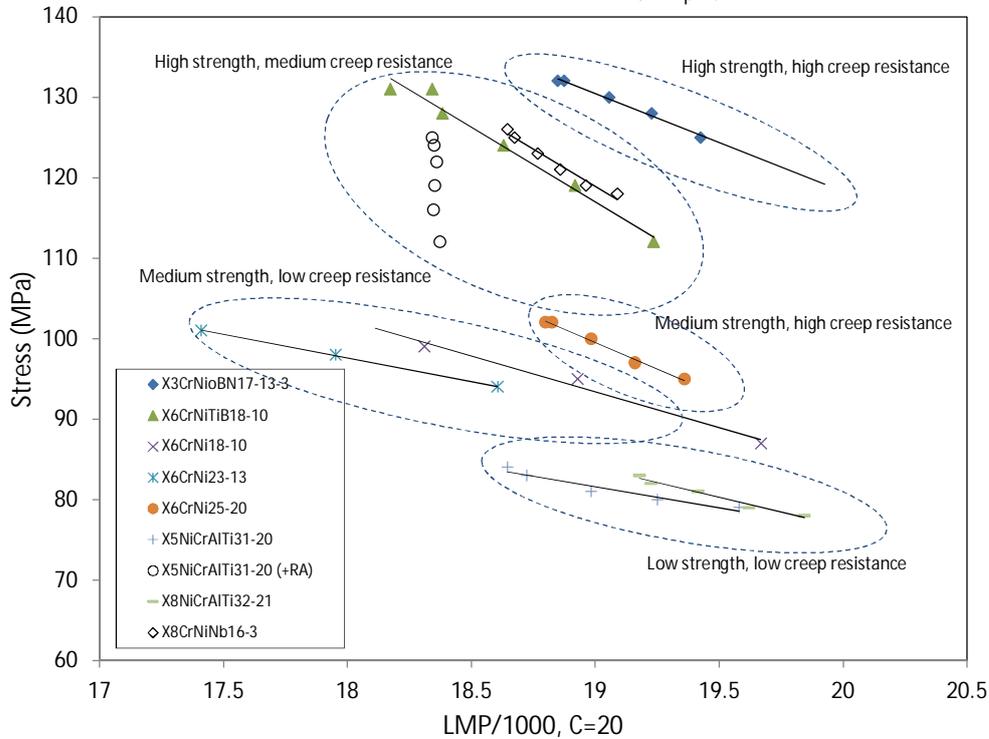
Figure 7. The creep resistant stainless steels of EN10028-7 plotted as reference stress vs. the time-temperature parameter LMP.

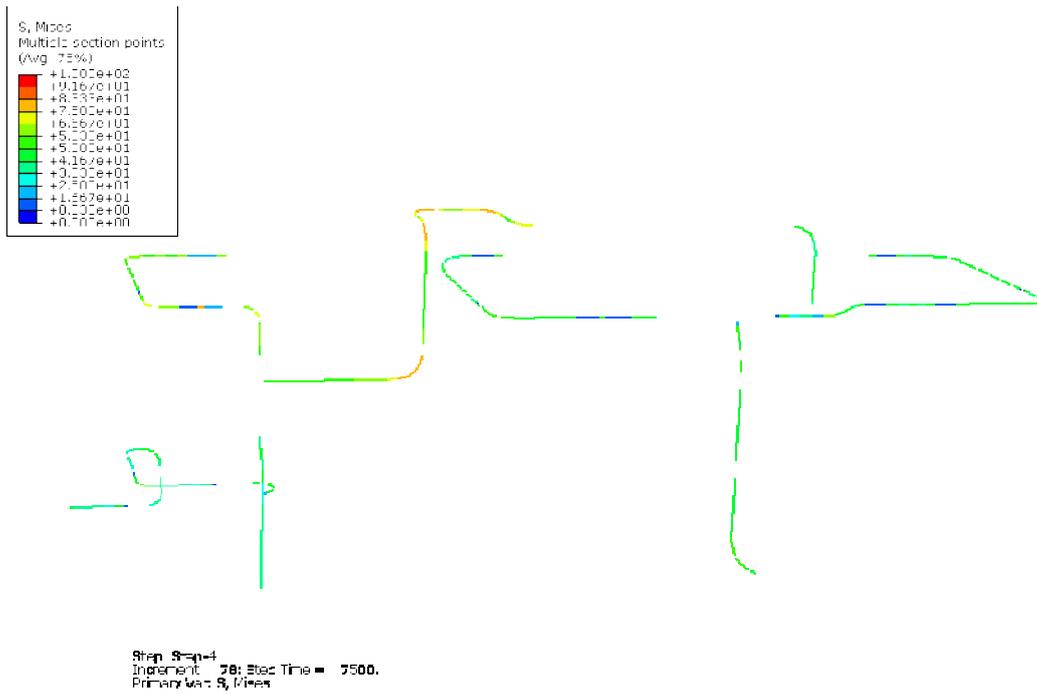
Figure 3. Stress distribution after one year in service

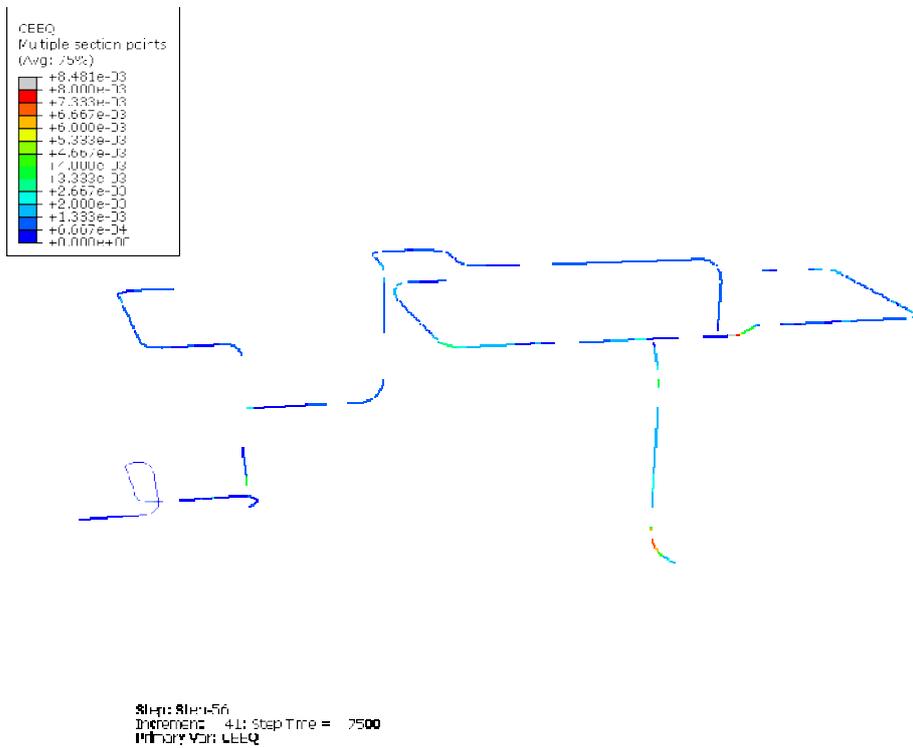
Figure 4. Strain distributions after 14 years in service and one stop each year.

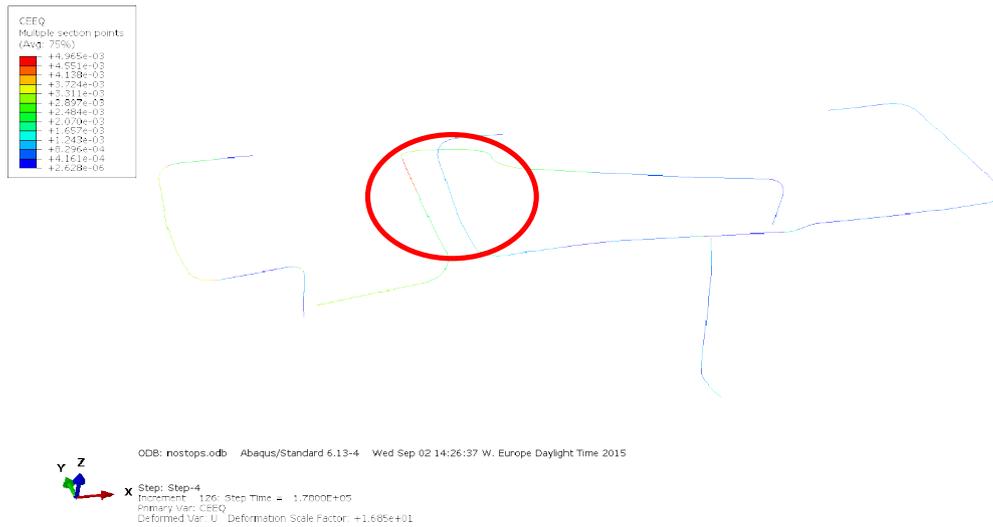
Figure 5. Simulated service without stops for 178 000 hours. Maximum equivalent creep strain = 0.5%

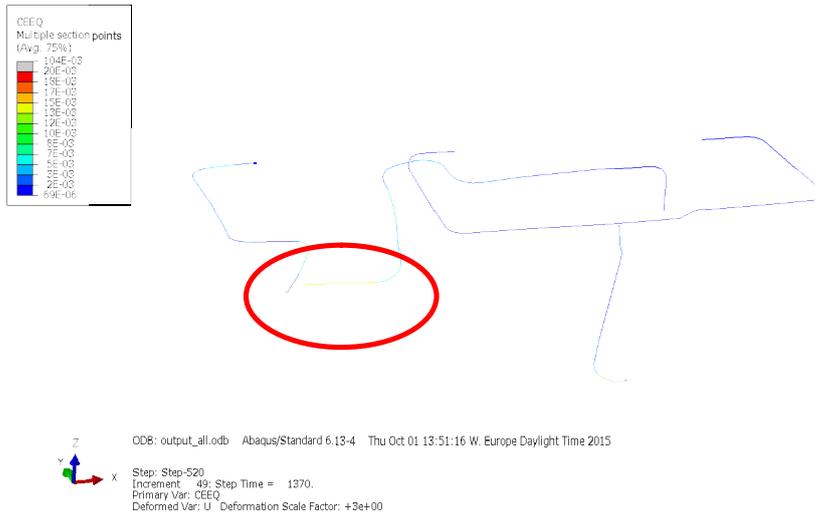
Figure 6. Simulated service with 130 cold starts for 178 000 hours. The maximum equivalent creep strain is higher and in different locations compared to no starts.

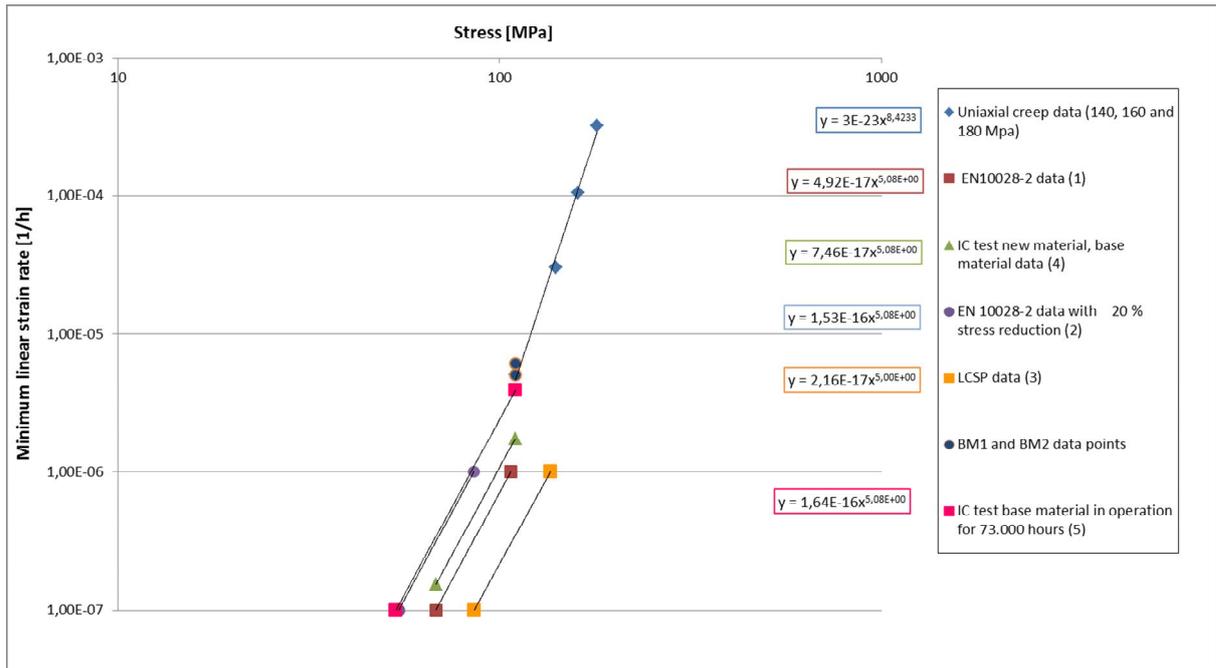
Figure 9. Minimum linear creep rates versus stress of parent metal for several Norton material models (numbered 1-5) as well as for produced data of uniaxial creep on new material and of impression creep on service exposed material (BM1 and BM2).

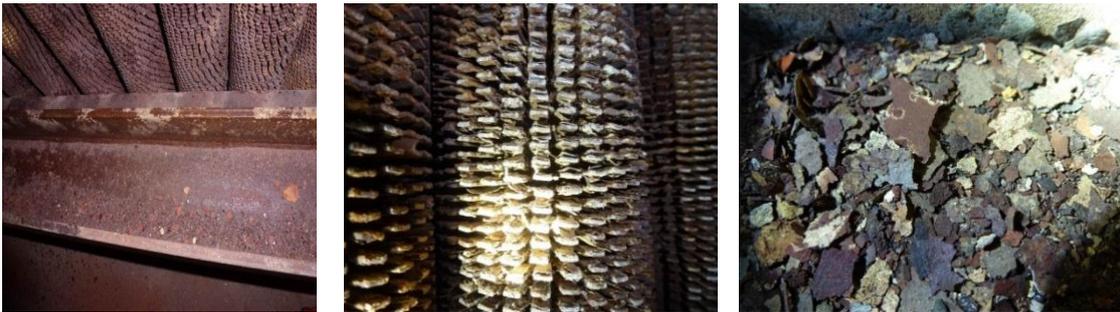
The inspection results regarding fouling of IJmond 1 are shown in Figure 2. Little to no fouling was observed at the high temperature end of the boiler while sticky layers were present (see Figure 4), especially at the 2nd and 3rd heat exchanger (numbered in flue gas flow direction). Most fouling was observed half-way at the 4th heat exchanger (HP eco 2), while also the coldest parts were fouled (dearator / evaporator). Typically, flakes are present on the fins, while flakes collect on the flooring as shown in Figure 4.

Figure 4. IJmond 1 boiler inspection results. Left: sticky layers. Middle: flakes on fins. Right: flakes collected on flooring.

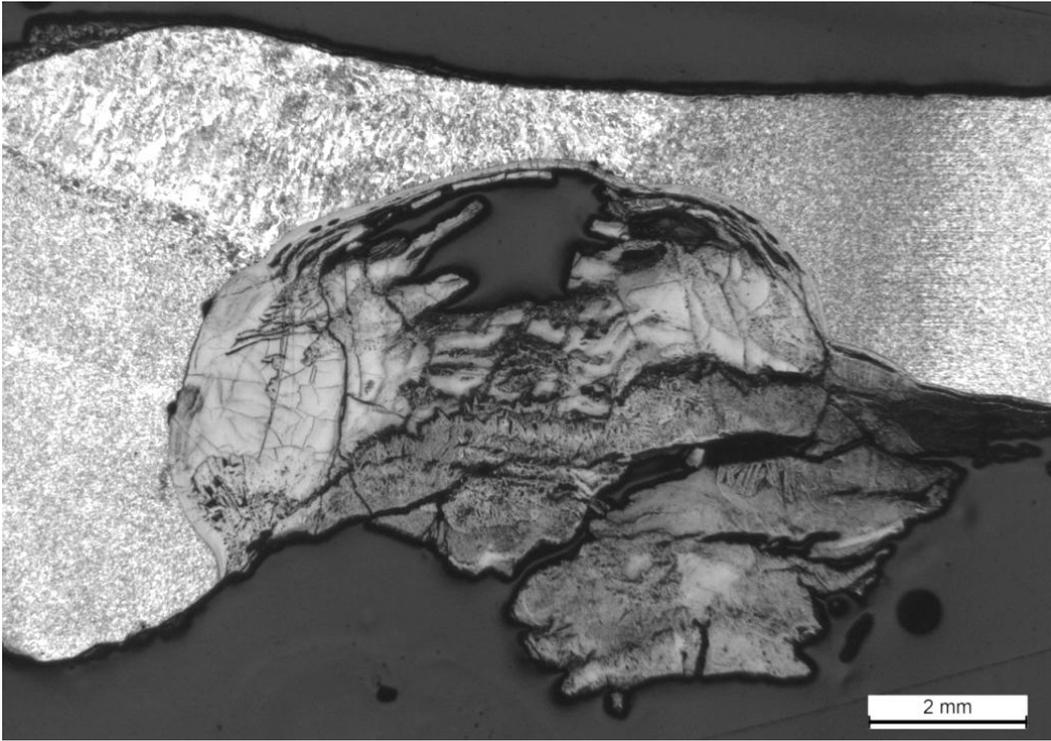
Figure 6. Oxide at a weld root next to the tube leak in 2015 (flow direction to right, etched).

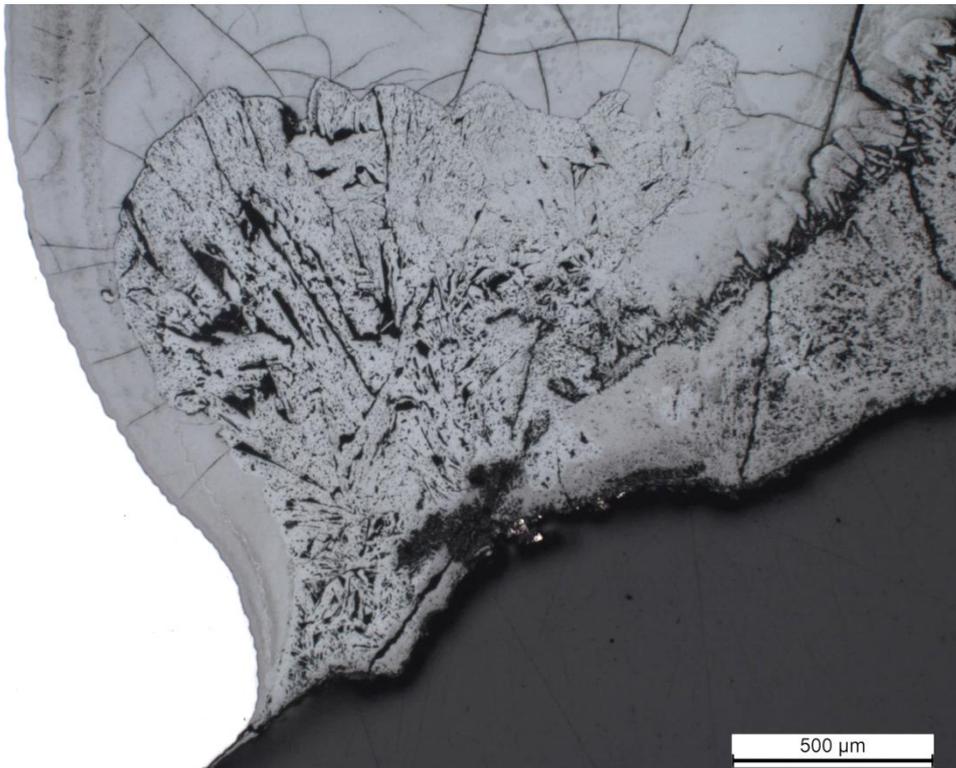
Figure 7. A detail from the bottom left side of Figure 6 (unetched).

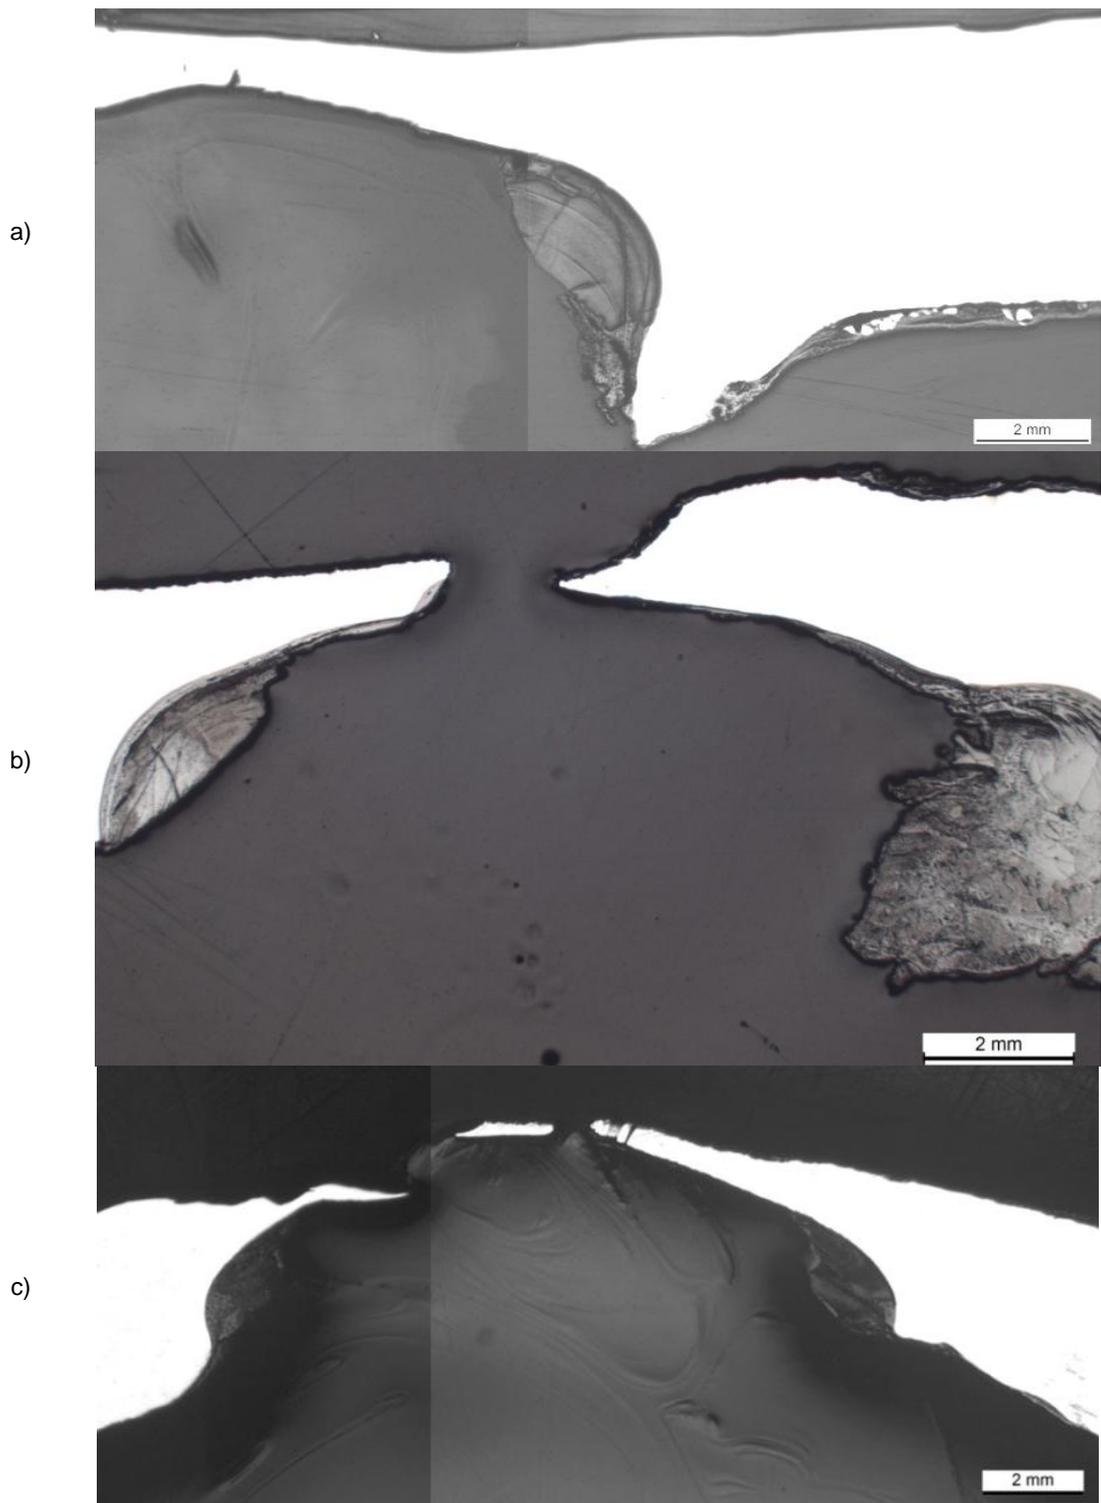
Figure 11. Unetched cross-sections from the leak locations in a) 2013, b) 2015 and c) 2016.

In all three cases the cross-sections at the failure locations showed a similar thick oxide at an internal corrosion pit (Figure 11). There was little evidence for any significant deviations in the water chemistry (Figure 12).

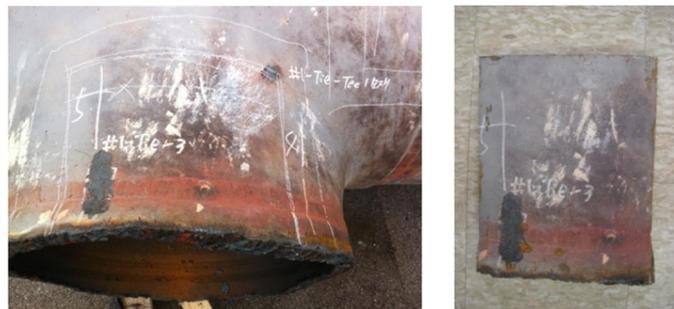
Figure 3. Gr.91 steel Tee part sampled from reheat steam piping after 73,716 h service in a USC plant

The fitting part of Gr.91 steel Tee shown in Fig. 3 has been sampled from reheat steam piping in a Korean USC plant to investigate the effects of thermal aging.

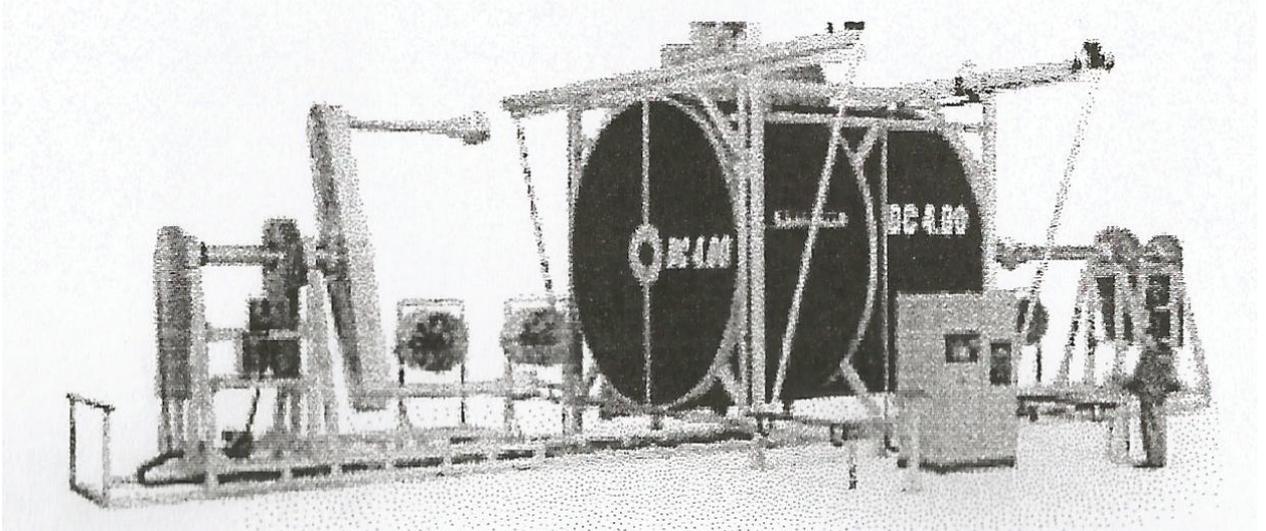
Figure 1. The moulding machine as shown in manufacturer's literature. The main drive shafts are at the extreme left and right ends of the installation. Two molds are employed, alternately being put within the centrally located heating furnace, each mold being carried by the two arms seen at the ends of the unit. Figure 2 shows the unit as installed, but after it had been partially shut down.

A preliminary visit was made to determine the nature of the problem; subsequently the writer being contracted to determine the source of the problems site, when it had been shut down to investigate operating problems after failure of the main drive shaft at the left side in Fig. 1.

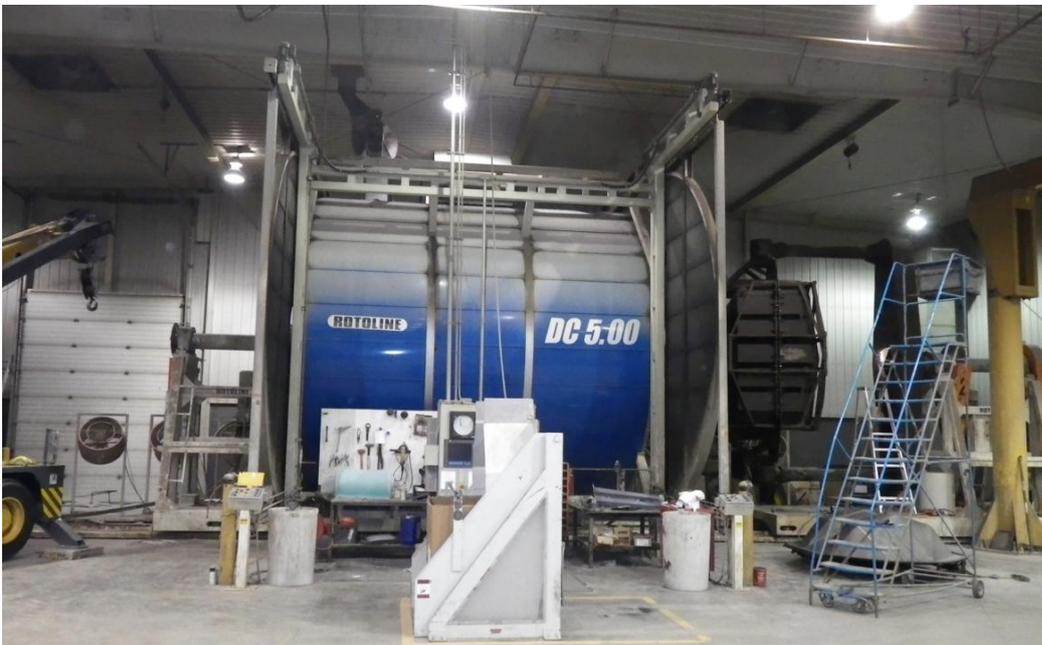
Figure 2. Installation after failure and shut-down.

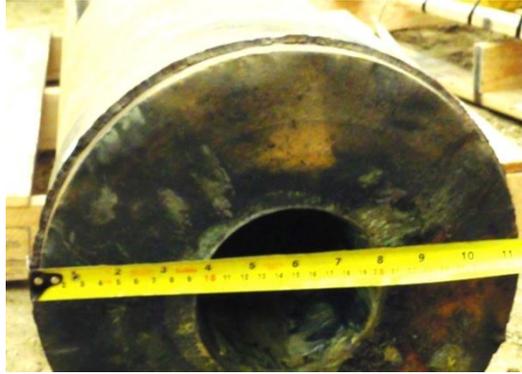
This occurred over the centre of the shaft while additional fatigue fracture was present in a fillet weld at the outside of the shaft (Figure 4).

Figure 4. Fatigue fracture of weld connecting repaired and joined inner and outer rotating shafts.

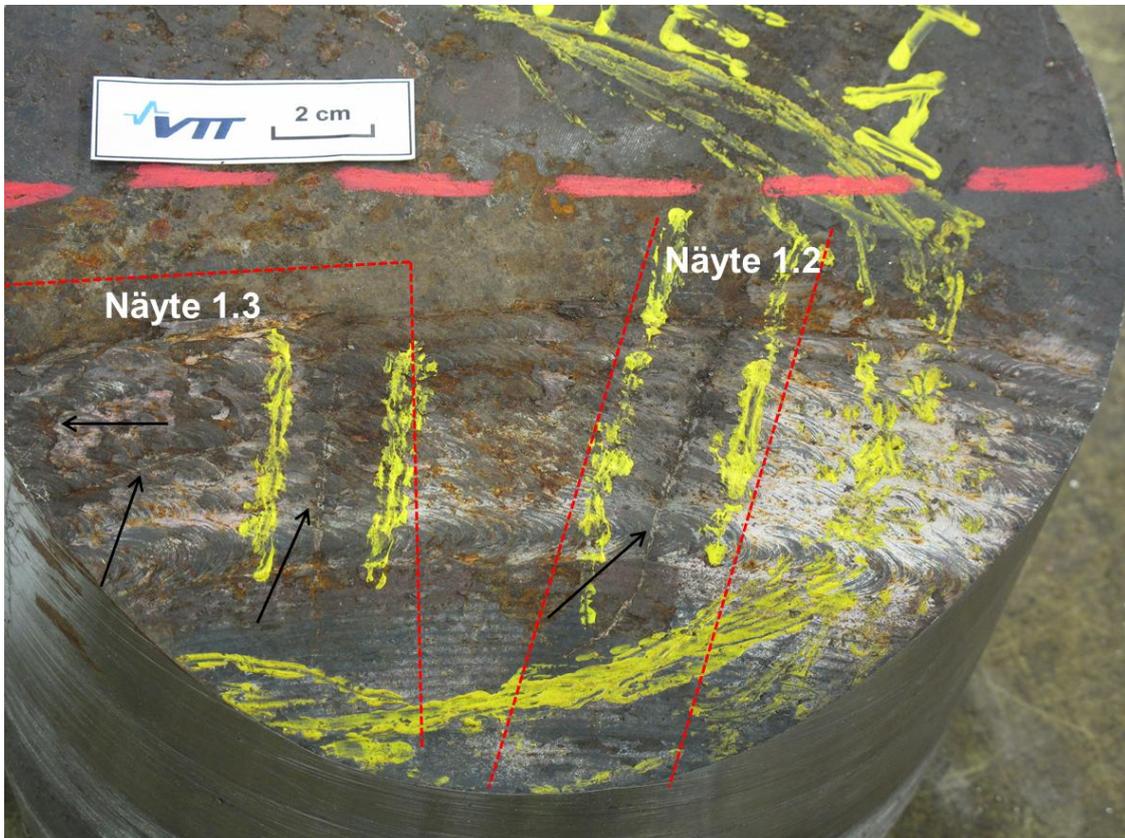
Figure 1. Transversal weld metal cracks at the outer surface of the specimen (denoted with black arrows).

Visual inspection revealed several transversal and longitudinal crack-like defects in the weldment area. Of these, transversal weld metal cracks were bursting open to the surface, often extending across the fusion boundary and into the HAZ side; see Figure 1. The longitudinal cracks, in turn, seem to have been typically initiated from machined steep notches in the weld root side, from where they had grown into the thickness direction up to the weld mid-thickness, often associated with crack branching, and sometimes even burst open to the surface, see Figure 2. A longitudinal crack c.f. Figure 3 had been initiated in approx. 45° angle orientation either from the weld surface or beneath the final weld bead layer, from where it has propagated towards the fusion boundary and further across the HAZ into the base material.

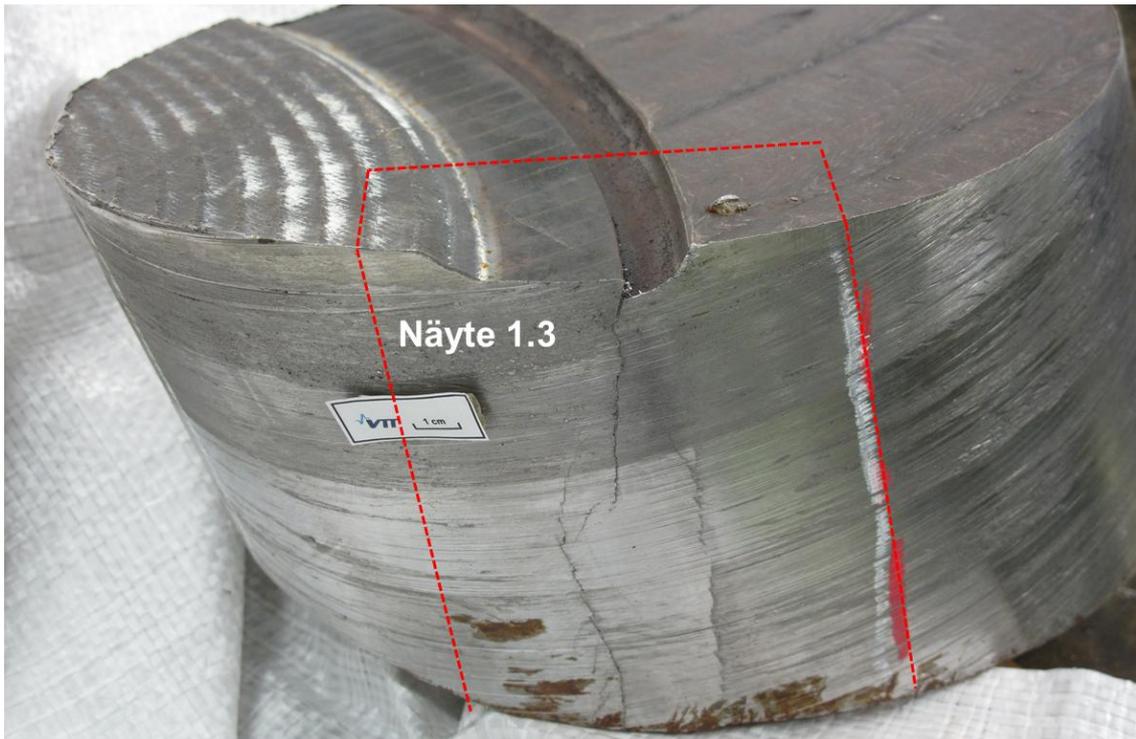
Figure 2. Longitudinal weld metal/HAZ cracks initiated from the corner of a machined notch at the inner surface (see: the top side) and grown into the weld mid-thickness area and finally the outer surface.

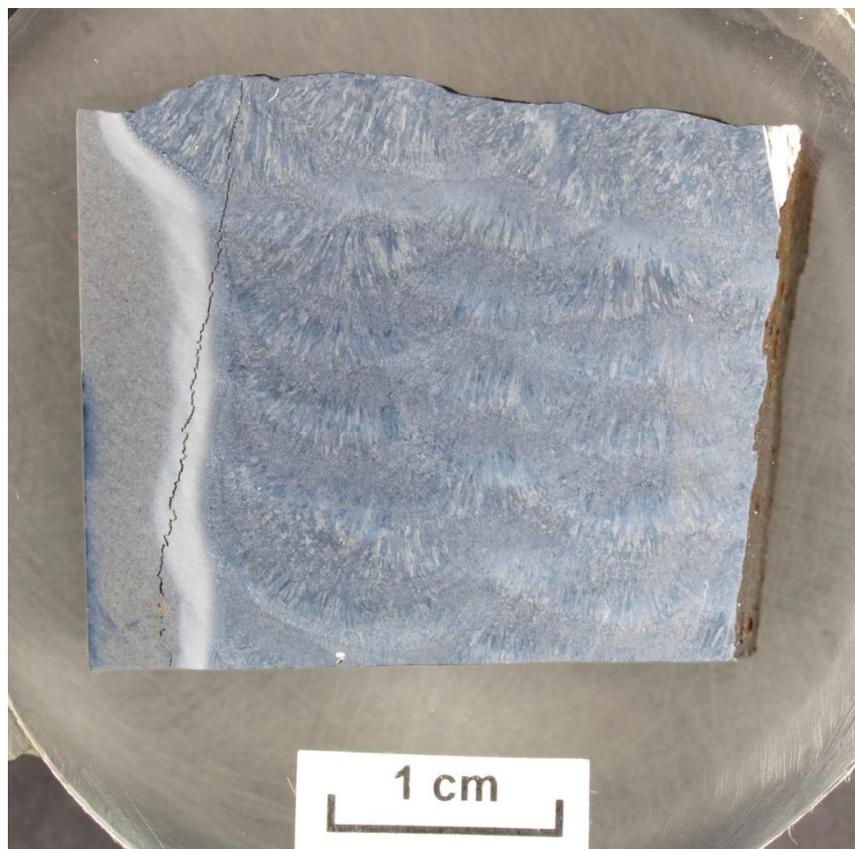
Figure 3. An example of typical appearance of discovered cracks: longitudinal crack in the HAZ region.

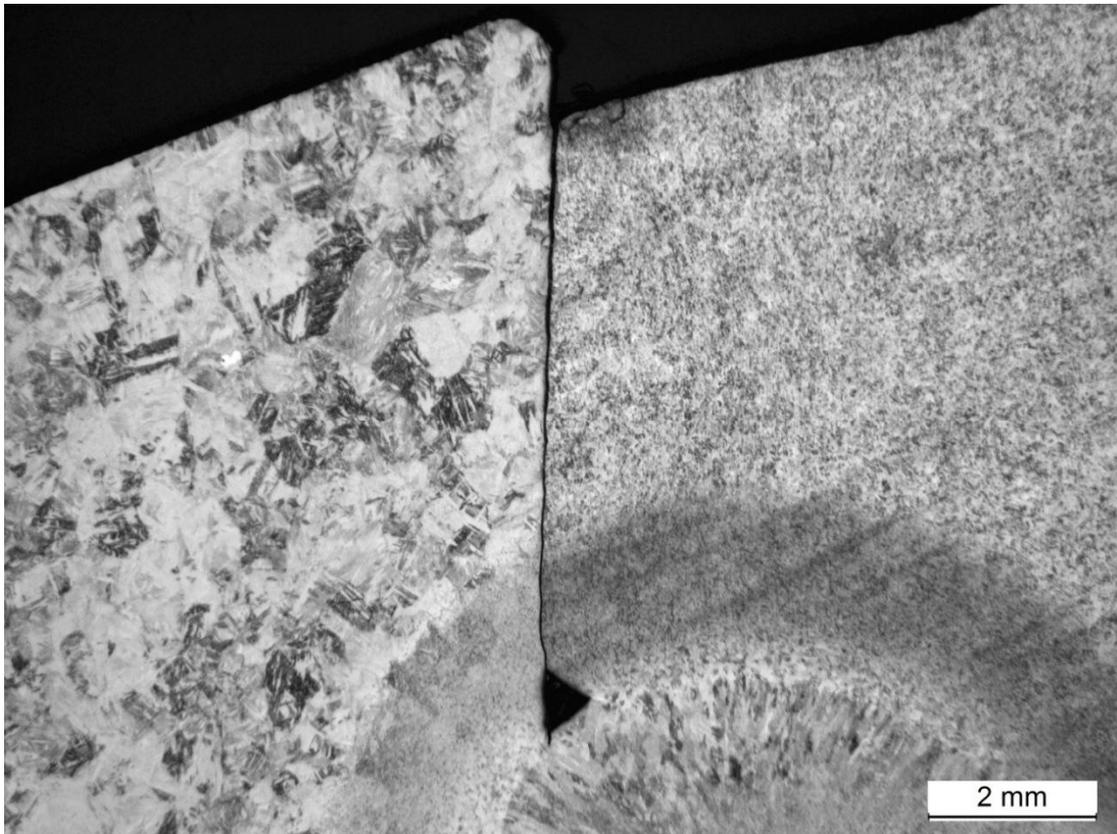
Figure 4. A crack initiated from a machined geometrical notch at the inner surface of the sample. A lack-of-fusion weld defect (triangle shaped) in the weld root area.

Metallographic investigation using optical microscopy (LOM) revealed a crack starting from the steep corner of a machined notch in the weld root side at the inner surface of the investigated sample; see Figure 4. The crack had been propagating inwards along the weld fusion boundary until it hit a lack-of-fusion weld defect existing in the root area of a subsequent weld bead, c.f. Figure 4. After this, the crack had continued to grow slightly ($\approx 160 \mu\text{m}$) within the weld bead. Relatively dense oxide layer was found within the crack (see Figure 5), which indicates that it was presumably formed at a high temperature. The oxide layer continued all the way up to the crack tip, along with a few small Mn-rich slag inclusions that were not found elsewhere within the weld.

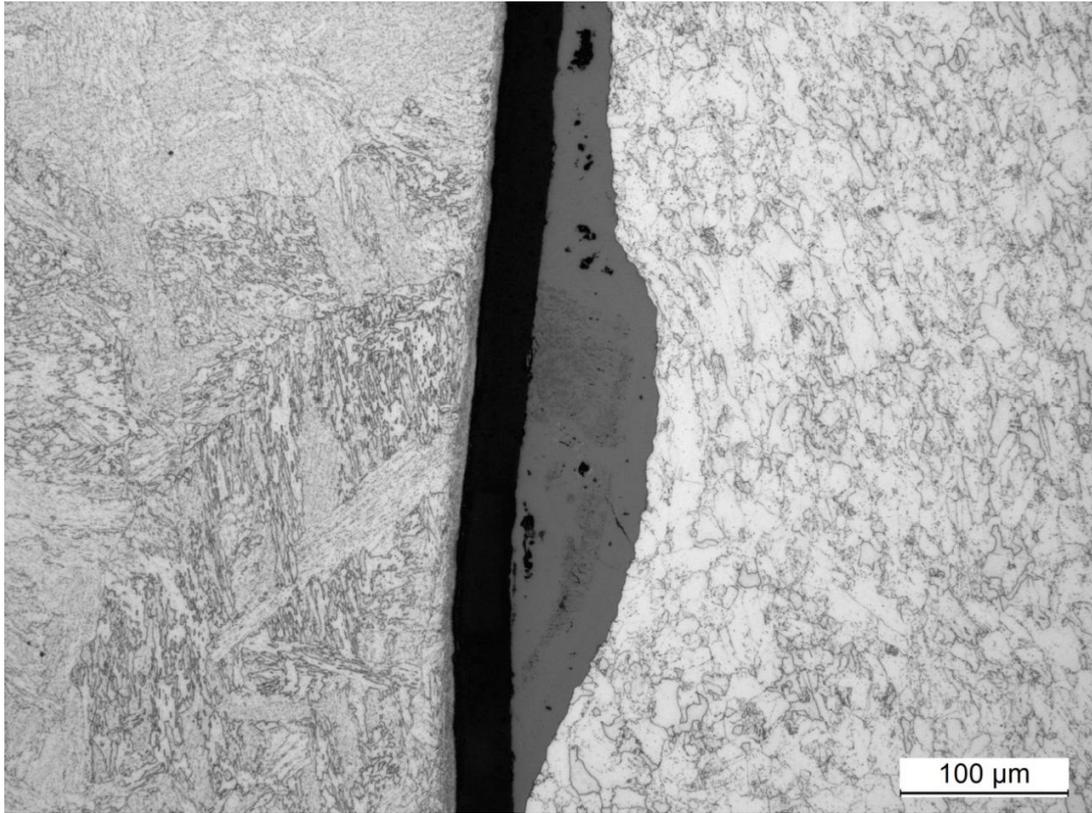
Figure 5. Oxide within a crack depicted in Figure 4. A bainitic HAZ microstructure (in the left side).

Otherwise, there were no detectable oxides associated with the other cracks found within the weld metal or in the HAZ. Small secondary cracks were frequently recognised with the LOM in the immediate vicinity of the discovered primary crack; often these secondary cracks seemed to follow the prior-austenite grain boundaries; see Figure 6. The microstructure of the weld metal and the coarse-grained HAZ consisted mainly of bainite (with both aligned and non-aligned second phase, see Figures 5 and 6).

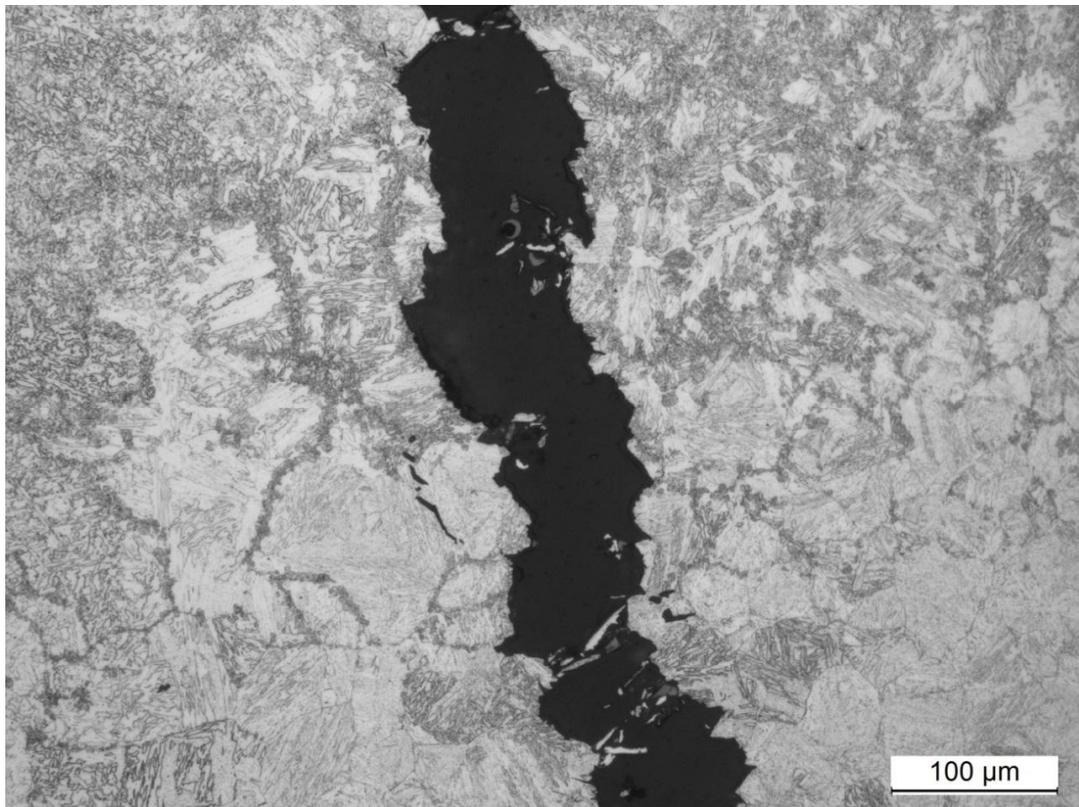
Figure 6. An example of small secondary cracks in the immediate vicinity of the primary crack.

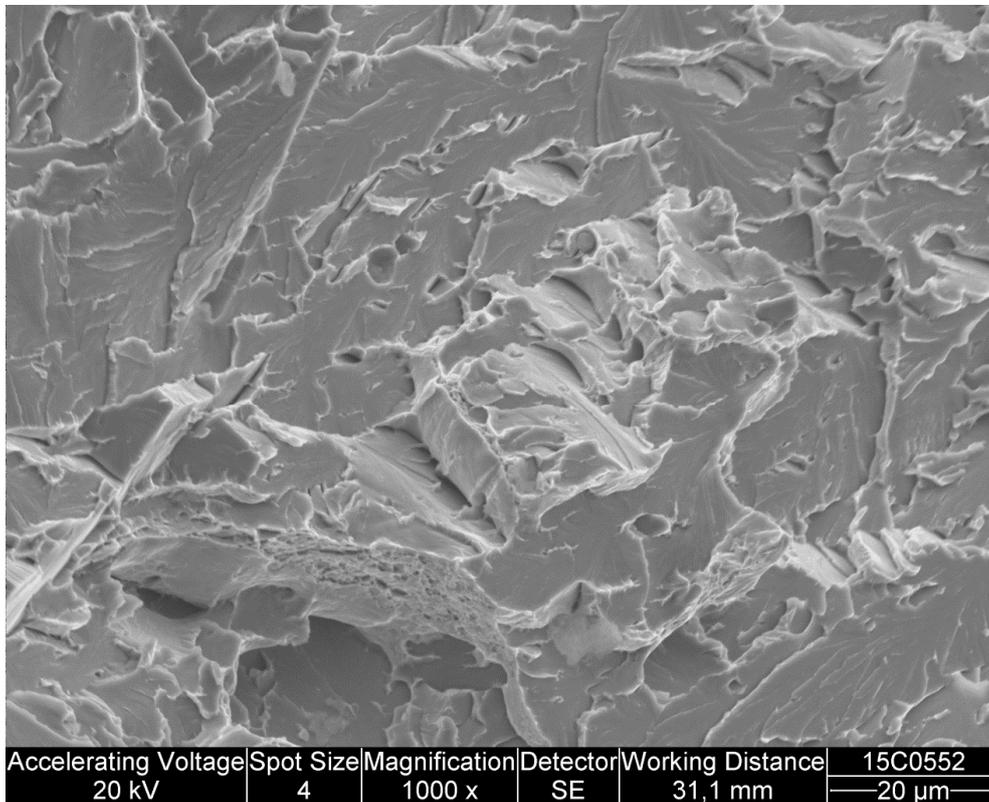
Figure 7. SEM image from the fracture surface of a transverse crack in the weld metal (specimen no 1.2).

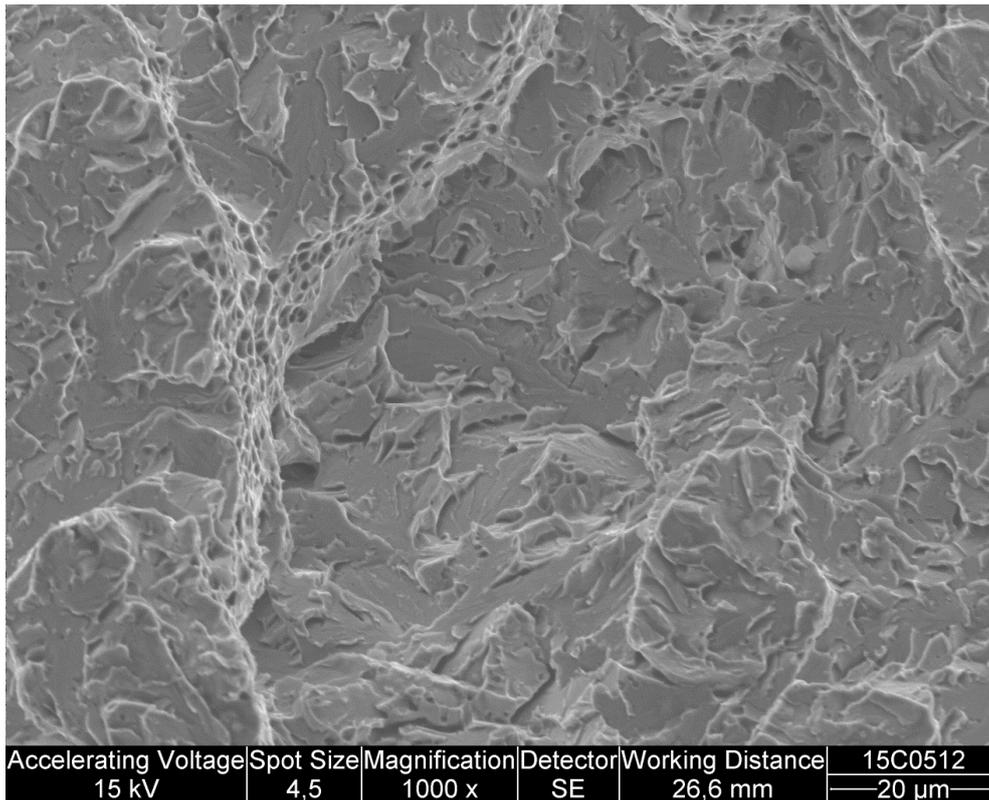
Figure 8. SEM image from the fracture surface of a longitudinal crack in the weld/HAZ (specimen no 1.3).

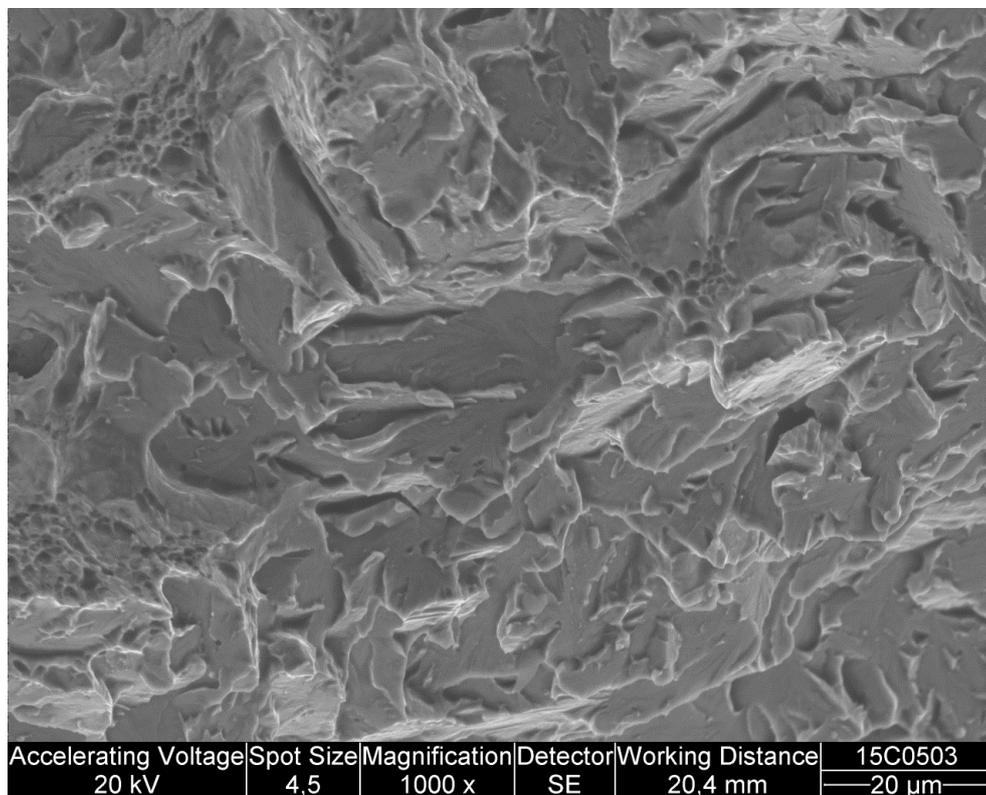
Figure 9. SEM image from the fracture surface of a longitudinal crack initiated from the corner of a machined steep notch on the inner surface of the specimen (specimen no 2.3).

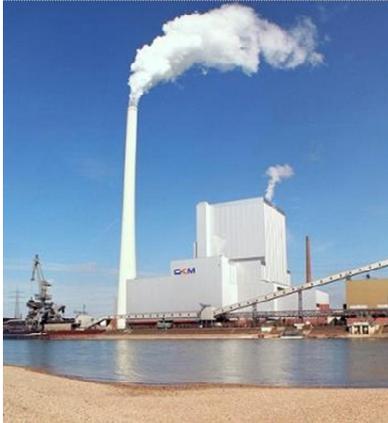
GKM Block 8 Kessel 19	Main Steam Line (A-System)
	Commissioning date	Oktober 02, 1992
	Operating hours	146409 (Juni 2015)
	Design temperature	545°C
	Design operating temperature	535°C
	Design pressure	211 bar
	Design operating pressure	190 bar
	Material	X20 CrMoV 12 1 (1.4922)

Figure 2: Design and operating data of GKM unit 8 (boiler 19) and the main steam line (A-System)
