Baltica X

International Conference on Life Management and Maintenance for Power Plants

7–9 June, 2016

VTT Technology 261

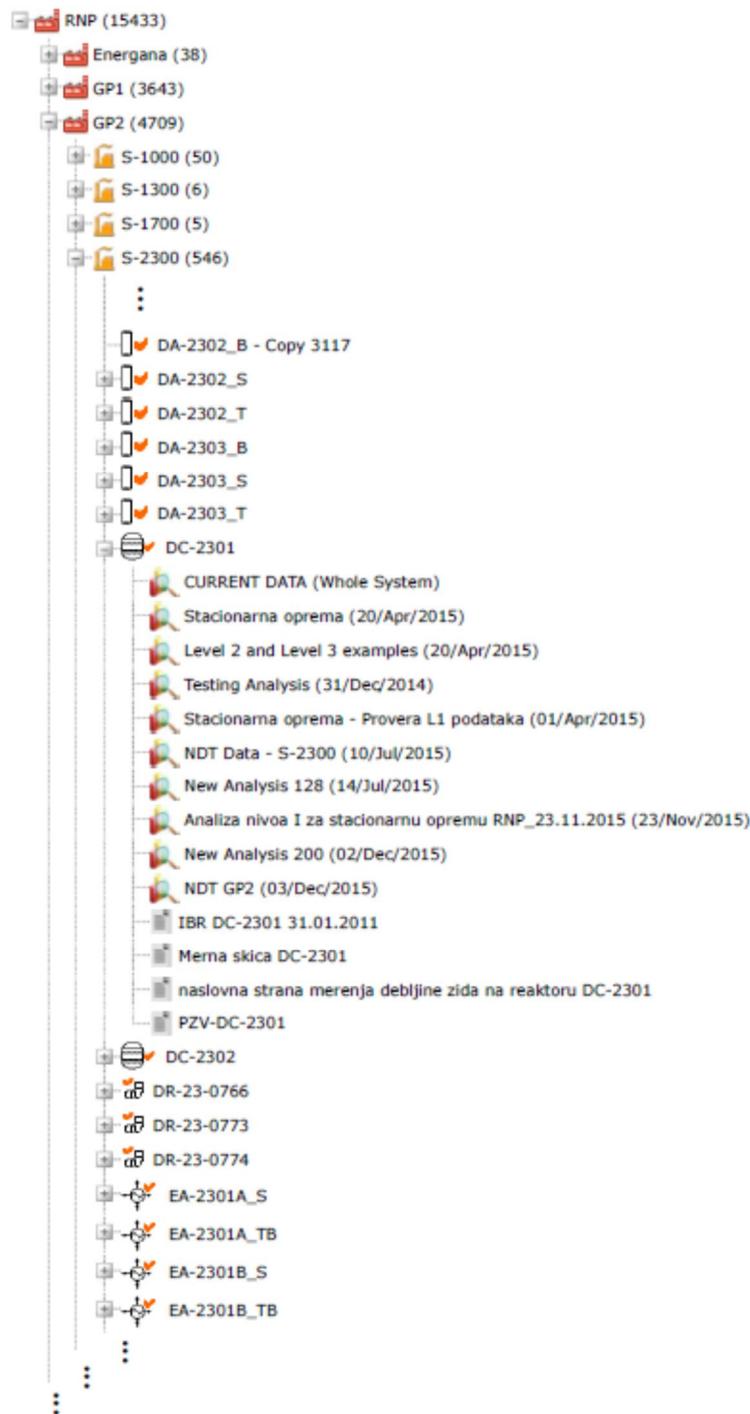
Figure 3: Organization of the refinery, areas, process units and components in the tree structure.

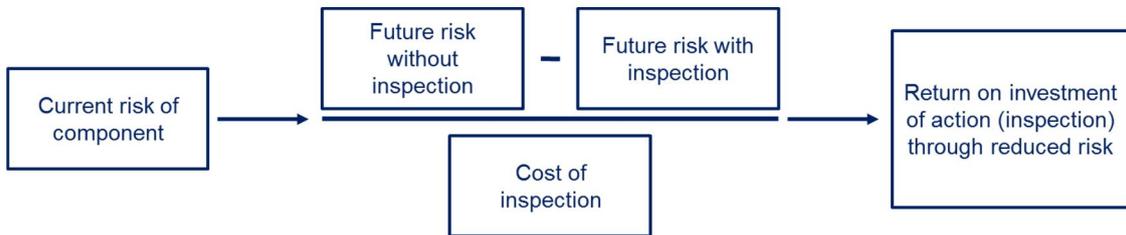
The S-Factor (Figure 18) gives the return on the investment (cost) of the inspection/action of equipment by taking into account the calculation of the future risk for the component (at the defined Plan End Date) without any additional inspections/actions, the future risk of the component with actions/inspections, and the cost of the planned actions/inspections.

Figure 18: S-Factor – return on investment of action through reduction of risk

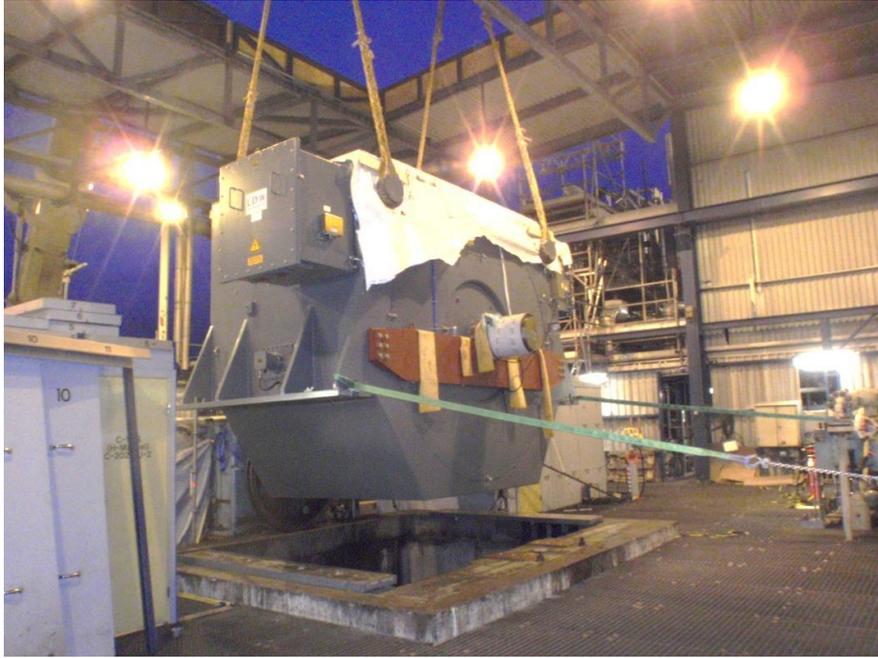
Step 2 was executed to Line C. During this implementation phase several major equipment were renewed. Most complex renewals were Hyper compressor electrical motor and three Hyper compressor intercoolers. The 6,8MW synchronous motor was needed to renew due to old motor stator deterioration. Today's ATEX-requirements were taken into consideration when new motor was ordered. To fulfil European legislation only few manufacturers could be considered. Lifting almost 77 tons electric motor from far distance required in depth safety planning.

Photograph 2. Installation of new Hyper compressor E-motor [6].

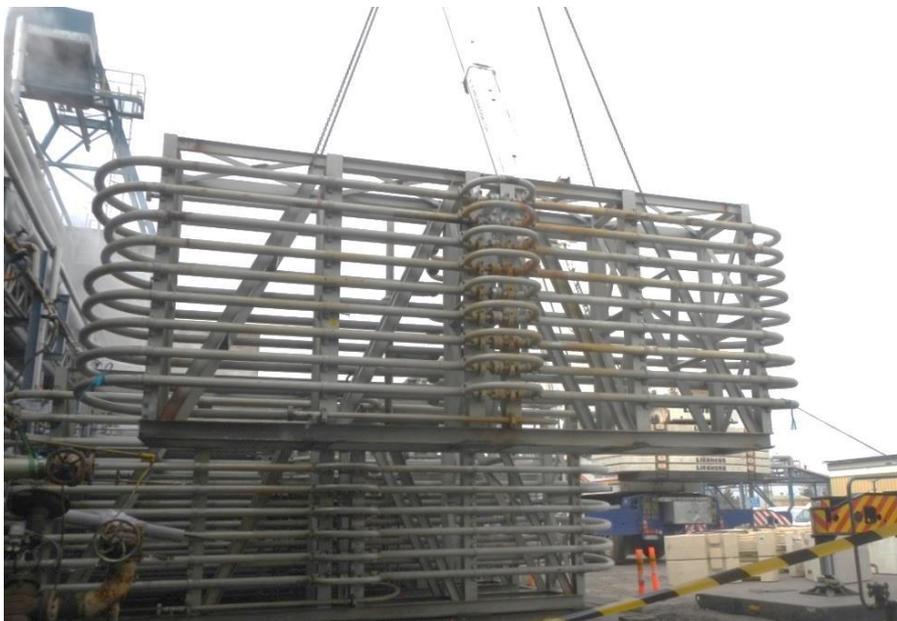
The old intercoolers suffered high vibration level. Due to inadequate cooling water chemistry control during early 80's, jacketed high pressure tube supports suffered intergranular stress corrosion cracking. Constant failures in high pressure pipe supports led to fatigue failures in high pressure pipe. Ethylene leakage from approximately 1000 bar gaseous ethylene to 4 bar cooling water circulation is not acceptable, even if implemented mitigation actions indicated ppm level ethylene in cooling water circulation.

Photograph 3. Old intercooler removal [7].

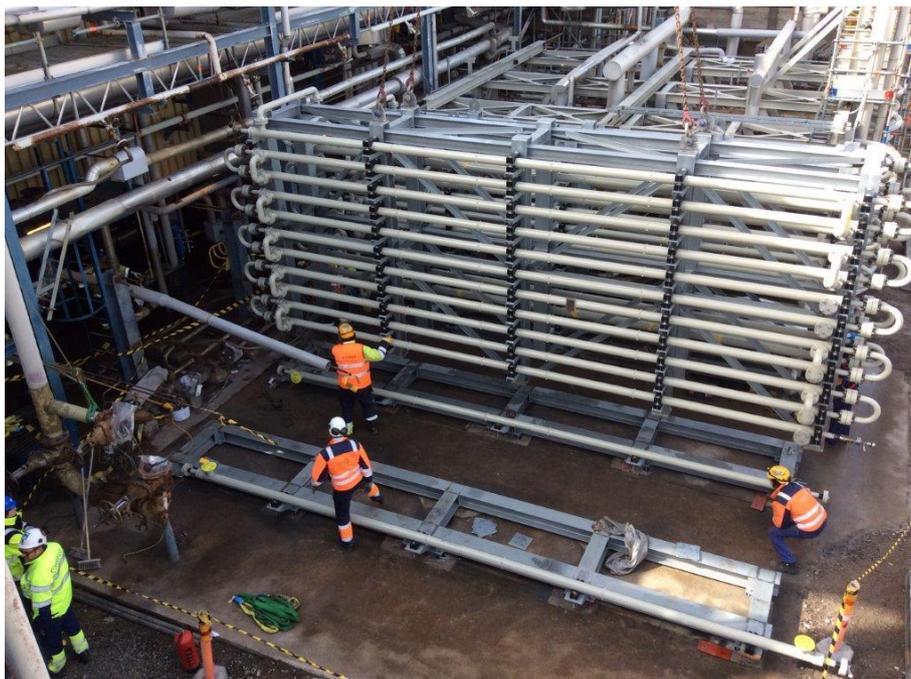
Photograph 4. One of the new intercooler installations [8].

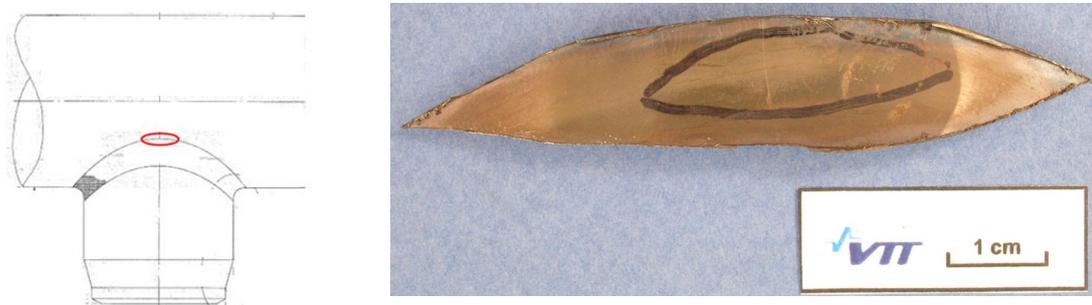
Figure 6. Outline of the branch to reduction valve, showing the saddle point position (left); and the extracted boat sample with a surface crack in the marked area (right).

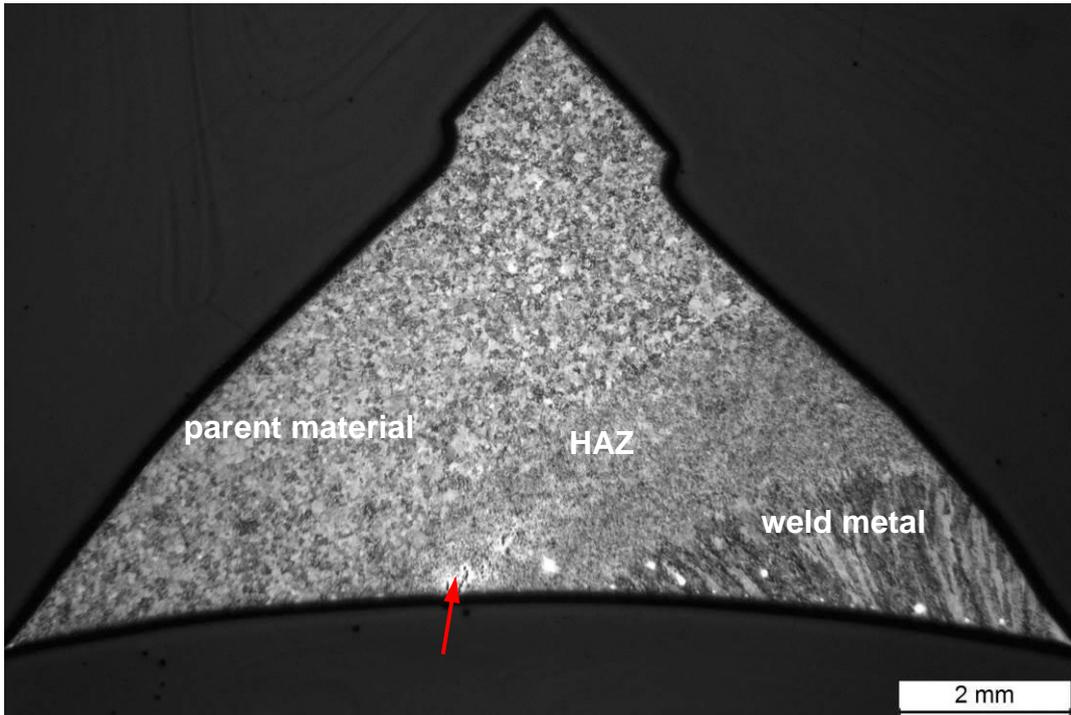
Figure 7. Cross-section of the boat sample, showing the position the creep crack (arrow).

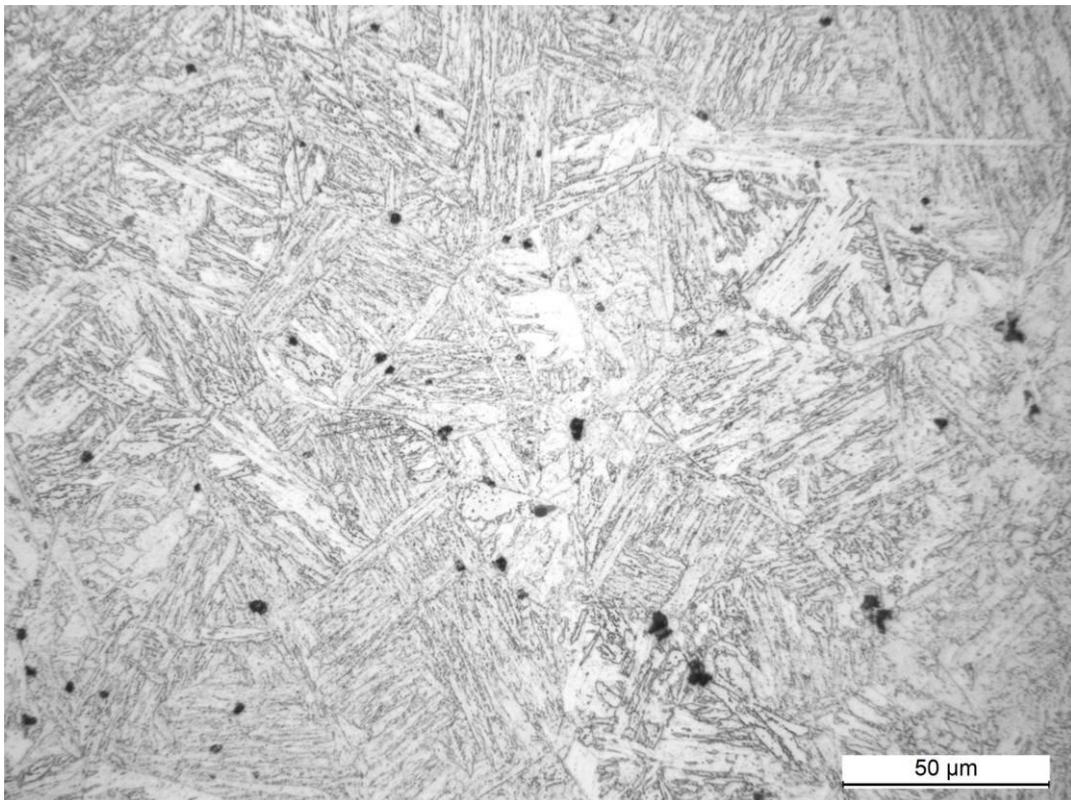
Figure 8. Cross-section surface of the boat sample in the type IV HAZ region, with creep cavities.

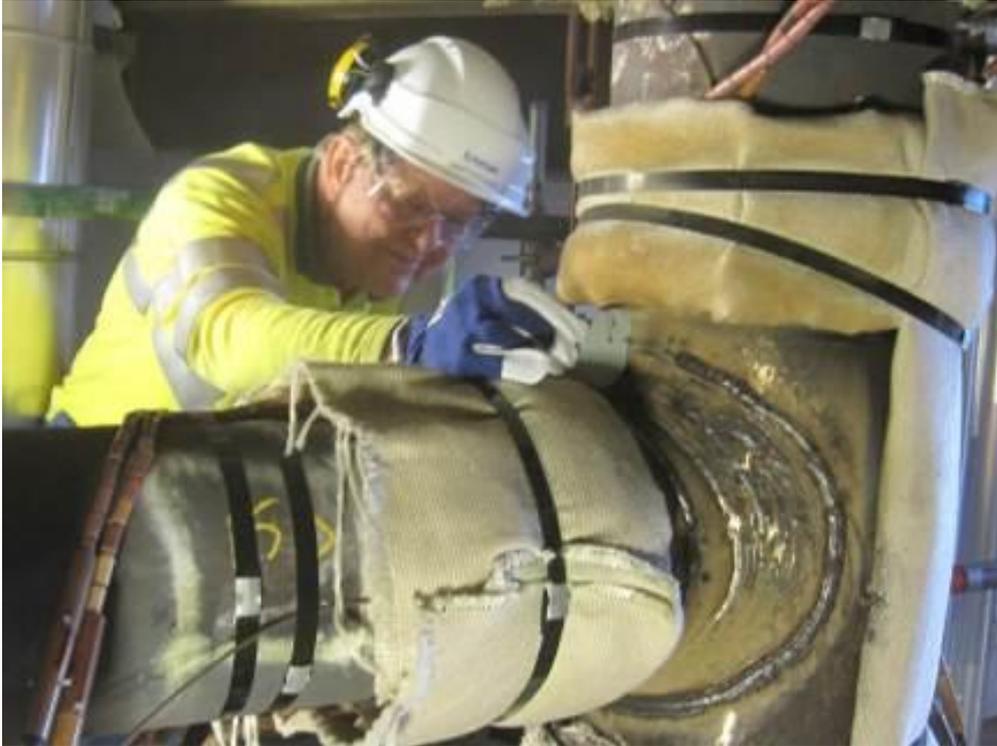
Figure 9. Repair welded branch to reduction valve (photo: Ville-Veikko Kylliäinen, Fortum).

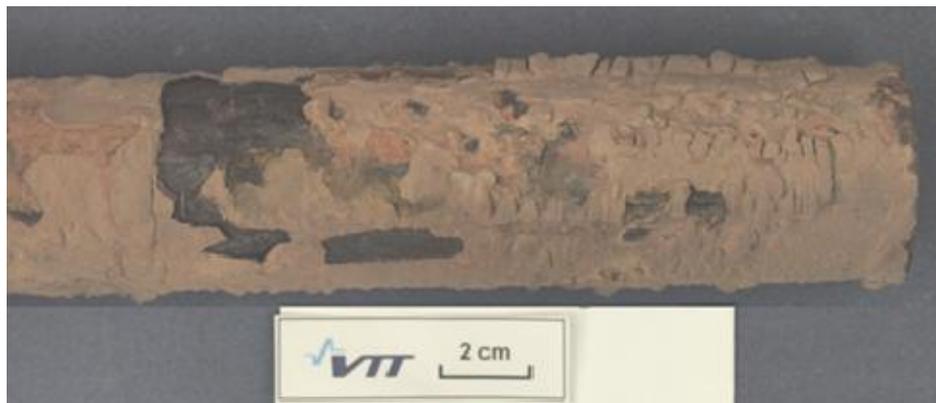
Figure 4. Overview of corrosion probe head after testing campaign

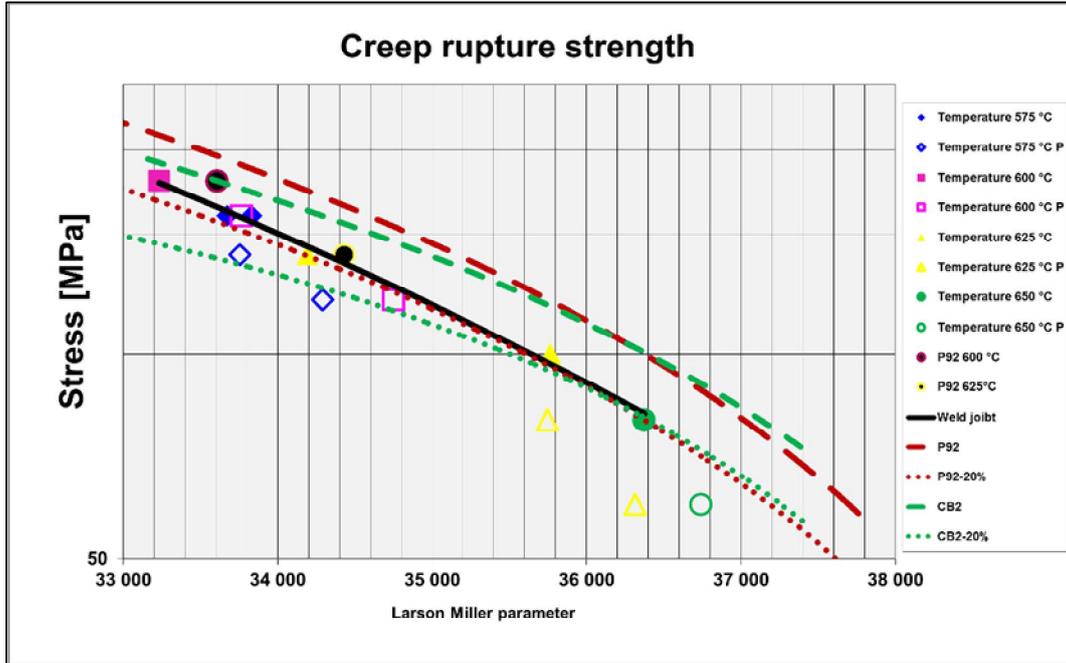
Figure 1. Creep rupture strength vs. LMP.

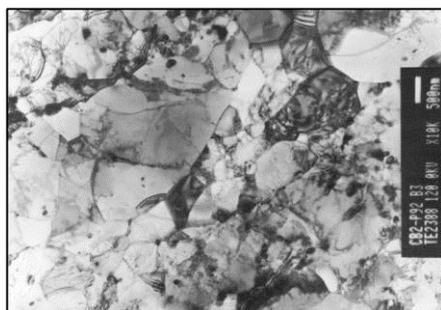
Fig. 14. Substructure of HAZ P92, TEM-thin foil.

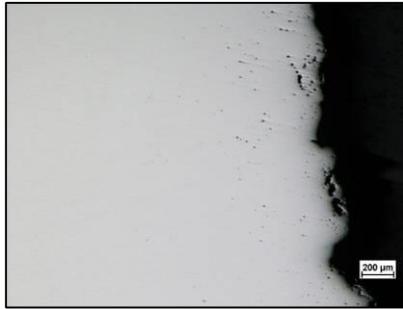
After creep tests of samples ruptured in HAZ of steel P92, cavities were concentrated in the FG regions of both the base materials. However, fractures occurred in the HAZ of steel P92, in the FG and/or IC regions. Cracks were formed by cavitation coalescence and they propagated parallel to the fusion line (Fig. 16a, 16b). A significant increase in the number of particles occurred inside the HAZ of P92 in comparison with the conditions after PWHT (Fig. 17). In addition to Cr-carbides, relatively coarse particles of Laves phase $Fe_2(W,Mo)$ were present (Fig 18). They usually nucleated at carbides situated at the boundaries. This increase was not prominent in the base material P92. Precipitation of fine particles of MX and M_2X , only slight coarsening of $M_{23}C_6$, and sporadic precipitation of Laves phase, occurred close to the fusion line. Higher temperatures and stresses promoted nucleation and growth of Laves phase. Dislocation at boundaries, which were occupied with large particles and clusters, formed pile ups and stresses in their surroundings and initiated cavitation. Recovery and recrystallization of the matrix were in progress at the same time. Cavities nucleated at clusters and coarse particles of Laves phase were surrounded by a 'soft' region of recovered/recrystallized subgrains/grains. Thus, space distribution of cavities depended on the number of initiation centres of new particles, the rate of their growth and extent of recovery. These phenomena also control the position of the maximum concentration of cavities in the HAZ.

Fig. 16a. HAZ P92, LM-bright field, sample 625 °C/ 100 MPa/ 6,661 h.

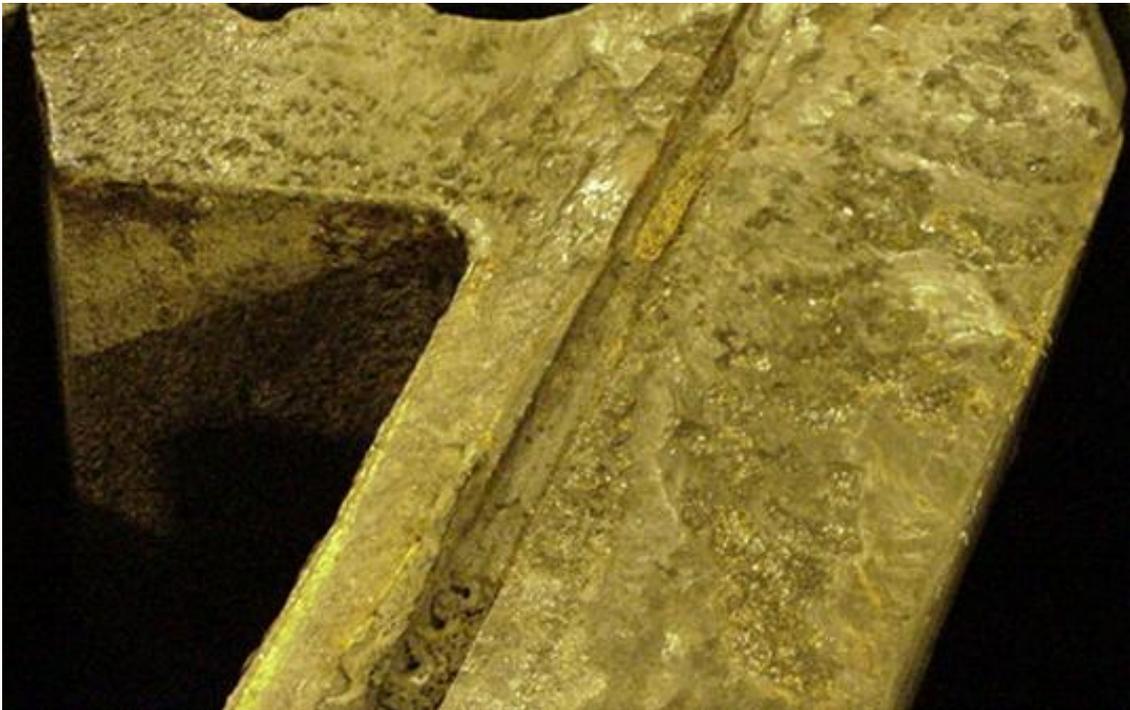
Figure 2. Surface damage of a turbine main flange (width ca. 150 mm; photo T. Tenkula, Telatek Service)

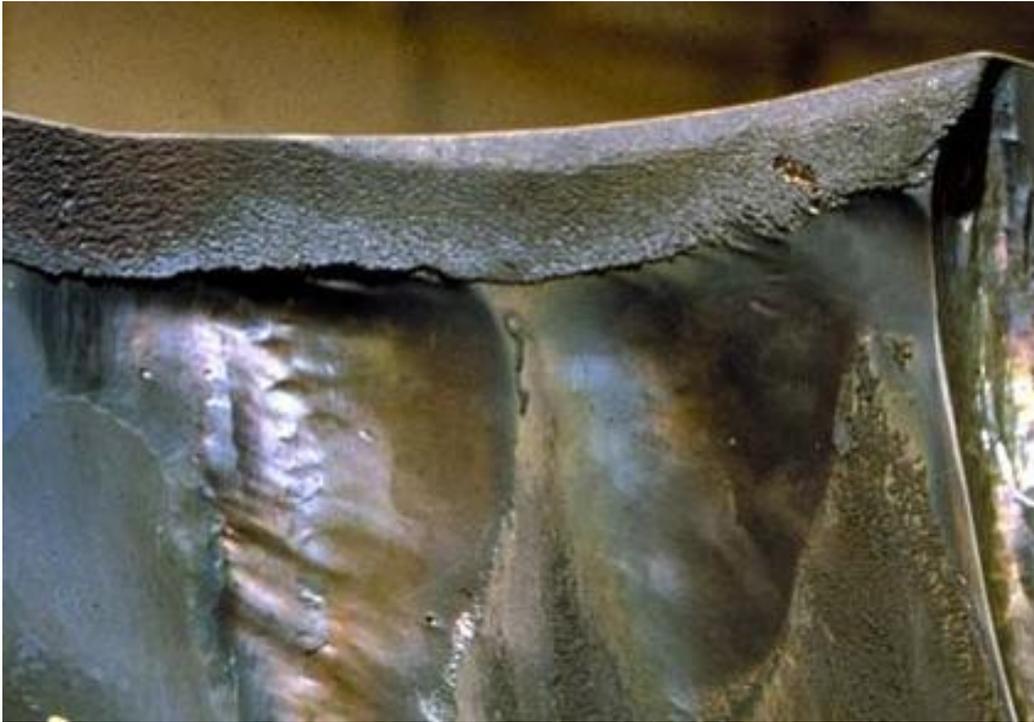
Figure 3. Steam erosion of a turbine casing body below a 35 mm layer of thermal spray restoration that did not suffer erosion and protected the flange surface (photo: J. Rintala, Telatek Service).

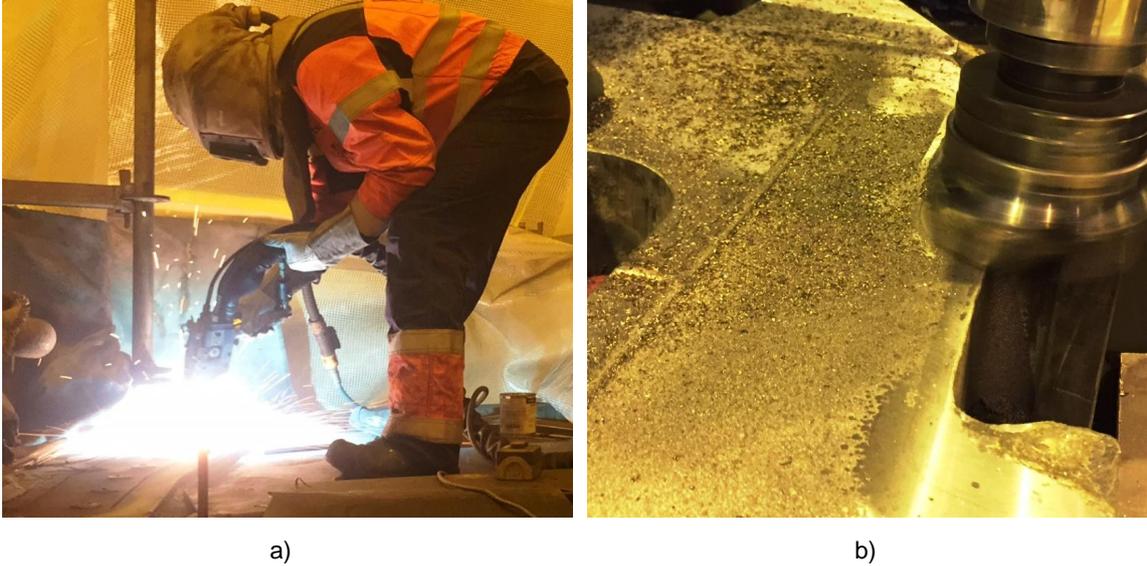
Figure 7. a) Surface restoration by thermal spray; b) machining of the flange surface after coating (photos: J. Sipilä, Telatek Service).

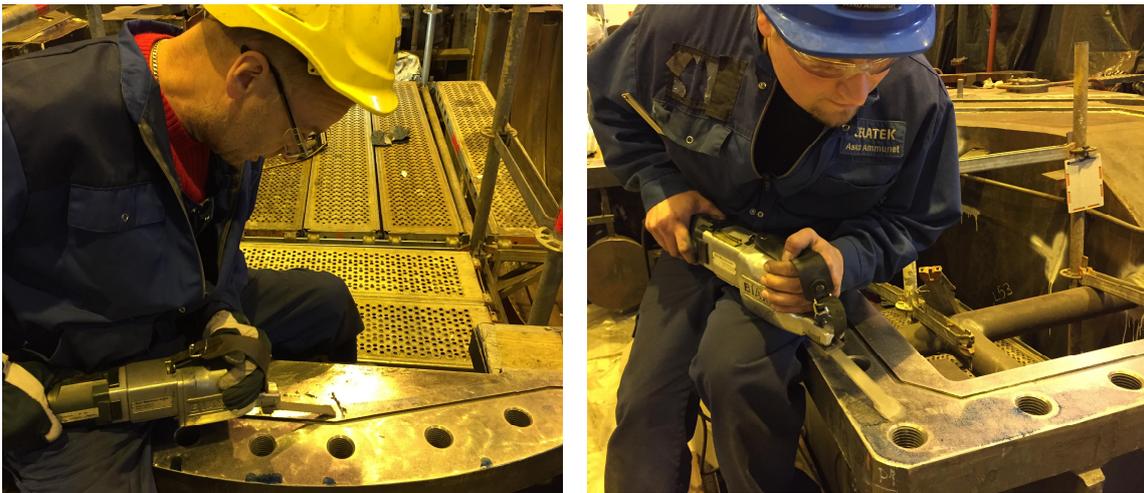
Figure 9. Scraping combined with surface colour inspection for achieving good surface contact (photos: J. Sipilä, Telatek Service) .

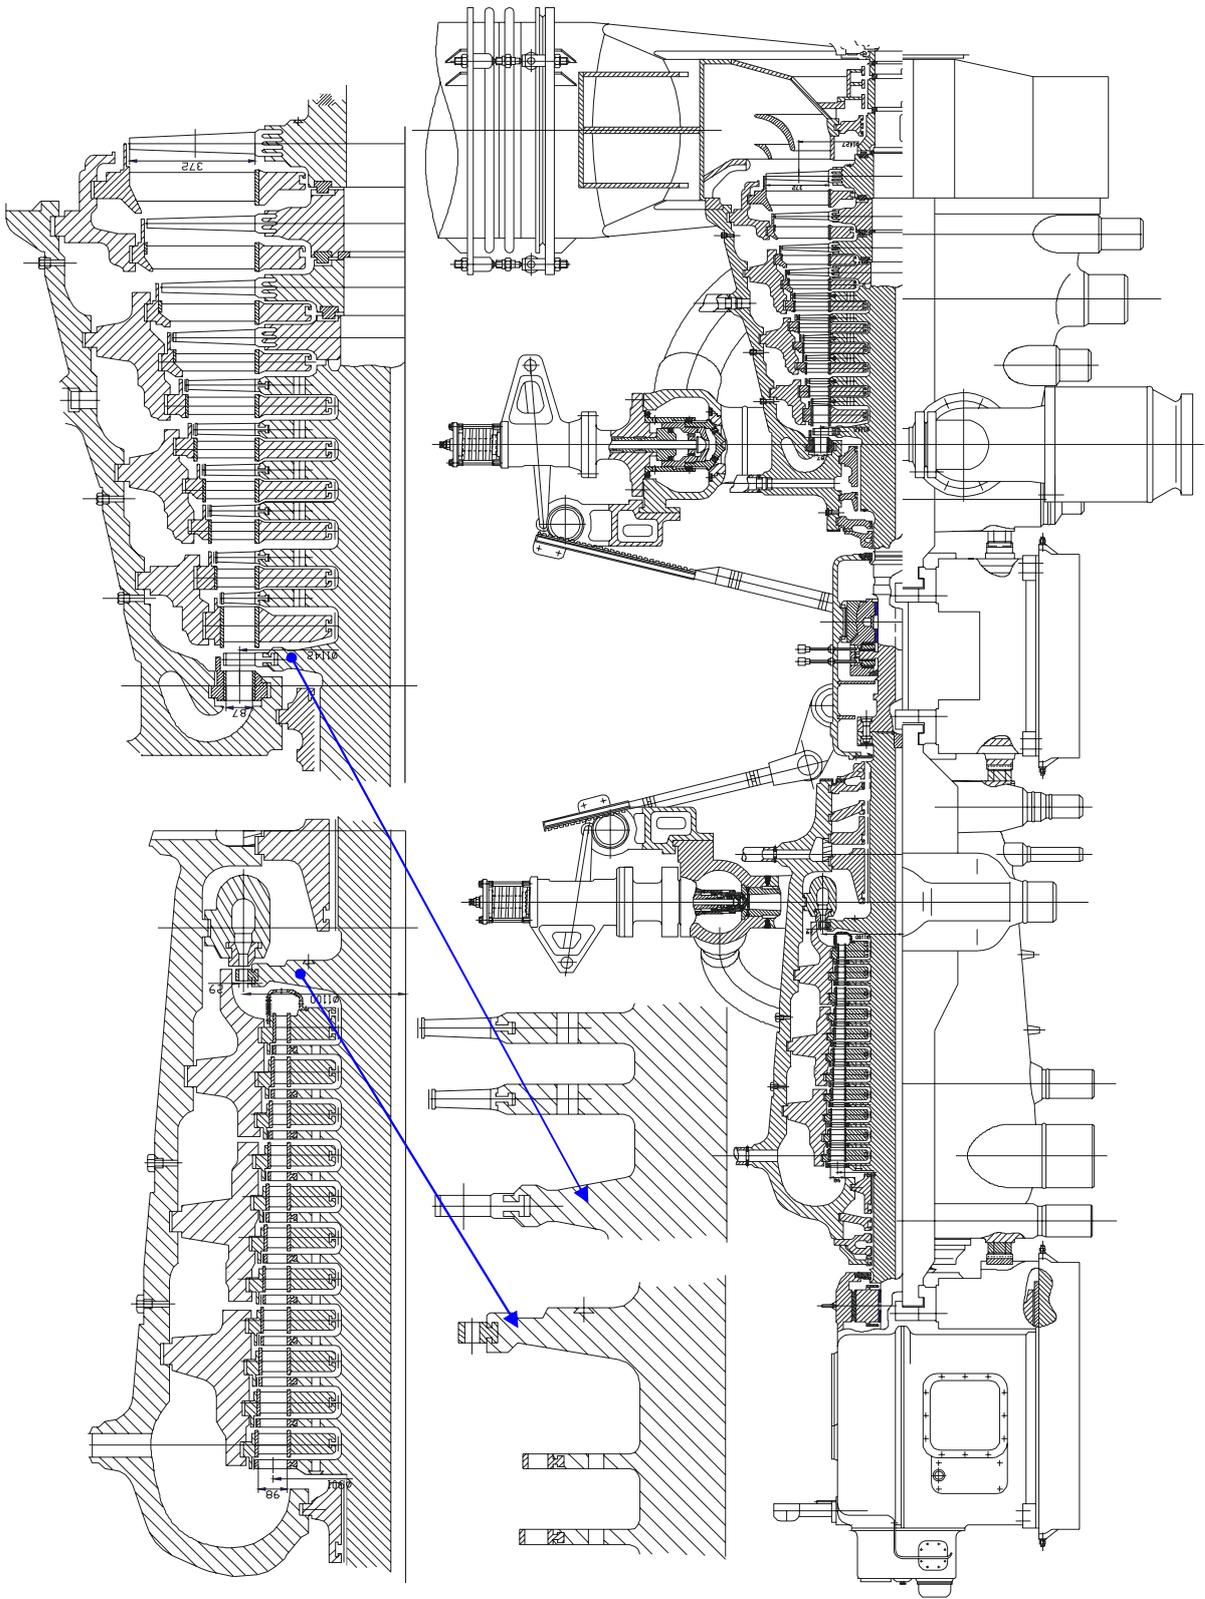
Figure 1. Longitudinal cross-section of HP and IP rotors of steam turbine K-200-130.

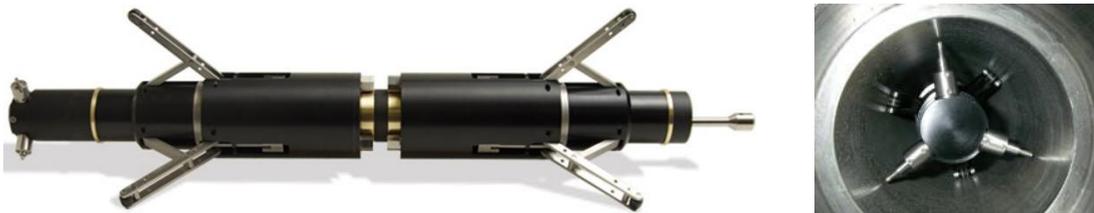
Steam turbine rotor is exposed at high temperatures and stresses that causes a plastic deformation of material. Plastic or creep deformation monitoring has been carried out by measurements of diameter of rotors bores. Bore micrometer is presented in Figure 3. The diameter has been measured every 100 mm along the length of rotors.

Figure 3. Bore micrometer for measurement of bore diameter

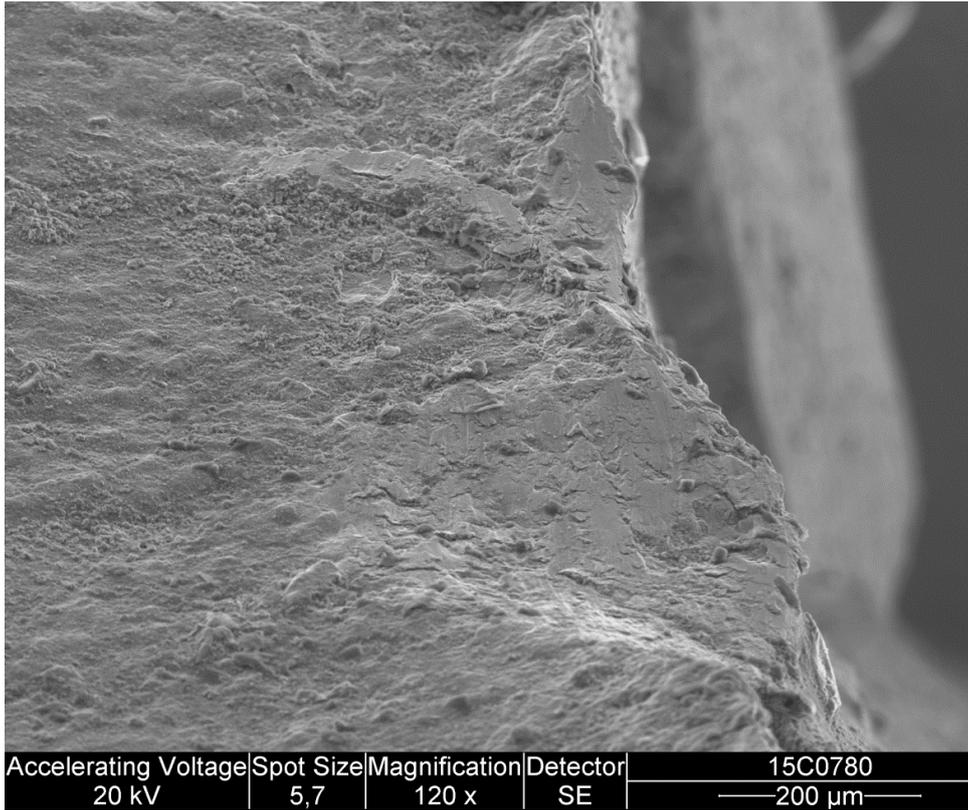
Figure 4. Detail from Figure 2b, near the fracture initiation (blade 45).

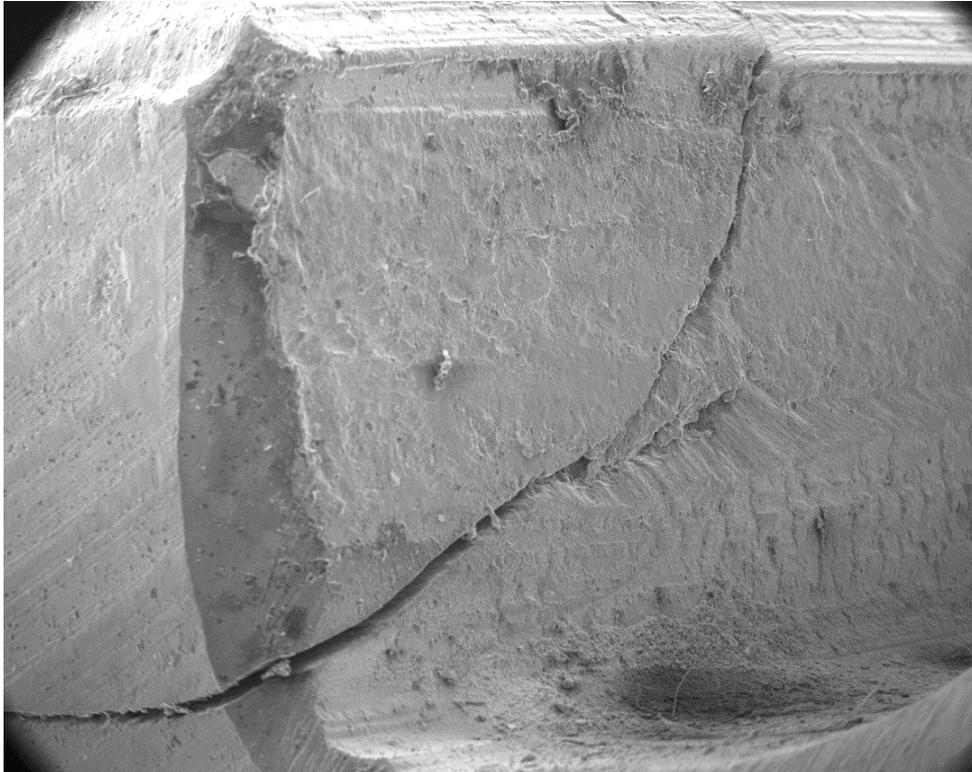
Figure 5. Crack of blade 108 as seen from the top side of Figure 3a.

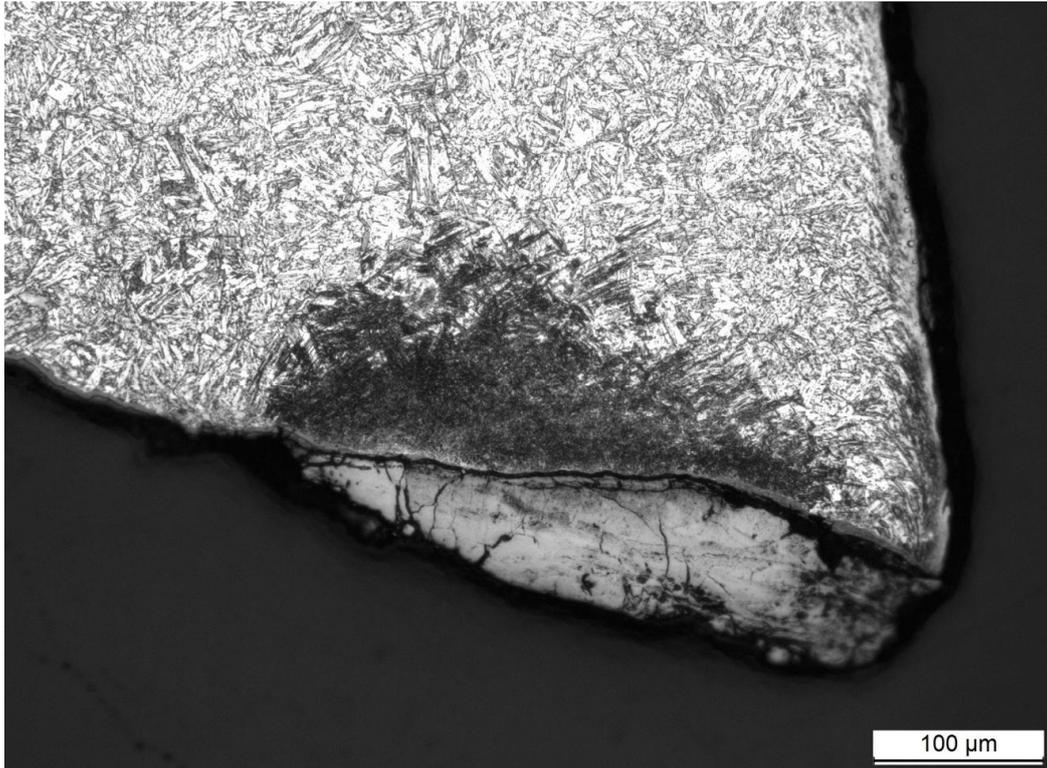
Figure 6. Cross-section with surface oxide at the fracture initiation site of blade 108.

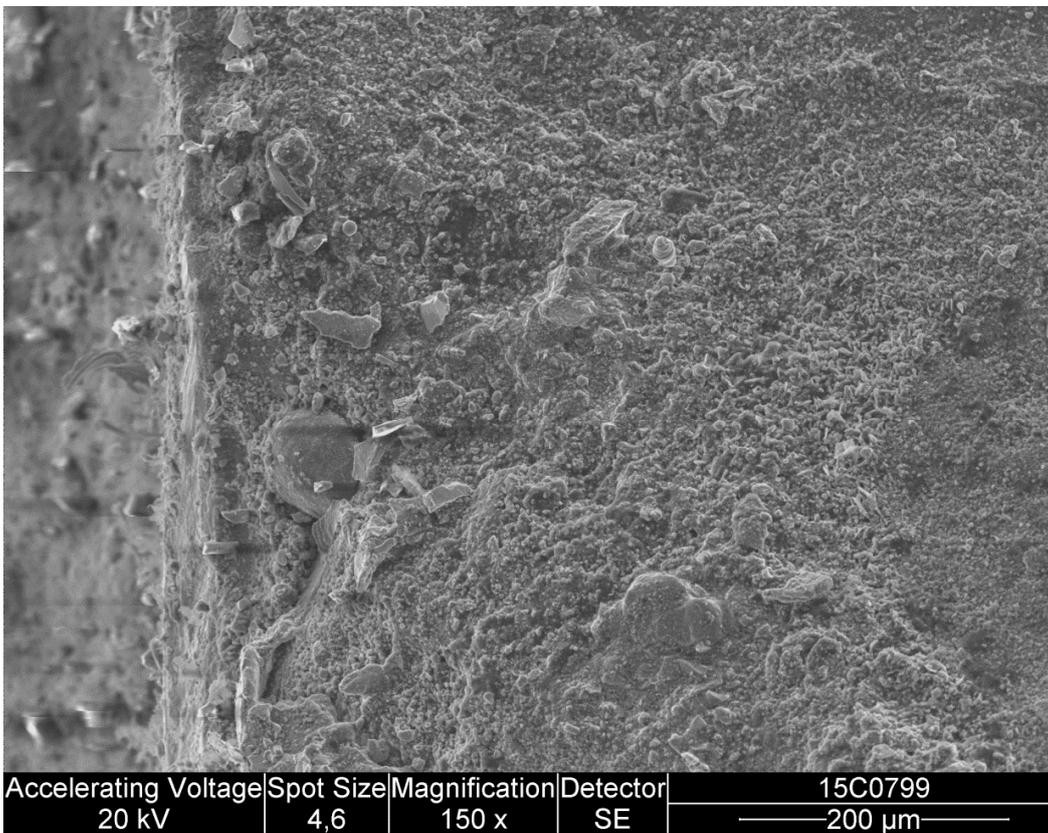
Figure 7. Surface of the fracture initiation site of blade 108.

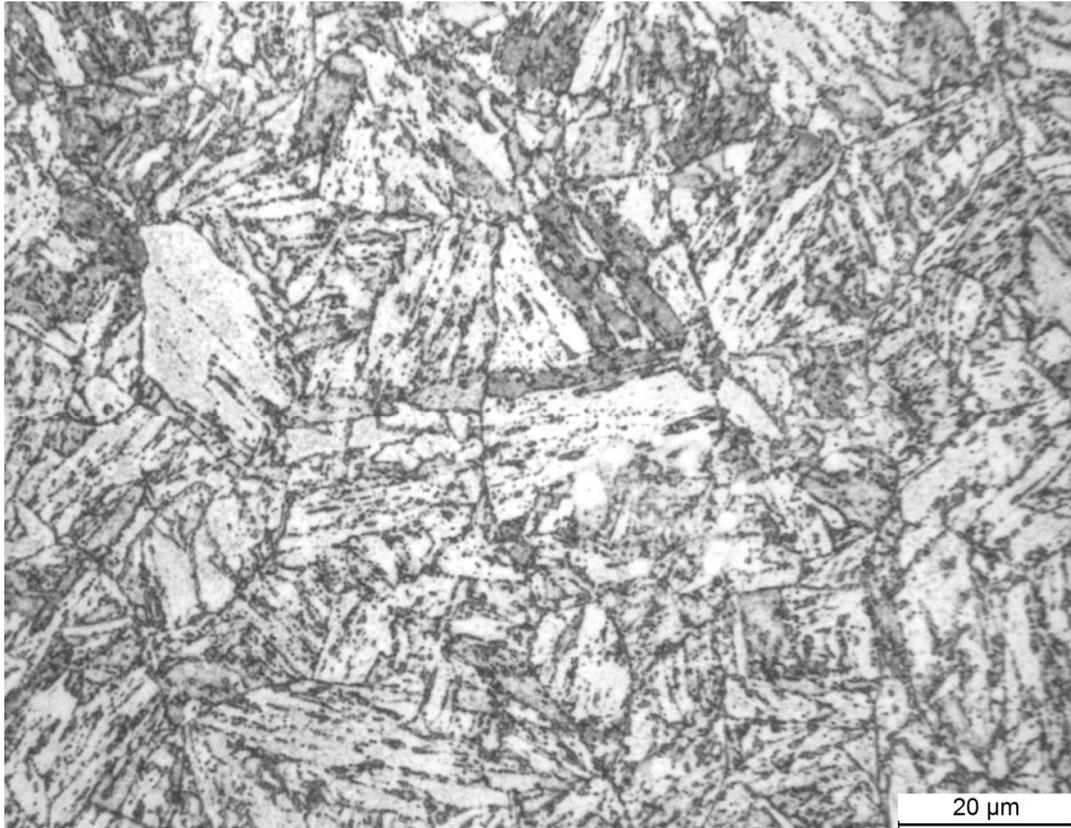
Figure 8. A detail of the tempered martensitic microstructure of blade 108.

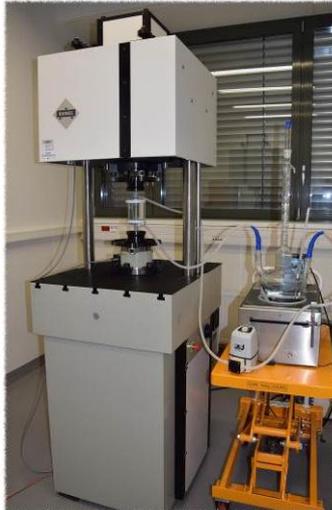
The resonant testing machine TESTRONIC 250 made by a Switzerland firm RUMUL was used for all following experiments (see Fig. 1). It is a dynamic testing machine which works in full resonance for loads up to 250 kN. The maximal oscillating stroke extension is available up to 4 mm. The resonant operating frequency is given in ranging from 40 up to 250 Hz by the oscillating masses and among others by the stiffness of the specimen. The load of specimen is a combination of a static and a dynamic force. Both parts are controlled separately. Measuring accuracy is better than 0.5 %. The dynamic drive with springs, masses and driving magnet is located in the upper part of the machine. The dynamic drive operates as a mechanical resonator and is excited by an electromagnet. Maximal dynamic load is ± 125 kN. The main inertia on the upper part and the lower part of the machine oscillate against each other. The resulting elasticity, which mainly determines the operating frequency, is being built out of the specimen and the spring rods. The main inertia can be varied in 8 steps. The static drive to apply the mean load is placed in the lower part of the machine and consists of a ball screw spindle with preloaded nuts, which are mounted in a cross bar. The cross bar, the columns and the upper part build the load frame. The ball screw spindle is being driven by a gear from the servo-motor controlled in closed loop. Maximal static load in tension or compression is 150 kN. Speed of the static drive is from 0 to 150 mm per minute. The power units for both static and dynamic drive are also located in the lower part of the machine. The main board of the control unit with amplifiers and processor is placed outside the machine below a cover. The load frame and the whole lower part of the machine are built to be the counter mass. The machine is designed to consume electrical power below 1 kW. This is a more economical advantage compared to servo-hydraulic systems (likewise maintenance for pumps, valves and cooling is not necessary).

Figure 1. The resonant testing machine TESTRONIC 250 with corrosion cell set-up.

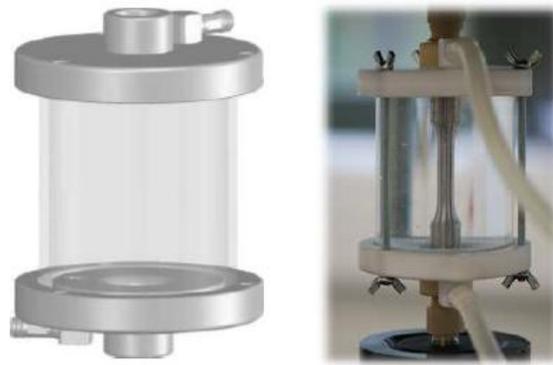
The corrosion measuring cell was designed, engineered and manufactured for tests in a corrosive environment. The cell is made of an inert material, Teflon, glass and silicone rubber. Its appearance is shown in Fig. 5. The cell has a flow volume of 1 litre, the entire electrolyte solution is about 1000 litres per hour and electrolyte is tempered to a required temperature with an accuracy of 1 °C. The bubbling an inert gas enables to control the content of dissolved oxygen in the electrolyte. It is also possible to adjust the pH. The control of electric conductivity is performed continuously. During the test of corrosion fatigue the electrode potential of specimen is also recorded.

Figure 5. Corrosion cell.

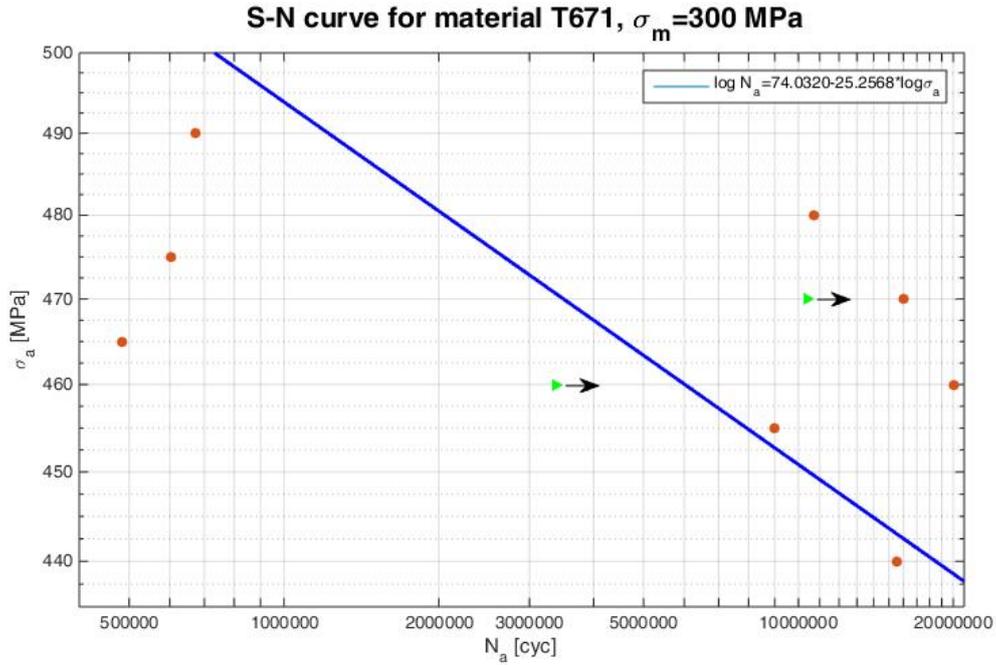
Figure 7. S-N curve for steel T671 for specimens taken from the blade body with pre-stress in a normal component $\sigma_m = 300$ MPa tested in the air.

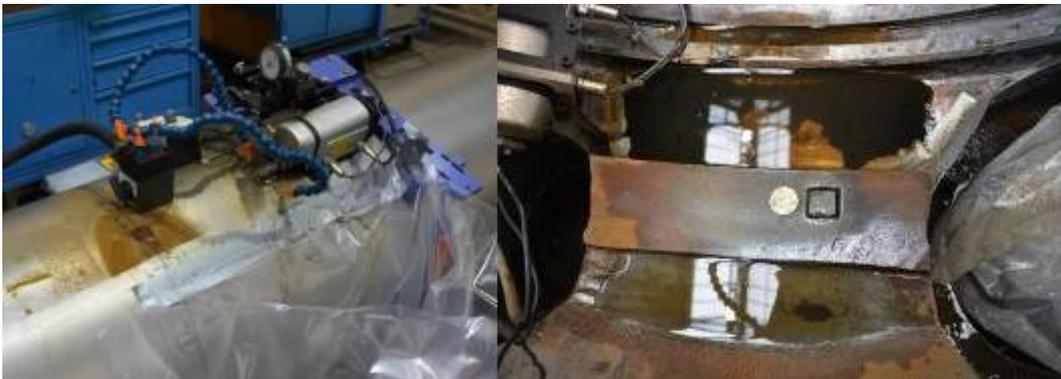
The device enables to adjust a wide range of work-piece thicknesses whereas the work-piece (boat sample) width of 20 mm is given by the electrode geometry. The thickness of the extracted material can be from 1 mm to 5 mm. In most cases, the depth was set to 3 mm using the adjustment screw. Used electrodes were customized in order to reduce a stress concentration on edges and were made of W-Co alloy. Extraction takes approximately from 1 to 3 hours depending on the material and surface curvature.

Figure 1. The set-up of EDSE left: sampling from roller, right: sampling from a part of steam turbine generator

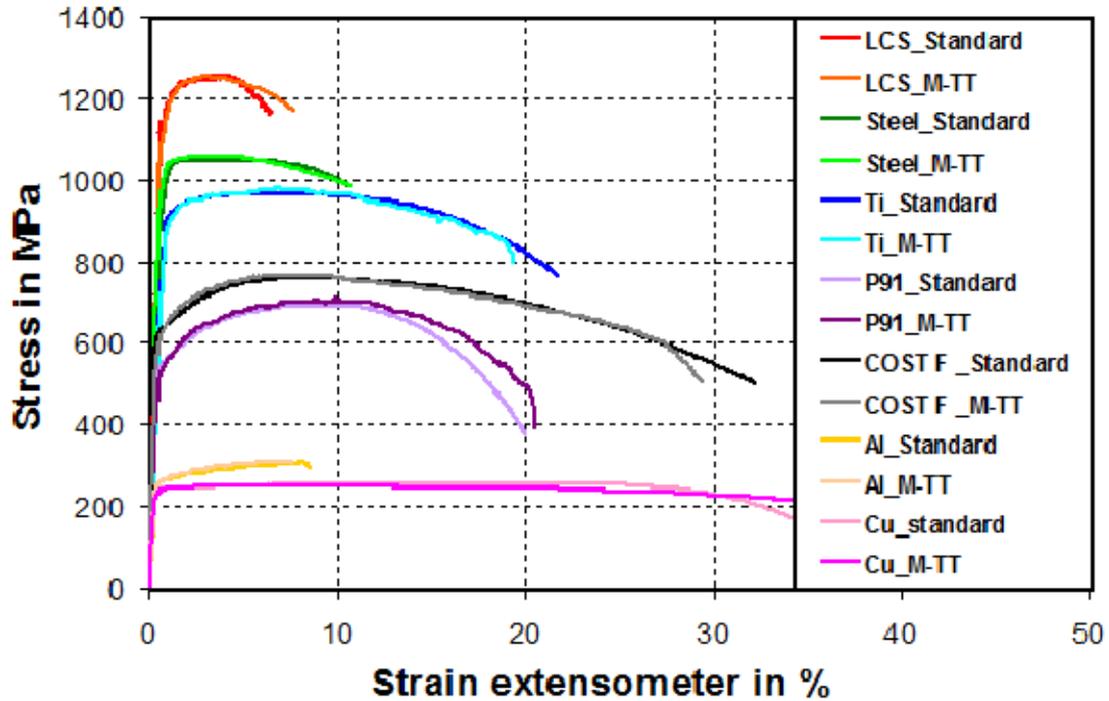
Figure 6. Comparison of tensile records obtained with DIC for M-TT measurement of various metallic materials

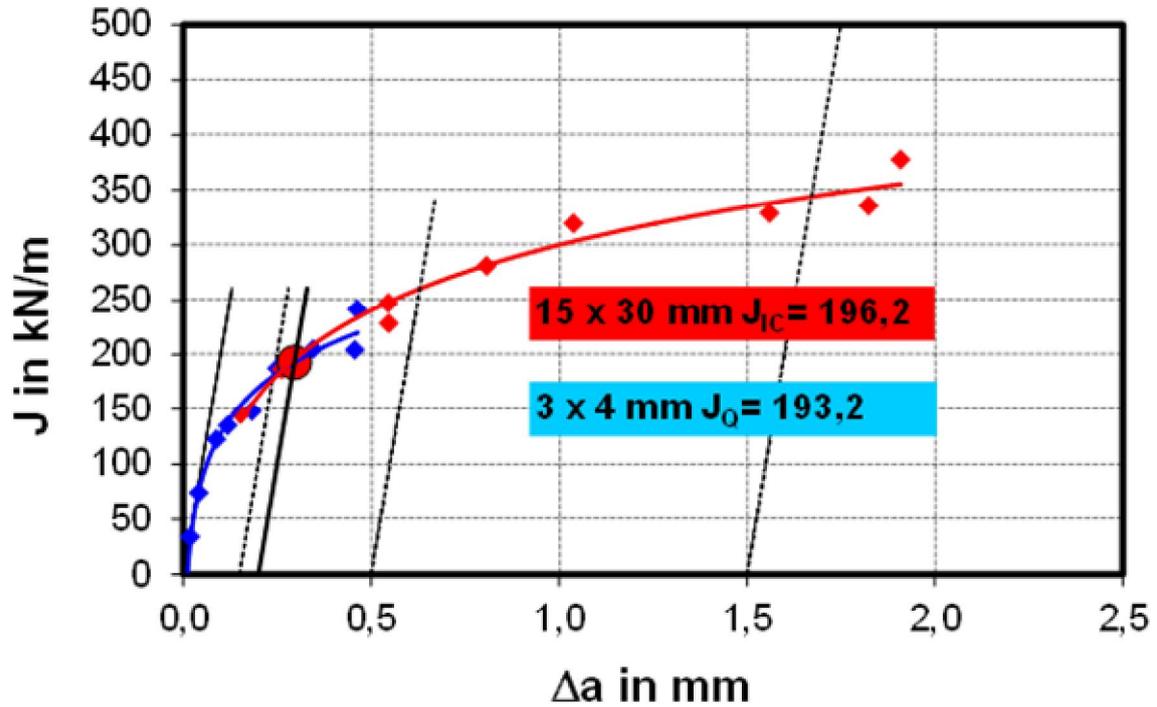
Figure 8. J-R curves of 34CrNiMo6, state as delivered

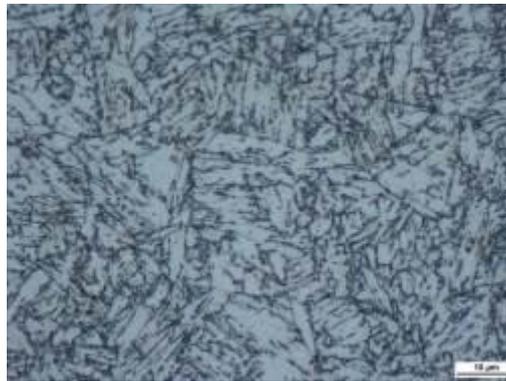
Applicability of miniature fatigue samples will be shown on 11CrMo9-10 steel alloy that is widely use in energetics (water boilers or super-heater tubes). The microstructure consists of tempered martensite, see **Figure 12**. Average grain size evaluated according to ASTM E112 was 41.1 μm .

Figure 12. Microstructure of 11CrMo9-10 steel at 500x magnification

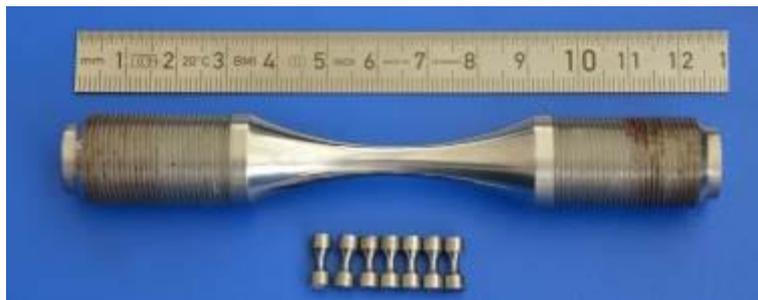
HCF tests on miniaturized specimens were conducted on servo-hydraulic testing machine MTS Bionix with load-carrying capacity of 25kN in tension-compression mode. Tests were carried out in load control with load ratio of $R = -1$ at frequency of about 50 Hz. Dimension of samples were measured using an optical measuring system to avoid scratching. If a scratch occurred the surface was additionally regrinded and measured. Wedge grips are attached to the testing machine in appropriate way to avoid bending stresses that was done with the use of alignment fixtures. After this, a fatigue specimen was put in jaws of the testing machine and the pre-load was set at zero. Size comparison with a standard HFC specimen can be seen in **Figure 15**.

Figure 15. Comparison of HCF specimens

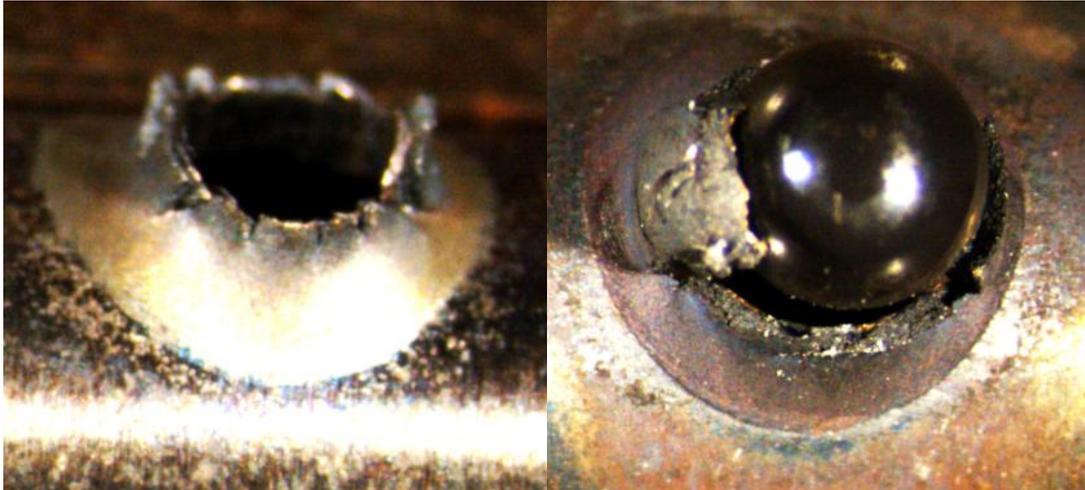
Figure 7. Fractured creep specimen A) $\varnothing 2$ mm ball 600°C / 700N, $t_r=2.8$, B) $\varnothing 2.5$ mm ball, 600°C / 700N. $t_r=2.35$
