Baltica X

International Conference on Life Management and Maintenance for Power Plants

7–9 June, 2016

VTT Technology 261

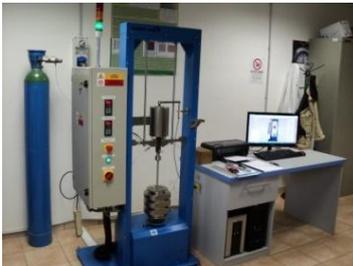
SPUTT 500 is a testing machine for residual life determining of structural components operating at elevated temperatures using a miniaturized test samples and the penetration test. The first version (V1.3 – Fig.2) based on Code of practice (CWA 15627) started to develop in 2010. At the end of the year the machine was built and its testing started. The device was semiautomatic, the temperature measurement wasn't carried out directly on its surface, but in the possible closest point (about 10 mm from the sample). The temperature of the sample was recalculated based on the mathematical dependence created by an automatic calibration process. Using the arm and LVDT sensor (Fig. 3) dependence of the punch displacement in time was measured and recorded. The punch and the lower die were made of a creep resistant nickel alloy and the sample penetration was made using the ceramic ball. Protection of the sample was ensured by argon, which was controllably (10 ml/min.) injected into the cartridge with specimen (Fig. 4).

Figure 2. SPUTT 500 V1.3.

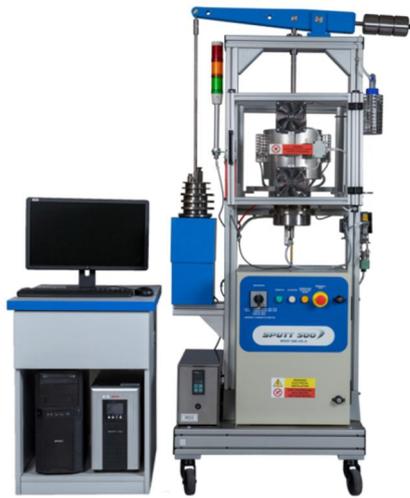
The removal of all causes could not have been done by modifying the existing machine, it was necessary to create a completely new design. Development was conducted during 2015. An entirely new version V3.1 SPUTT500 (Fig. 9) was the result of development conducted during 2015.

Figure 9. SPUTT 500 V3.1.

The new version (V3.1) differs from the previous in all directions - complete new design (Fig.10) guarantees 100% full argon protection of the sample via gas-tight chamber with bellows (tested by helium test with allowable leakage rate $1 \times 10^{-9} \text{Pa} \cdot \text{m}^3 \cdot \text{s}^{-1}$), accurate temperature measurement directly on the sample surface (thermocouple type S, class 1), entirely smooth line load (ball bearings), direct load measurement under the sample (measurement accuracy 0.1% of MR), a new construction of the cartridge with the ceramic punch and the lower die and the new control software (Fig.11,12,13) for fully automatic system with nine user-programmable cycles (Fig. 12). The preload of the sample has been eliminated completely. Minimum torque of the cartridge was set to preserve the initial diameter of the sample throughout the test. The resulting dependence of sample deflection vs. time is entirely smooth (Fig.14,15). Three stages of creep can be clearly identified from the curve of the creep rate (Fig.16,17).

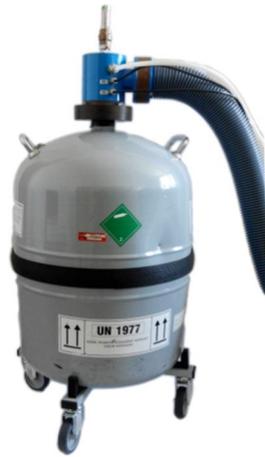
Figure 18. Special probe in Devar container.

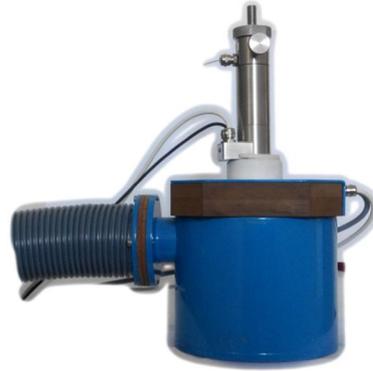
Figure 19. Test chamber.

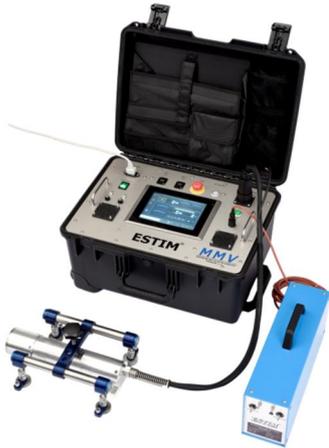
MMV company has been using the sampling machine Rolls-Royce SSAM-2 since 1996. Over the years the equipment was repaired by our staff, reviewed and improved. Based on gained experience MMV has developed own sampling machine called ESTIM (Fig. 27, 28, 29). Its design is built on the principle spoon

Figure 27. Estim.

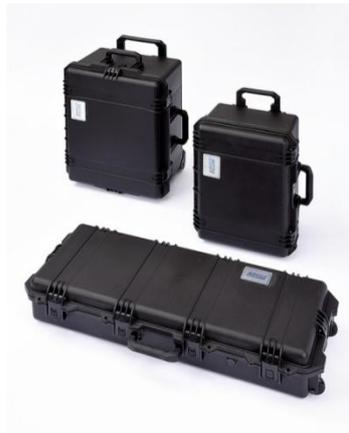
Figure 28. Estim transport package.

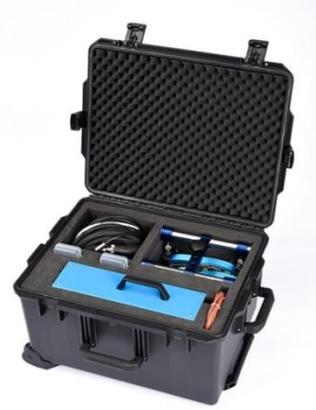
Figure 29. Suitcase with accessories.

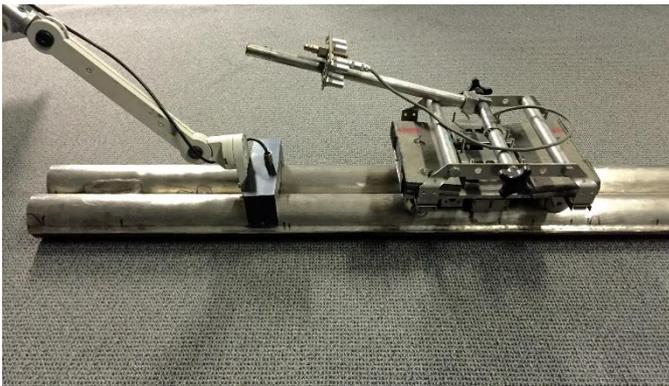
An advanced technique of eddy current method is array ET. It consists of multiple probes that are arranged in the measurement head modified specially to the inspected component. It enables relatively fast and extensive inspection of challenging components, e.g. recovery boiler floor tubes, see figure 2.

Figure 2. The special measurement heads for recovery boiler floor tubes and fins, array ET.

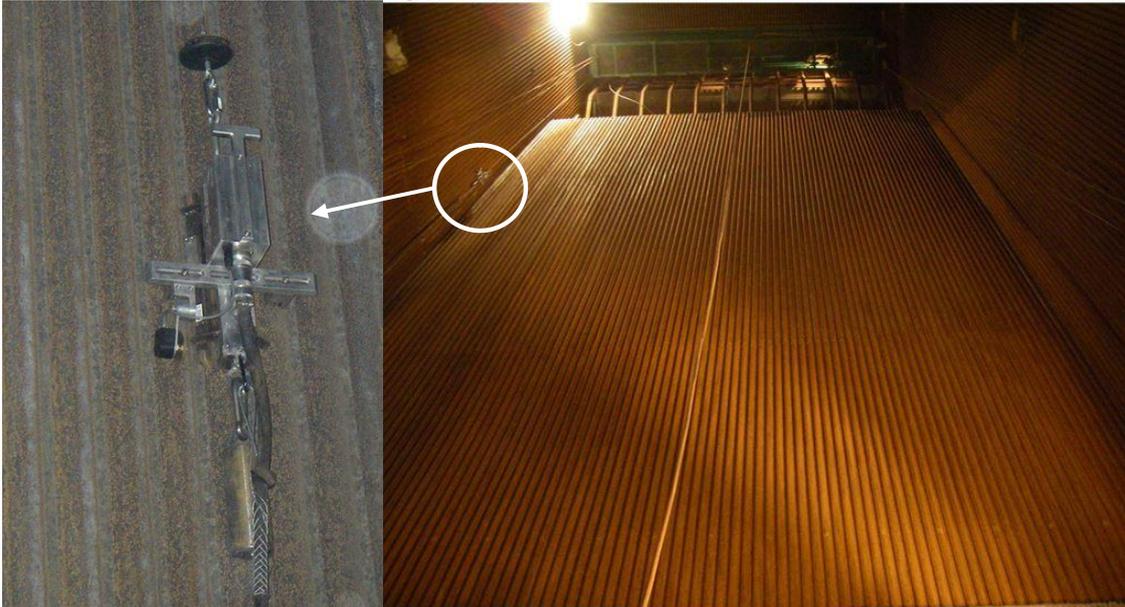
T-Scan is a brand name for tube scanning method that combines EMAT, crawler and a client view, C-scan. Basically in T-Scan the crawler with three probes measures the tube wall thickness from fin-to-fin and the crawler moves the probes through the whole furnace from bottom to top of the boiler, see figure 3. The special C-Scan client view displays the results in 3-D form and the customer gets the software for adjusting the color scheme appropriate to the purpose, e.g. red color for locations where the wall thickness is below the minimum allowed value. T-Scan is developed specially for inspecting of straight furnace tubes with membrane structure, but it can also be applied for superheaters in the areas where accessibility is possible. No grinding is needed for the surface. For opening tubes and lower bends manual EMAT can be applied.

Figure 3. T-Scan crawler scanning the boiler membrane wall.

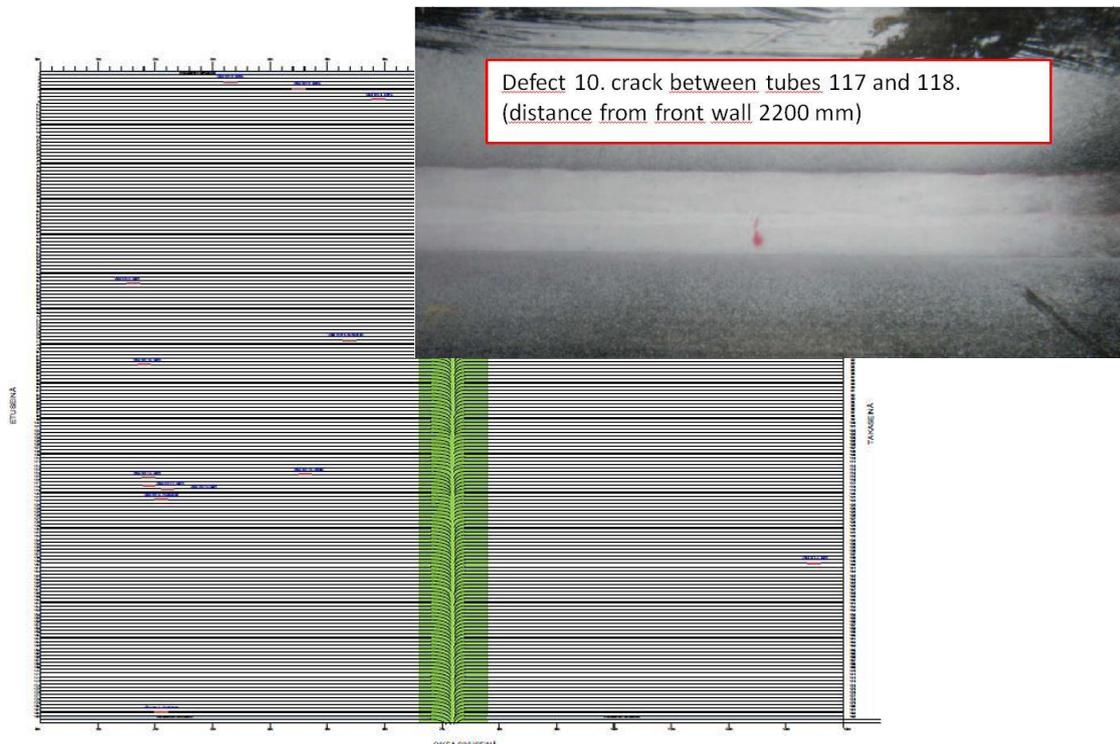
Figure 9. Map of detected defects with array ET and example of a crack verified by PT.

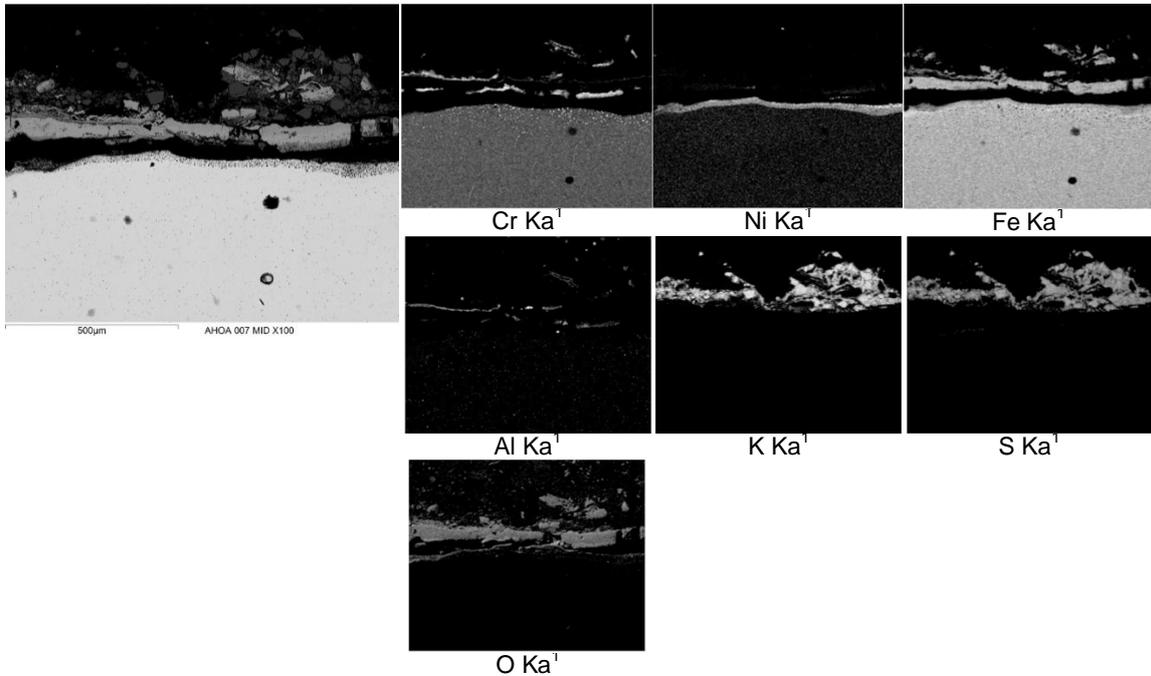
Figure 11. EDS analysis of the laser clad FeCrAl coating exposed to simulated eucalyptus combustion atmosphere for 3000h at 650 °C.

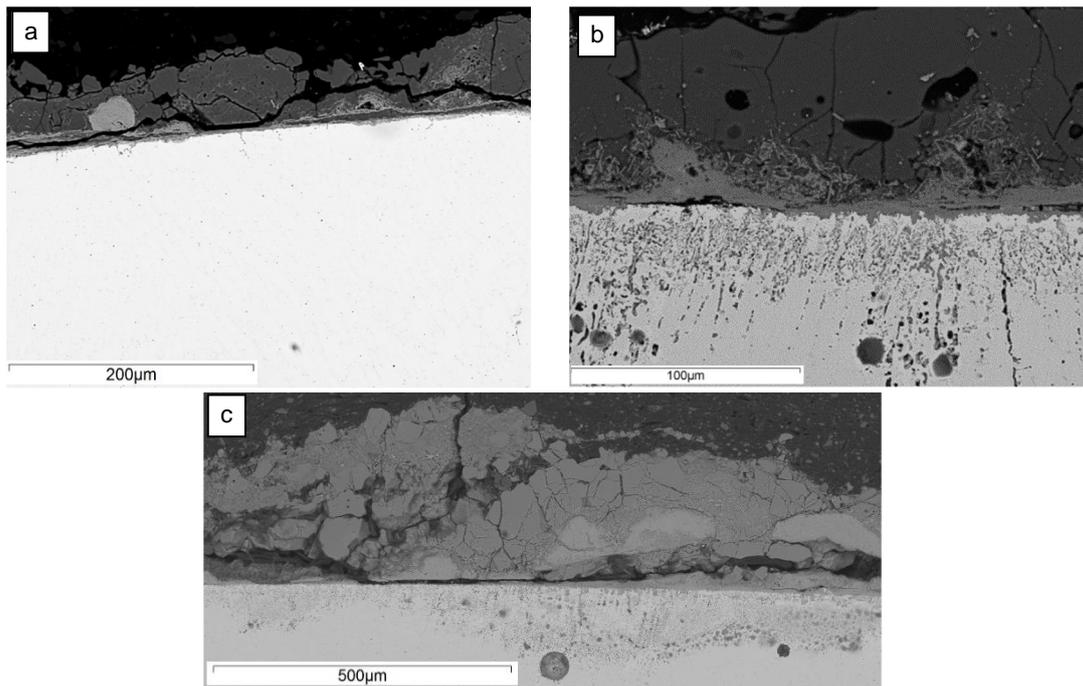
Figure 14 SEM micrographs of laser clad NiCr exposed to simulated eucalyptus combustion atmosphere at 650 °C for a) 1000, b) 2000 and c) 3000 hours.

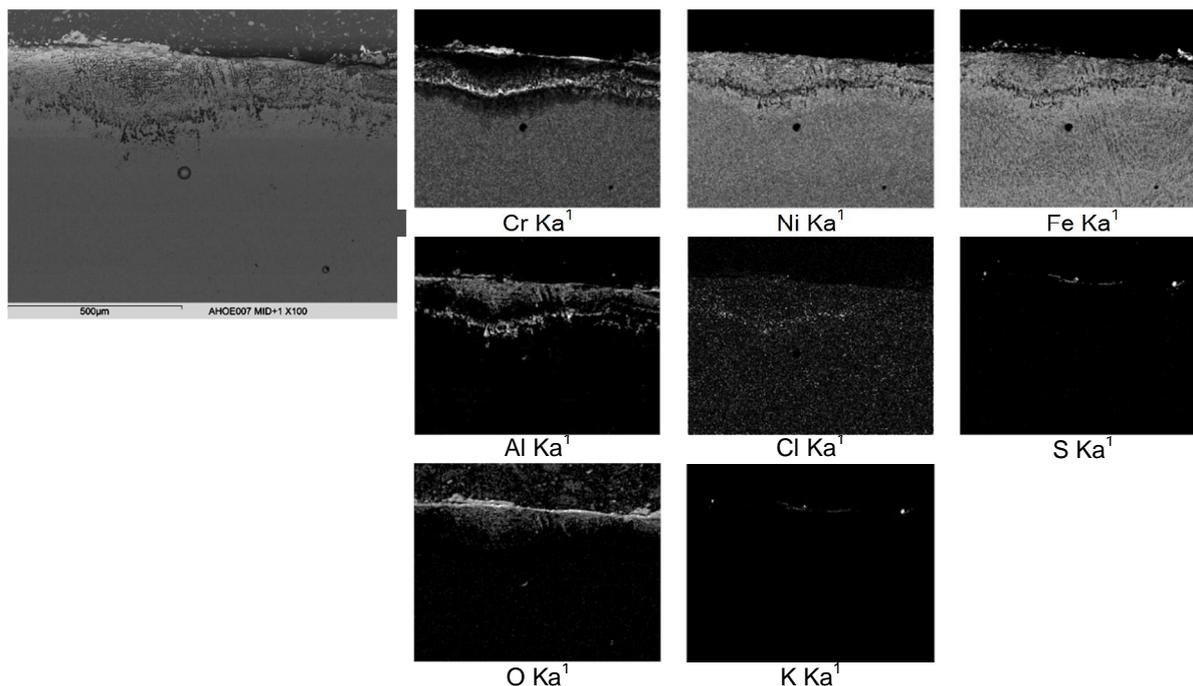
Figure 18. EDS relative chemical distribution maps of laser clad NiCr exposed to simulated eucalyptus (high HCl) combustion atmospheres for 3000 hours at 650 °C.

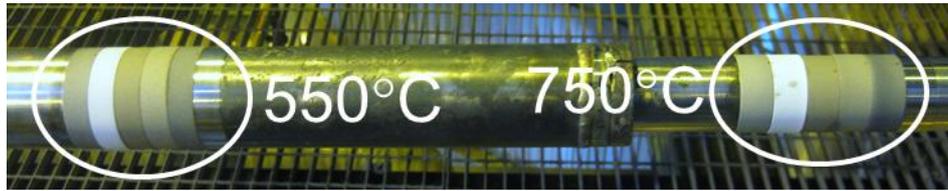
VTT has developed an advanced water- and air-cooled probe, which can be used for controlled material testing in boiler conditions. The probe is approximately two meters long and has two sections with six test rings in each. One section is water- and air-cooled and was exposed to metal temperatures of approximately 550 °C and the second is air-cooled with metal temperatures around 750 °C. The probe with the two separate sample regions is presented in Figure 2. The temperatures were measured on windward side (the control temperature) and leeward side and they were recorded once a minute throughout the exposure. The flue gas temperature was measured in the tip of the probe with one covered thermo-couple. Process data was collected from the plant's reporting systems after the exposure together with monthly fuel data. The amounts of sulfur dioxide SO₂ and hydrogen chloride HCl were monitored during the exposure.

Figure 2. The test probe with two temperature regions: lower temperature (550 °C) with water- and air-cooling, and higher temperature (750 °C) with air-cooling.

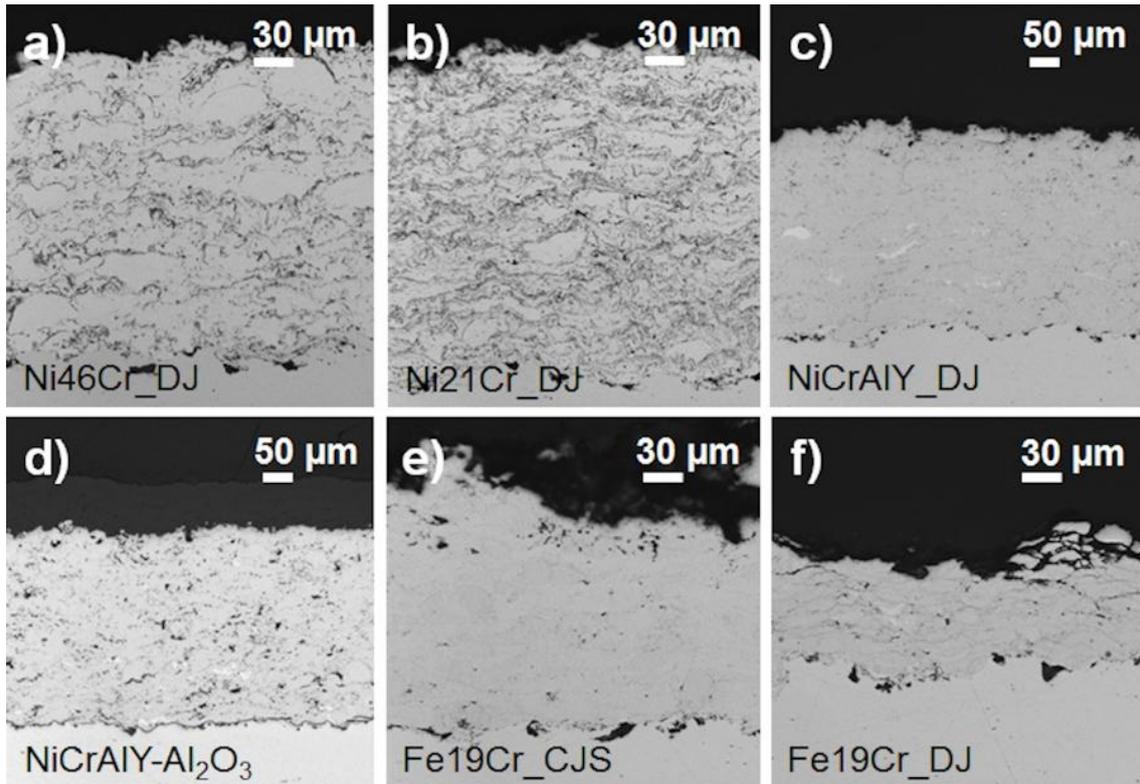
Figure 4. Optical micrographs of the cross-sections of the as-sprayed coatings before the boiler exposure. a) NiCr, b) Ni21Cr, c) NiCrAlY, d) NiCrAlY-Al₂O₃ (Al₂O₃ layer darker grey), e) FeCr (CJS) and f) FeCr (DJ).

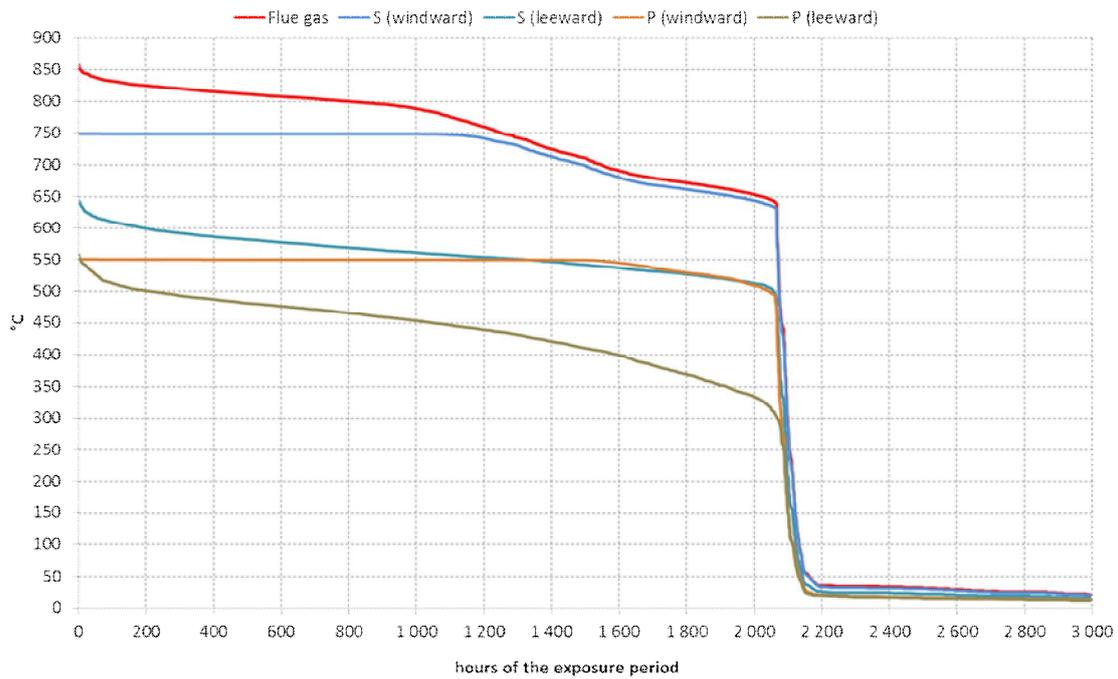
Figure 6. The measured temperatures during the 3000 (3400) h exposure presented as stability curves. Red line presents flue gas temperature, upper blue line windward side temperature and lower blue leeward side temperature at higher temperature region; yellow line presents windward side and green leeward side temperature at lower temperature region.

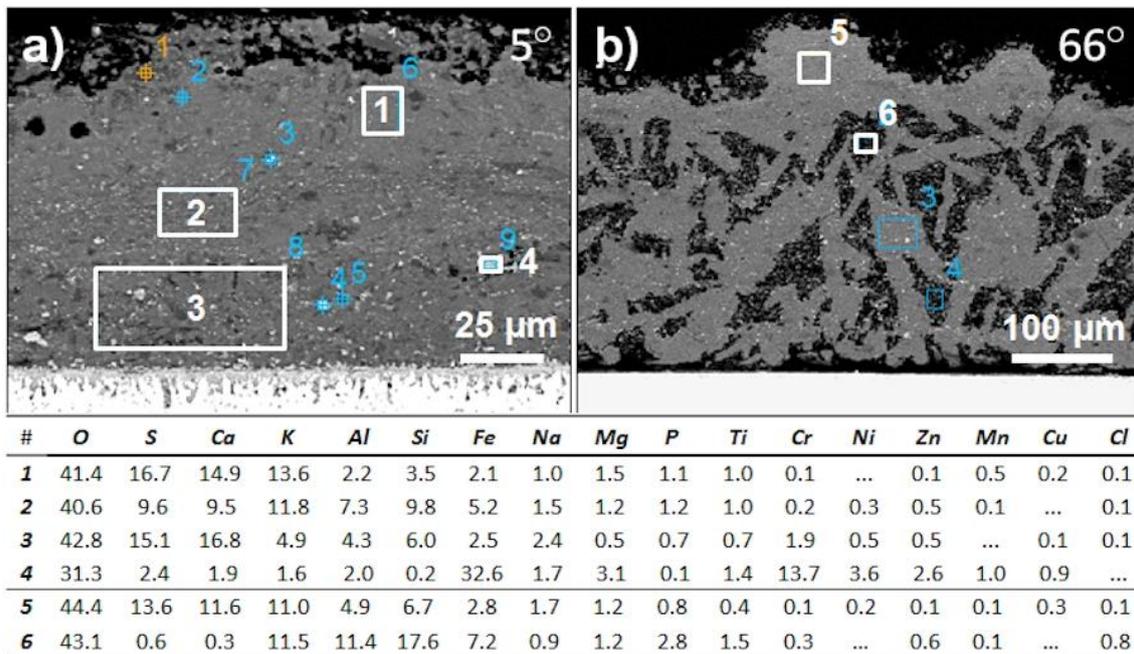
Figure 9. SEM images (back scattered electrons - BSE) and EDX analyses of the deposit on A740 material in the flue gas side (5°) and in the side of the probe ring (66°).

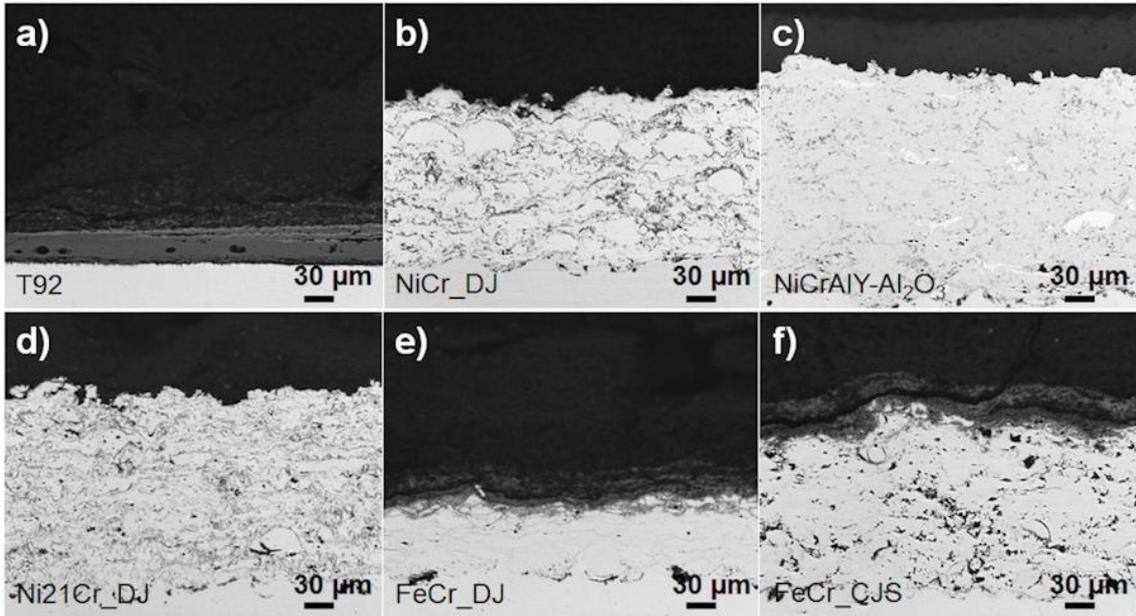
Figure 10. Optical micrographs of the materials after the 3000 h exposure in co-fired boiler at 550°C. a) T92 steel, b) NiCr, c) NiCrAlY-Al₂O₃ (Al₂O₃ layer darker grey), d) Ni21Cr, e) FeCr (CJS) and f) FeCr (DJ).

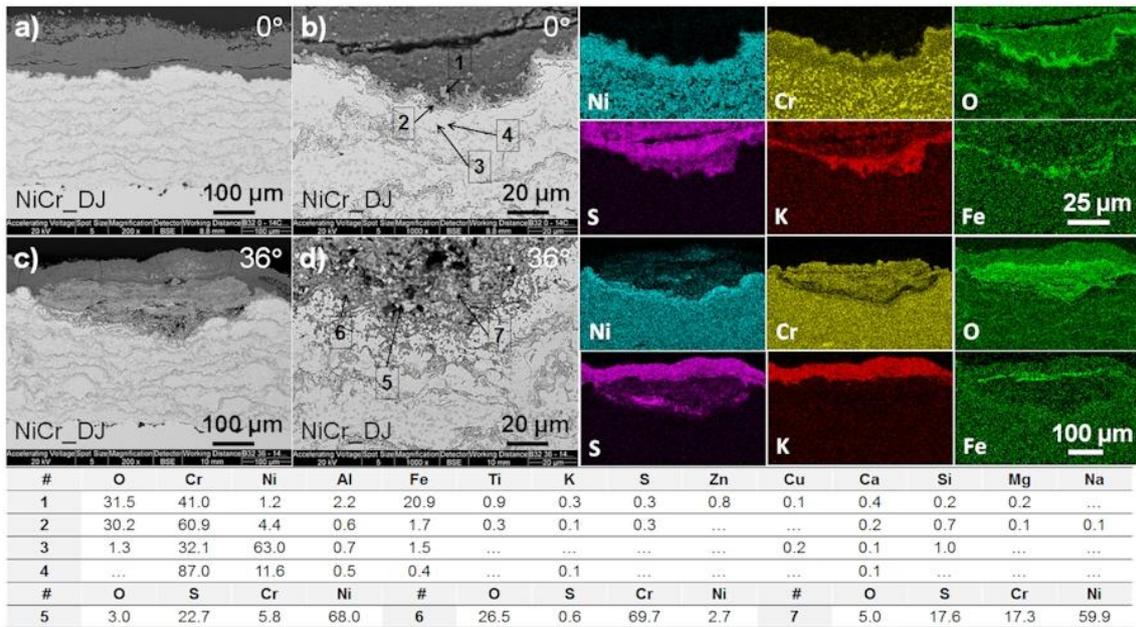
Figure 12. SEM image (BSE) and EDX analyses of NiCr coating after the boiler exposure in the flue gas side (0°) showing excellent corrosion resistance and local severe corrosion at 36°.

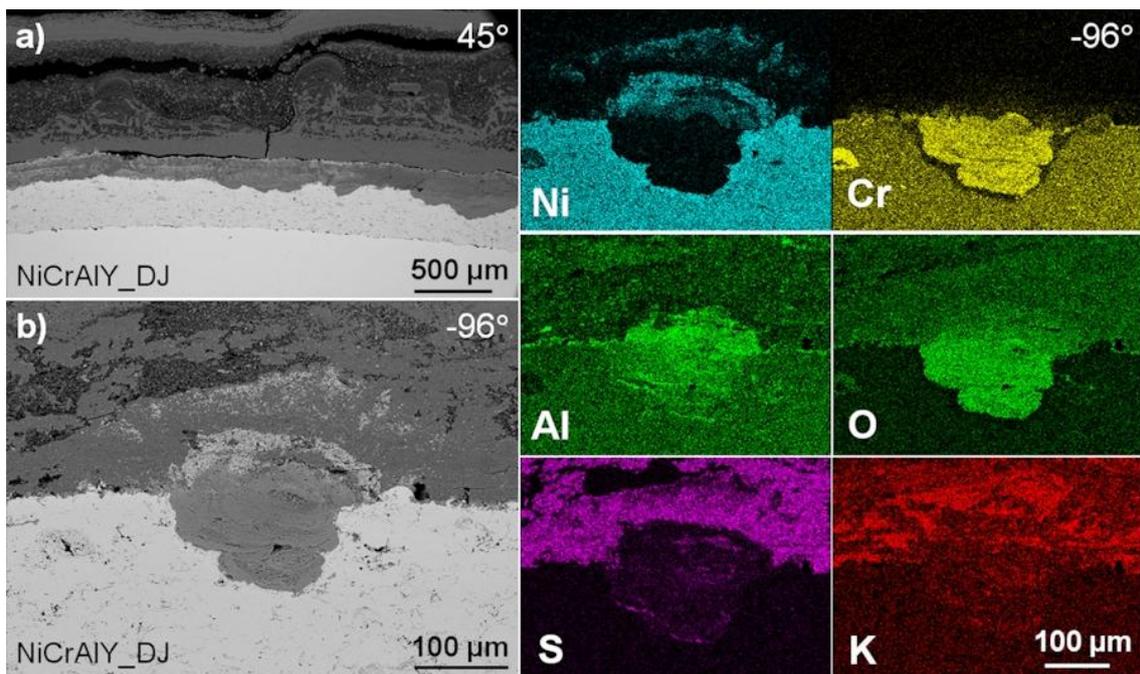
Figure 13. SEM image (BSE) and EDX maps of NiCrAlY coating after the boiler exposure in the side areas of the probe ring (45° and -96°).

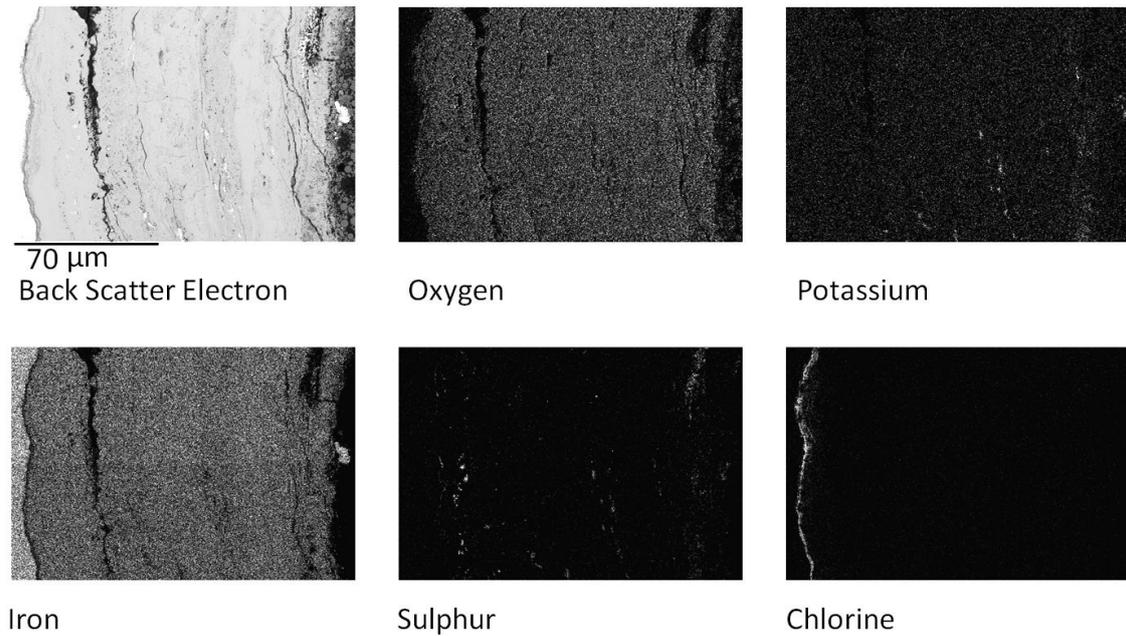
Figure 5. Elemental mapping of 16Mo3 sample, the left side of the figure is substrate. Chlorine is found in the corrosion front and is penetrated to the iron.

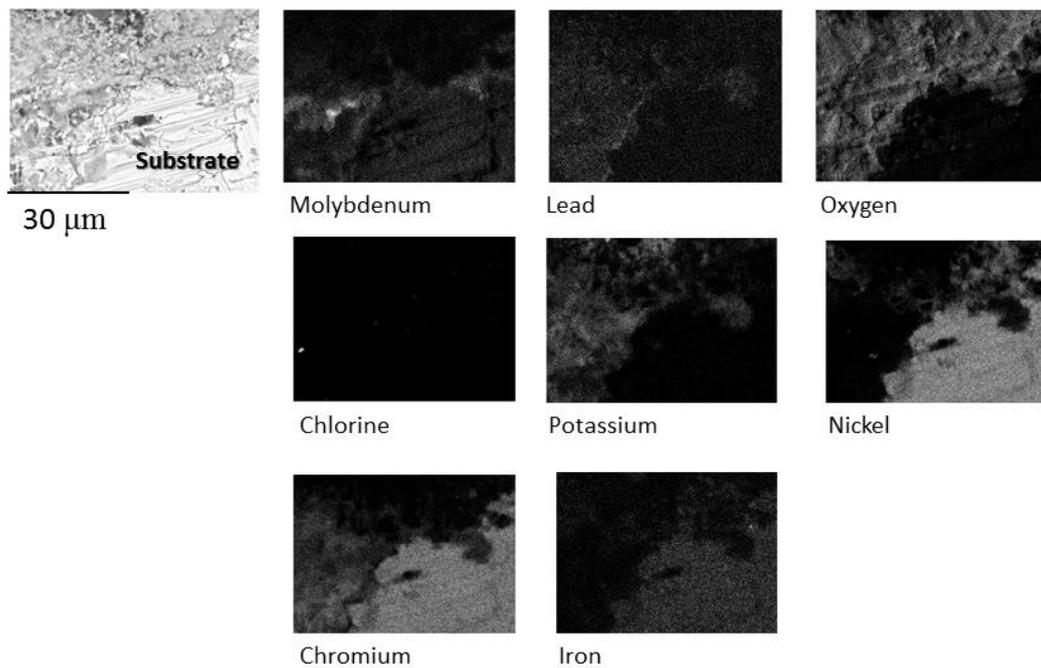
Figure 6. Elemental mapping of Alloy 625 sample, the right side of the figure is substrate. Chlorine is not found in the corrosion front, however lead and potassium are found. Chromium is enriched in the corrosion product.

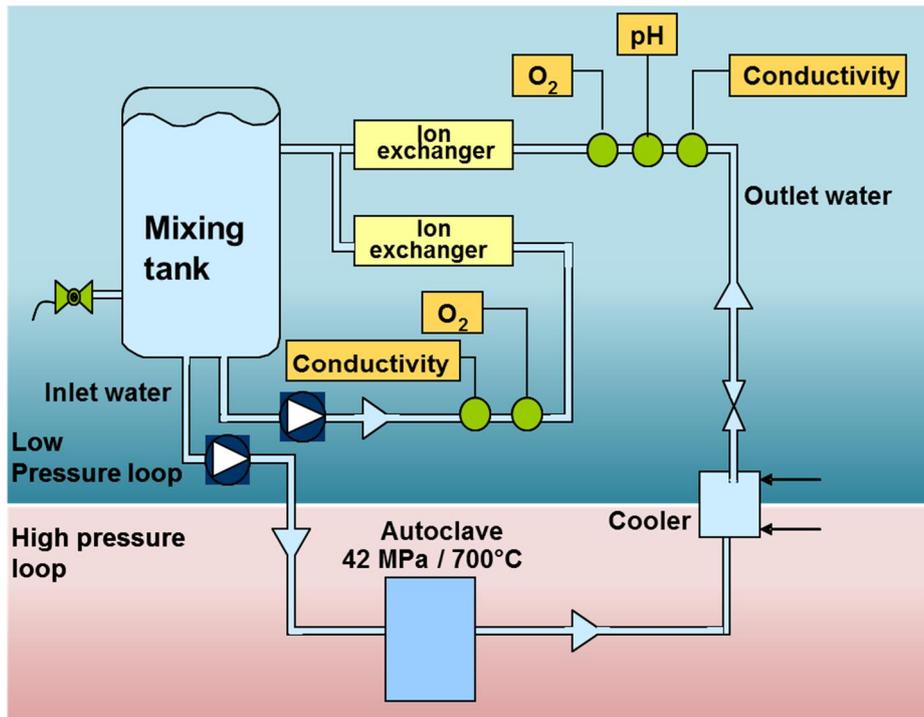
Figure 2. A schematic presentation of the supercritical water autoclave system with water recirculation loops [13].

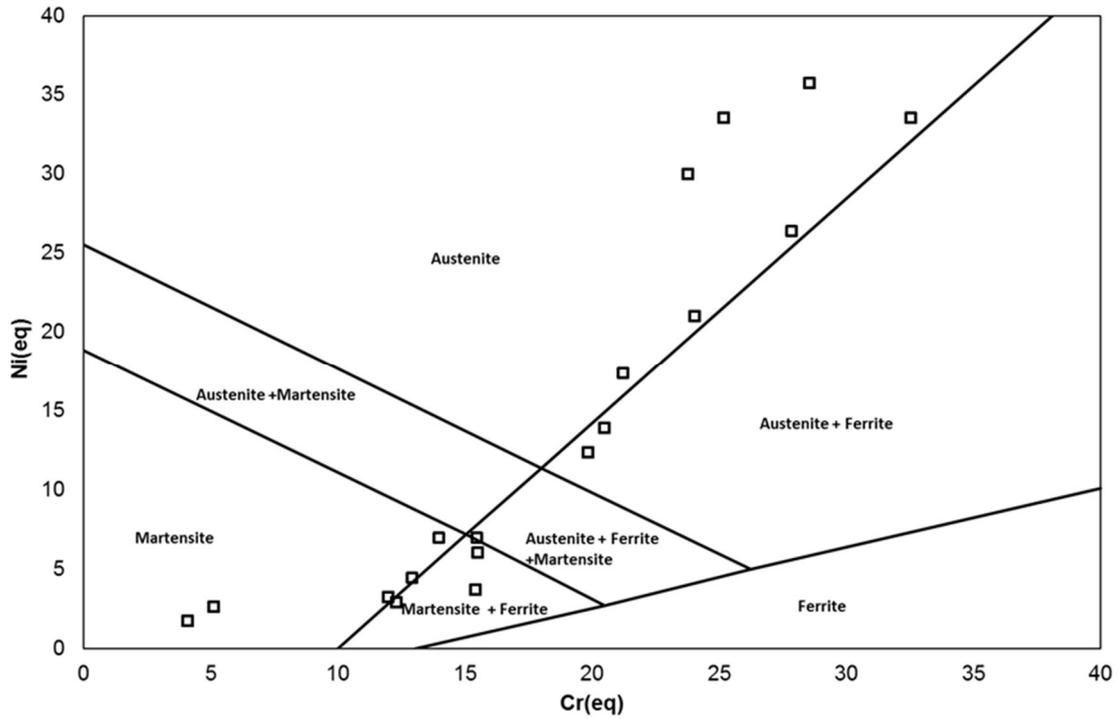
Figure 3. Test materials plotted in the Schaeffler diagram according to the P_{OX} model.

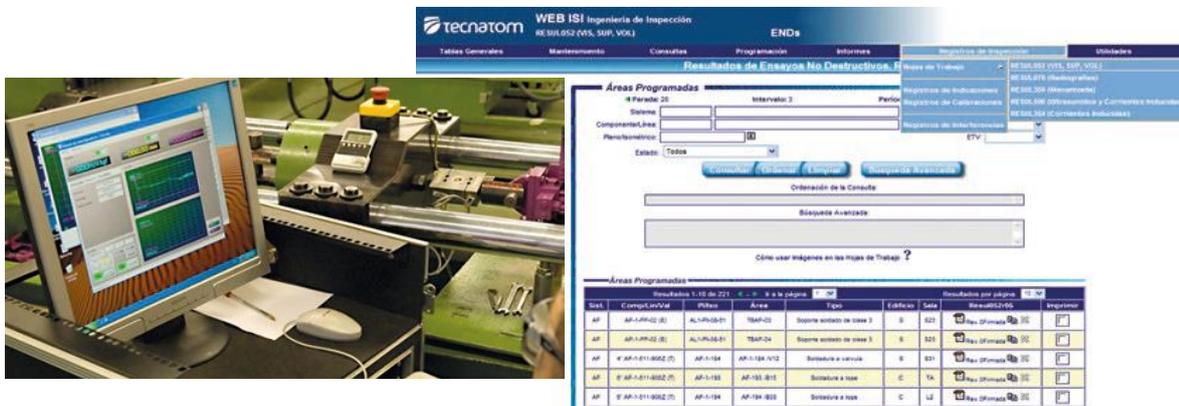
Moreover this specific tools, upgrade of some existing applications to support inspection has been performed, i.e fig 4.

Figure 4. Inspection support tool: WebSI.

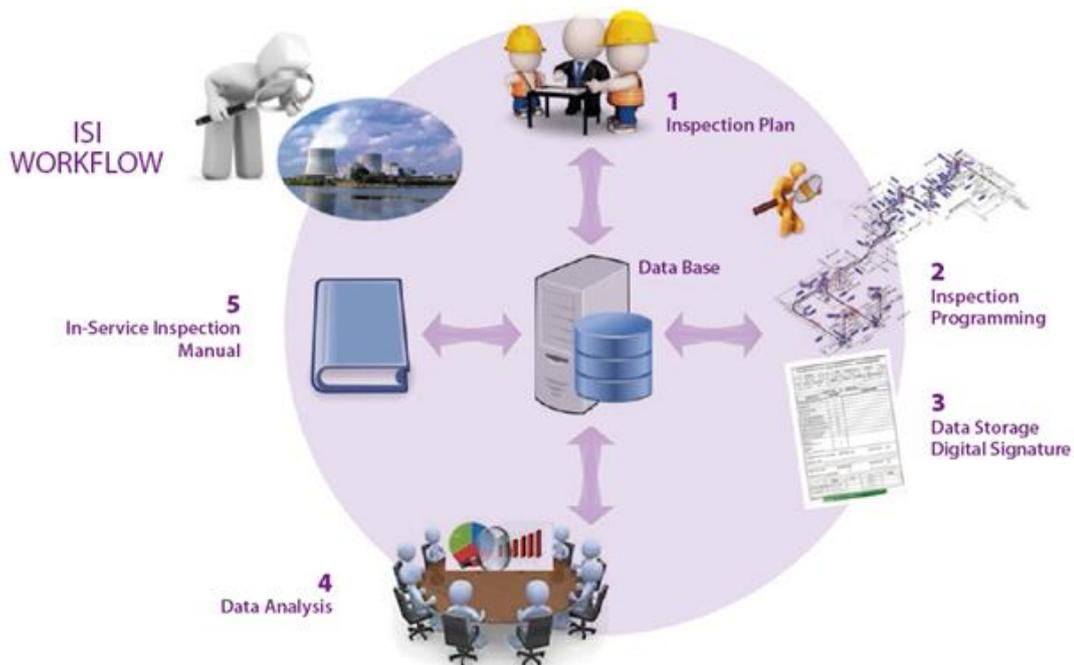
- Inspection Manual: the areas are selected based on the plan described on the manual. This manual is included in the system in order to know the scope of each inspection and moreover to have an updated of the results of each inspection.
- Available inspection results: All the previous results are consulted in order to identify which areas have experienced previous defects and have to be inspected. In addition, these systems allow to check which areas were inspected in the previous inspections and to change them for others that never have been inspected.
- Automatic preprogramming inspection: based on the Inspection Manual recommendations, previous results and additional information, the system generates a preliminary inspection which has to be approved by the maintenance staff. This plan can be modified.

Figure 1. Inspection process.

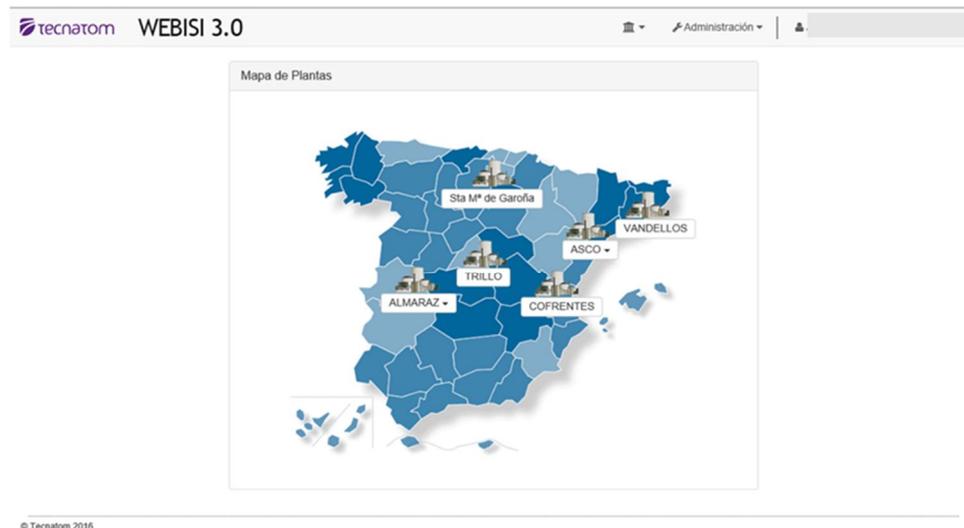
Figure 2. Web ISI main page.

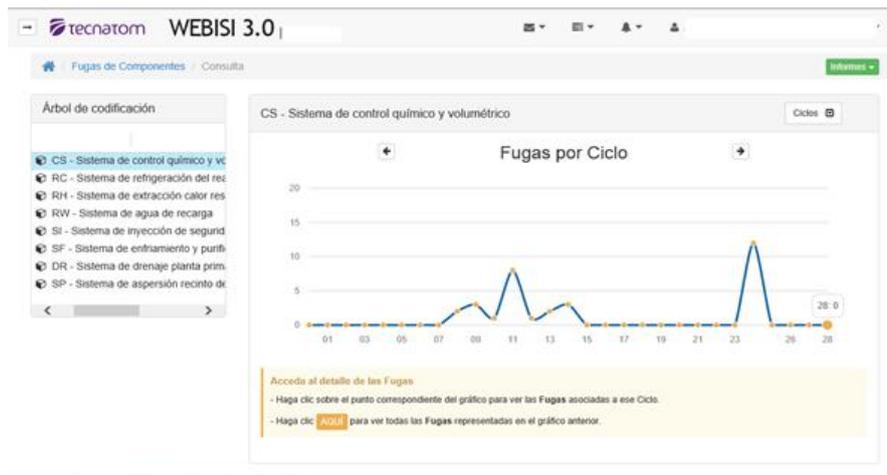
Figure 4. Module Dashboard.

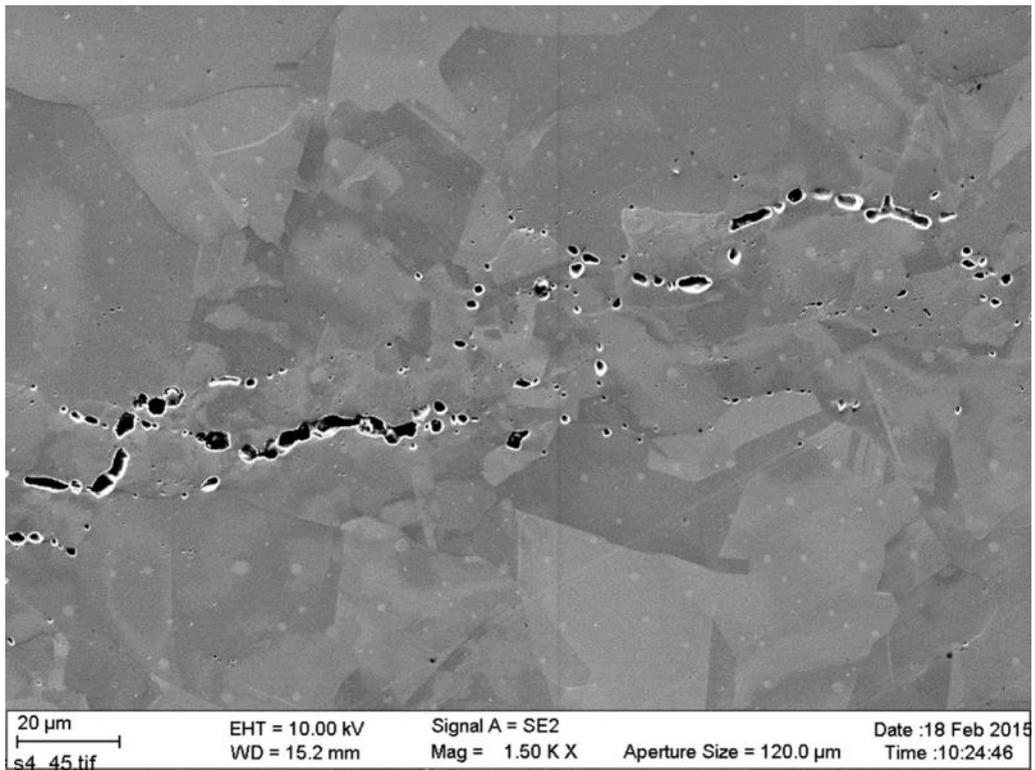
Figure 3. Oxide particle zone in a CT specimen after 50,000 h of testing at 175°C at 35MPa√m.

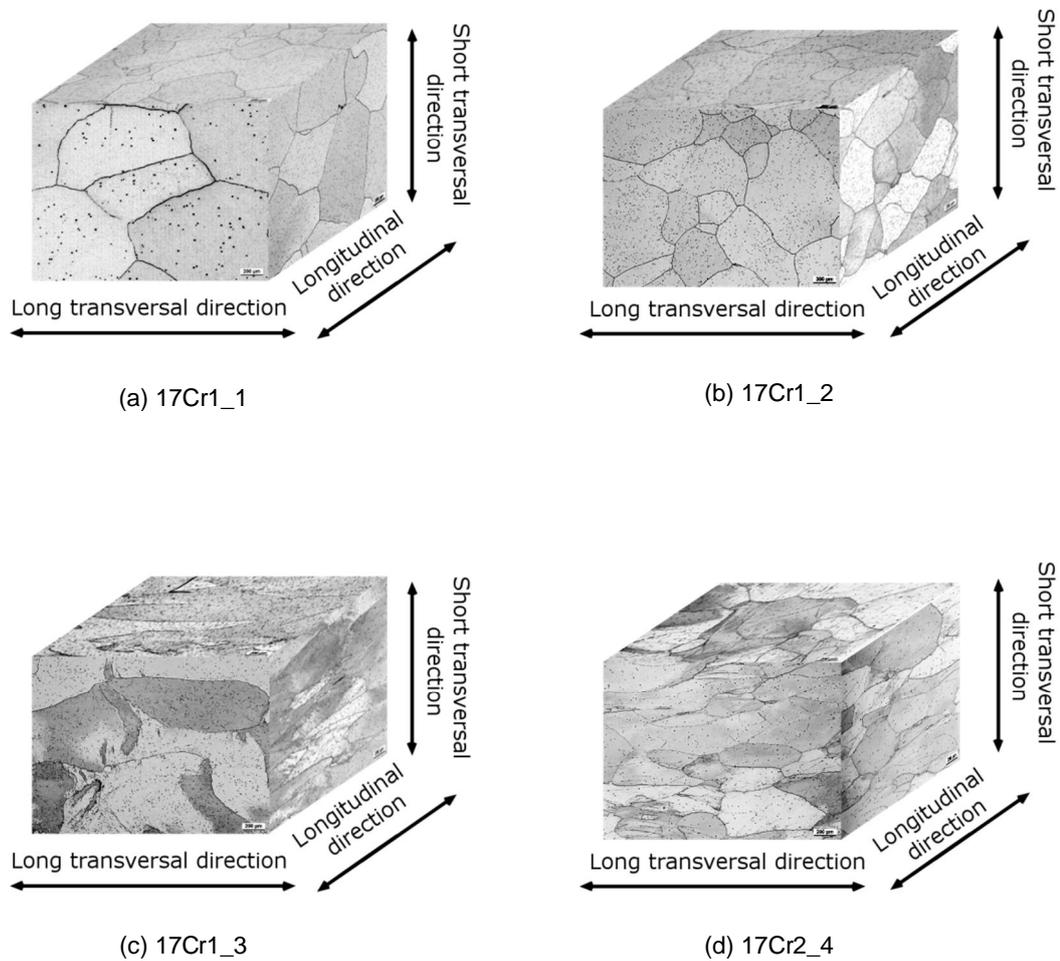
Figure 2. Macrostructure of differently rolled HiperFer batches.

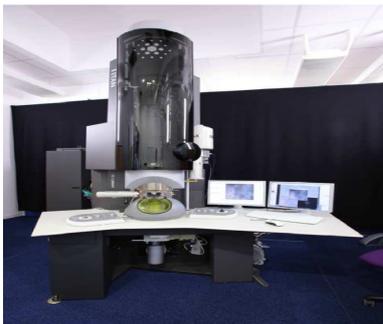
Figure 1: FEI TITAN 80-300 kV FEG STEM electron microscope of MAI

The **Microstructural Laboratory** allows for metallographic analysis and observation down to the atomic scale which are necessary to study ageing mechanisms. The MAI holds the latest generation of scanning electron microscopes (SEM, ESEM) and a dual-beam nanolab, providing two or three dimensional images of damaged areas down to the nanoscopic scale. The ultrahigh resolution TITAN microscope is the flagship technology of the microstructural laboratory with a resolution of 70 pm, below the atomic scale. The MAI also holds APT capabilities via some members.

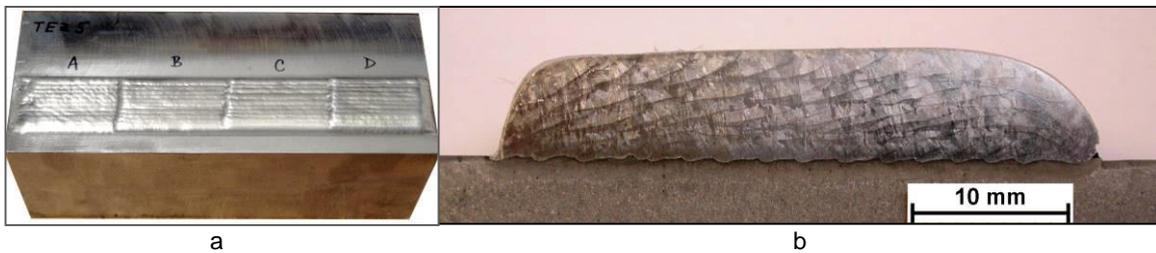
Figure 1. Inconel alloy 52 deposited on 15Ch2MNFA steel: a) specimen covered by 1(A), 2 (B), 3(C) and 5(D) layers, b) macrograph of cross section in part D.

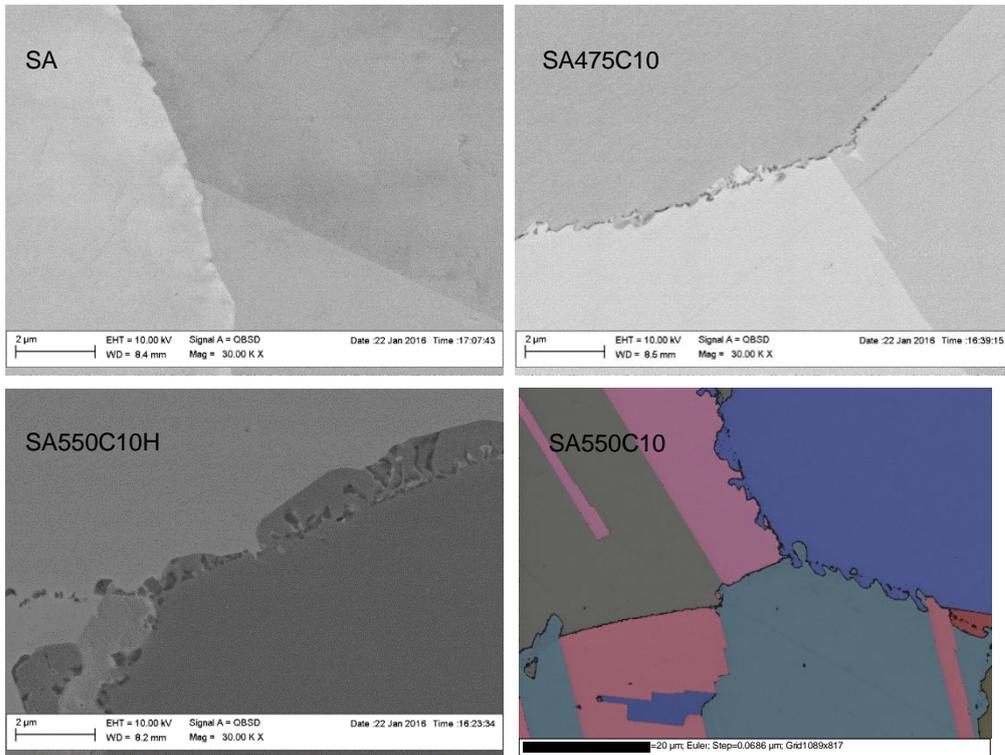
Figure 3. Evolution of GBs in the SA condition from the as-received state (SA) and after 10 000 h at 475 °C (SA475C10H) and 550 °C (SA550C10H). An EBSD mapping for the SA550C10H sample (bottom right) confirms the occurrence of GB migration.

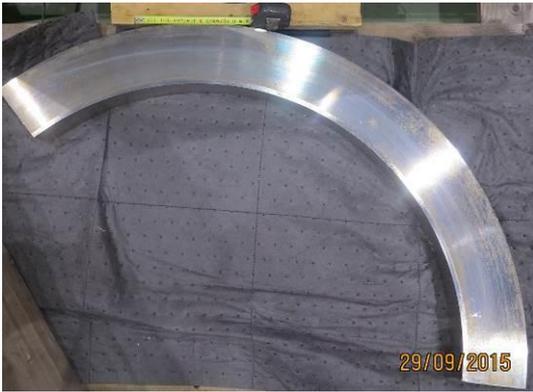
Figure 1. Received piece of the MHI narrow-gap weld mock-up.

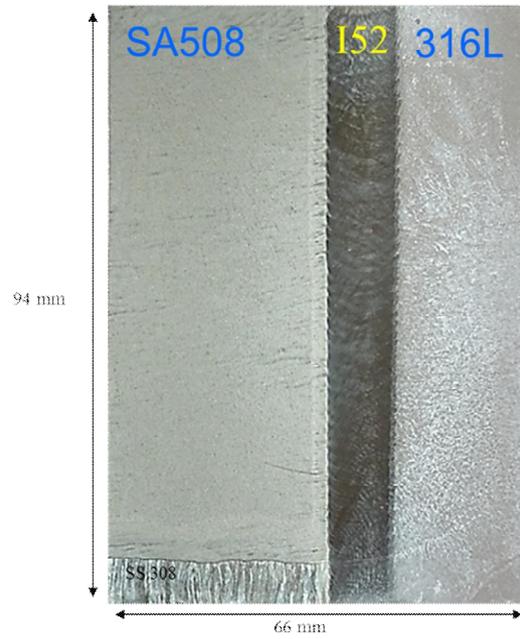
Figure 2. Cross-section of the MHI narrow-gap weld mock-up.

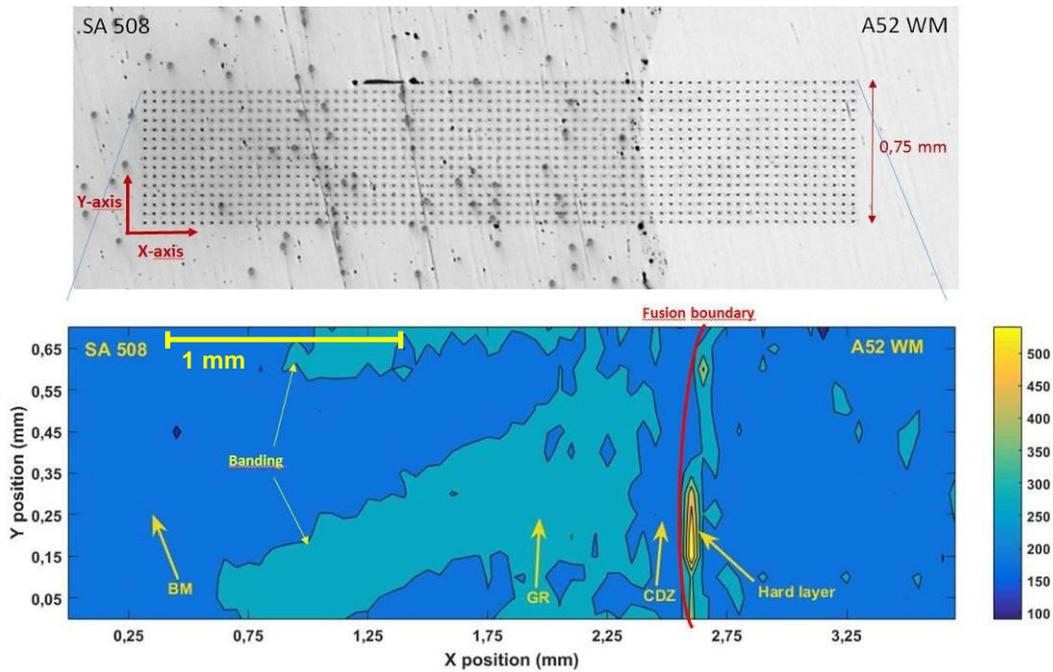
Figure 8. Microhardness measurements performed for the fusion boundary region, starting from the base metal (SA 508) on the left to the HAZ, CDZ, fusion boundary and finally Alloy 52 weld metal. From top to bottom a visualization of the matrix of indentations, the corresponding hardness map and the corresponding hardness-profile, respectively.
