Baltica X

International Conference on Life Management and Maintenance for Power Plants

7–9 June, 2016

VTT Technology 261

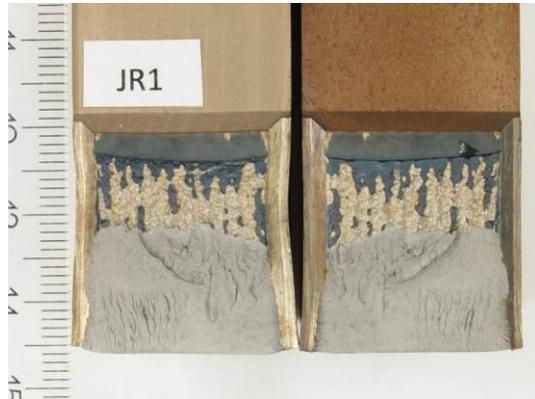
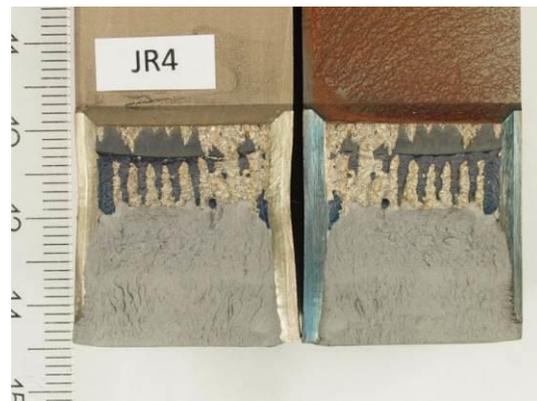
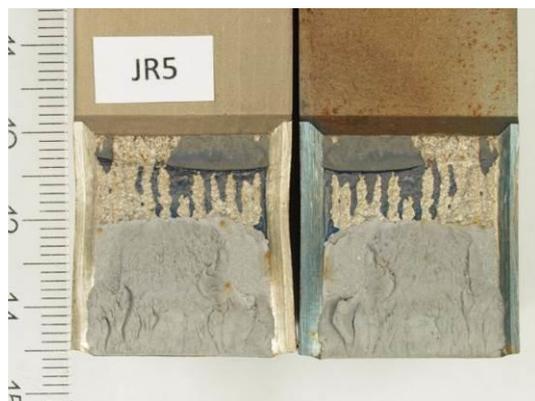
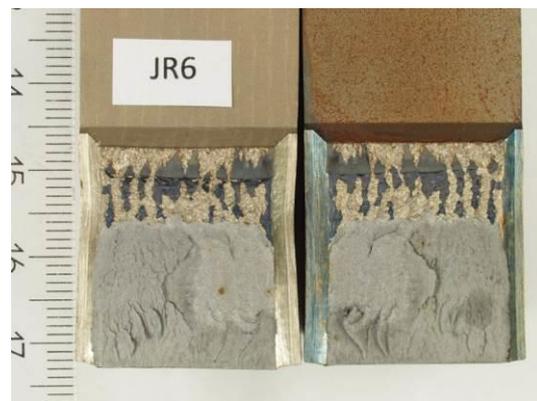
Figure 10. Photographs of fracture surfaces of the J-R test specimens JR1-JR6 from a) to f), respectively. The different regions of the fracture surface are marked in b), illustrating the specimen JR2, and they exhibit the same pattern for each specimen.

The photographs of the fracture surfaces are presented in Figure 10. The fracture morphology follows the wavy shape of the fusion boundary illustrated in the cross-section image (Figure 4). The bead size corresponds well with the frequency of the wavy fracture surface morphology, and the fracture surface appearance is similar in all the studied samples. Based on the photographs it was observed that the location of the fatigue pre-crack was very close to the fusion boundary because in all cases both materials of the joint, i.e. Alloy 52 weld metal (lighter in photographs) and SA 508 low-alloy steel (darker in photographs), are present on the fatigue pre-crack fracture surface. The wavy appearance of the onset of the J-R test part of the specimen fracture surface is different from the fatigue pre-crack fracture surface where the morphology is smoother typical of a fatigue pre-crack. The wavy topography is illustrated in optical 3D topography image shown in Figure 11. It was observed from the sides of the specimen halves that the Alloy 52 weld metal side of the specimens, shown on the left in images (a) – (f) in Figure 10, were more deformed during the J-R test than the SA 508 low-alloy steel side.

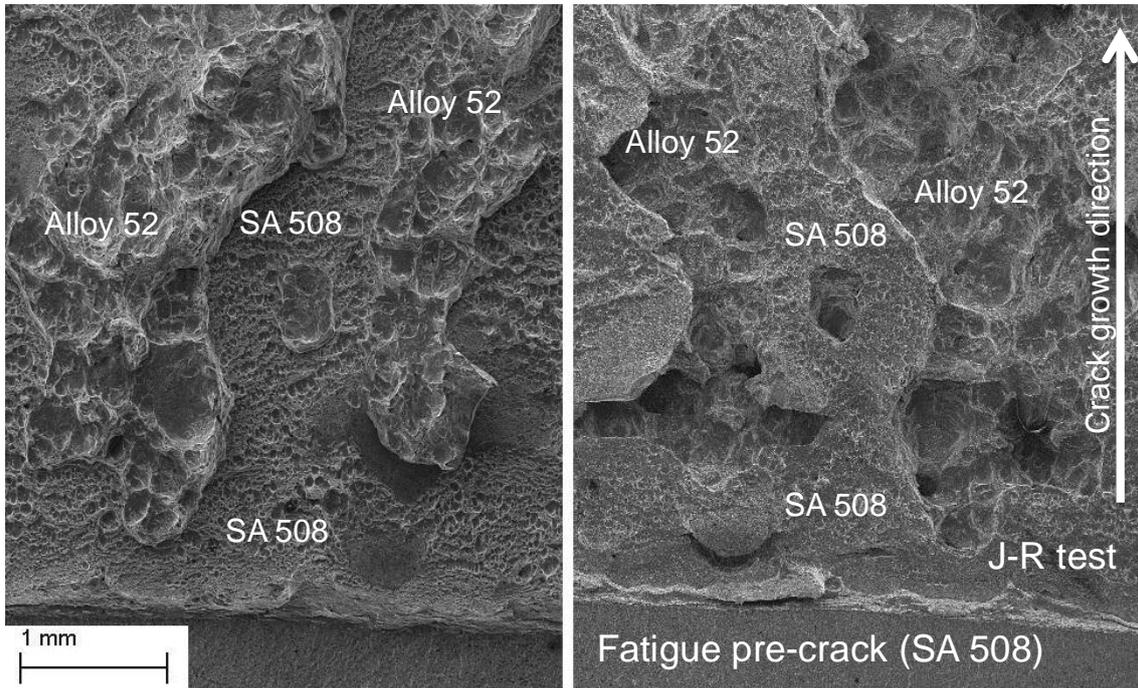
Figure 12. SEM images from the both sides of the fractured specimen at the same location showing alternating areas of Alloy 52 weld metal and SA 508 low-alloy steel.

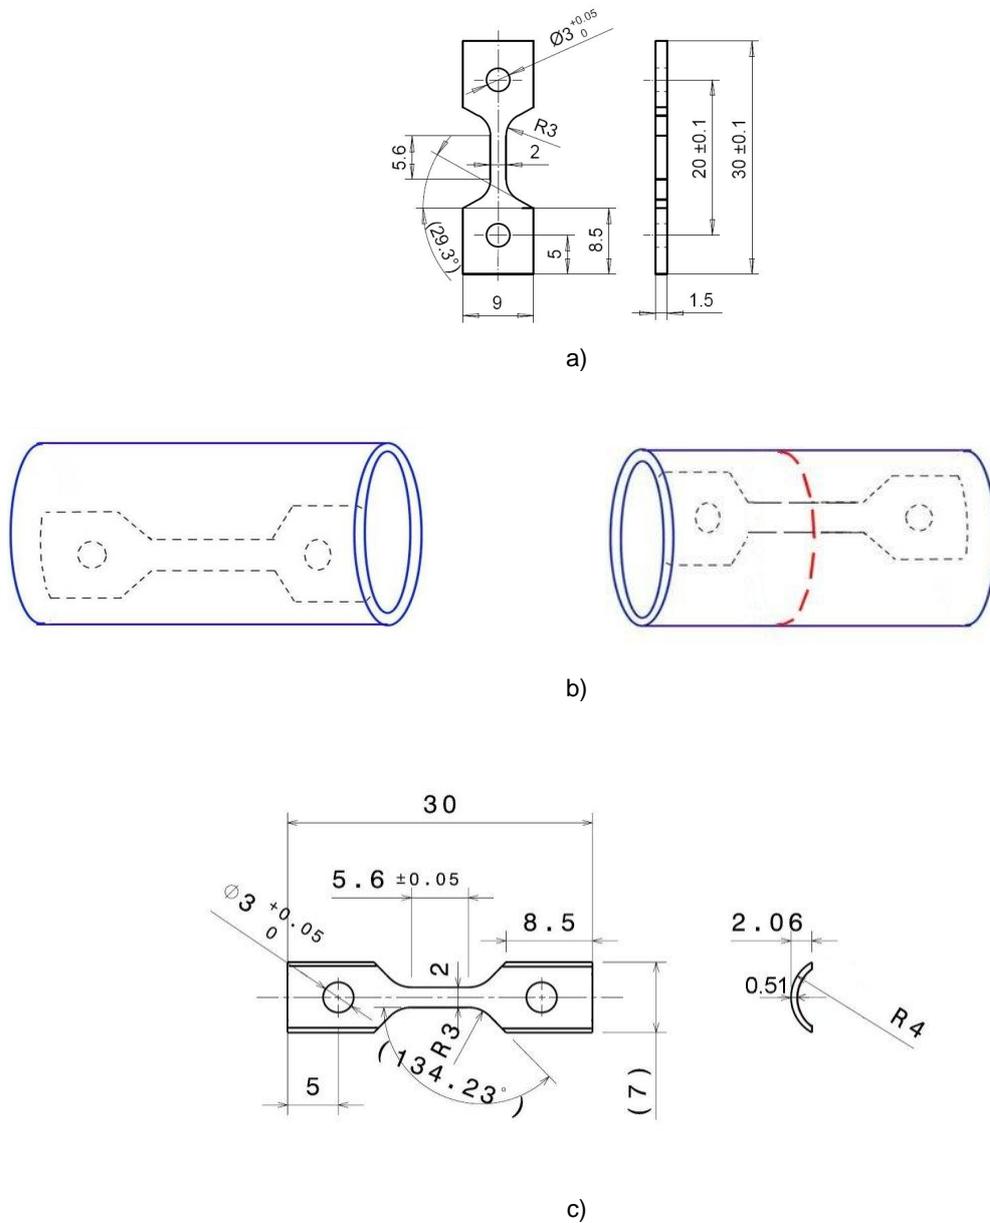
Figure 1. Geometry of the plate type specimen cut from larger samples used in most of the tests a) cutting schematic of specimens from as-received or shot peened $\sim 8 \times 0.5$ mm tube (left hand side) and from a tube that had a circumferential TIG weld in it (right hand side) b) and geometry of the specimens cut from the $\sim 8 \times 0.5$ mm tube.

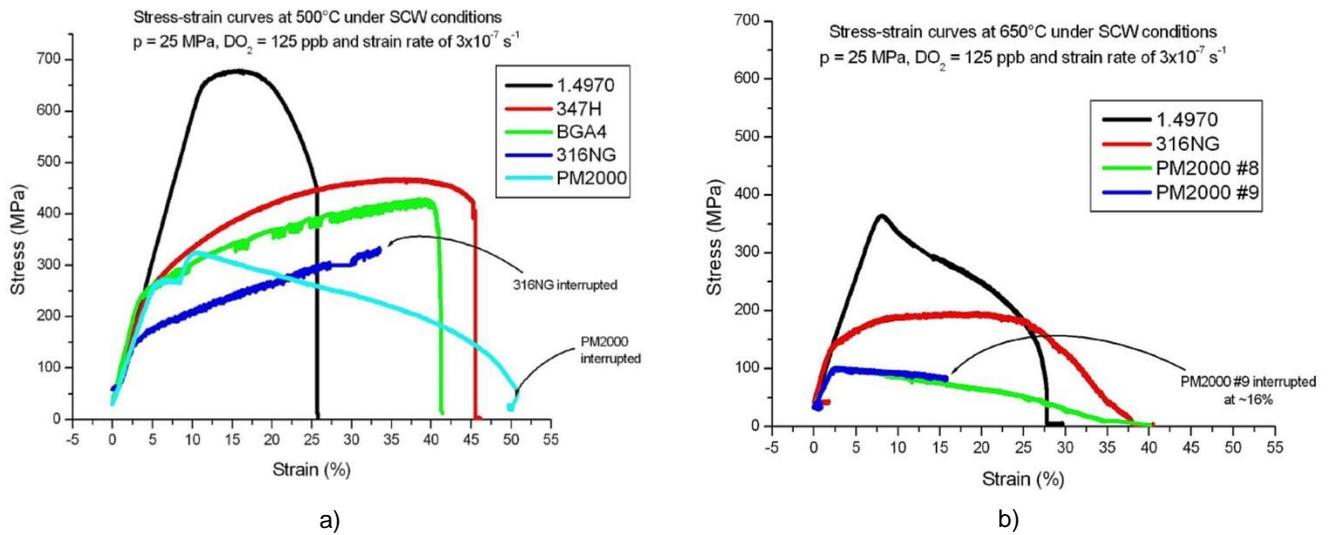
Figure 7. Stress-strain curves of the studied alloys in SCW conditions at a) 500°C and b) 650°C. Strain rate was 3e-7 1/s (except in the beginning of the test of PM2000 at 500°C the strain rate was 3e-8 1/s).

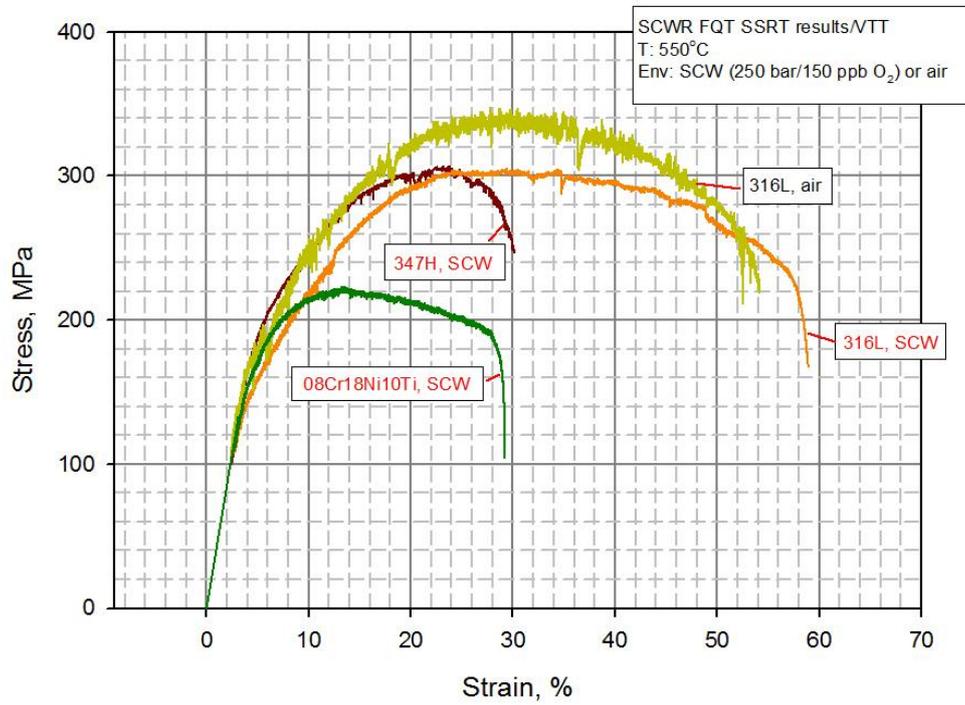
Figure 10. Stress-strain curves of the initially selected SCWR-FQT steels in SCW and air at 550°C. Strain rate was $1e-7$ 1/s.

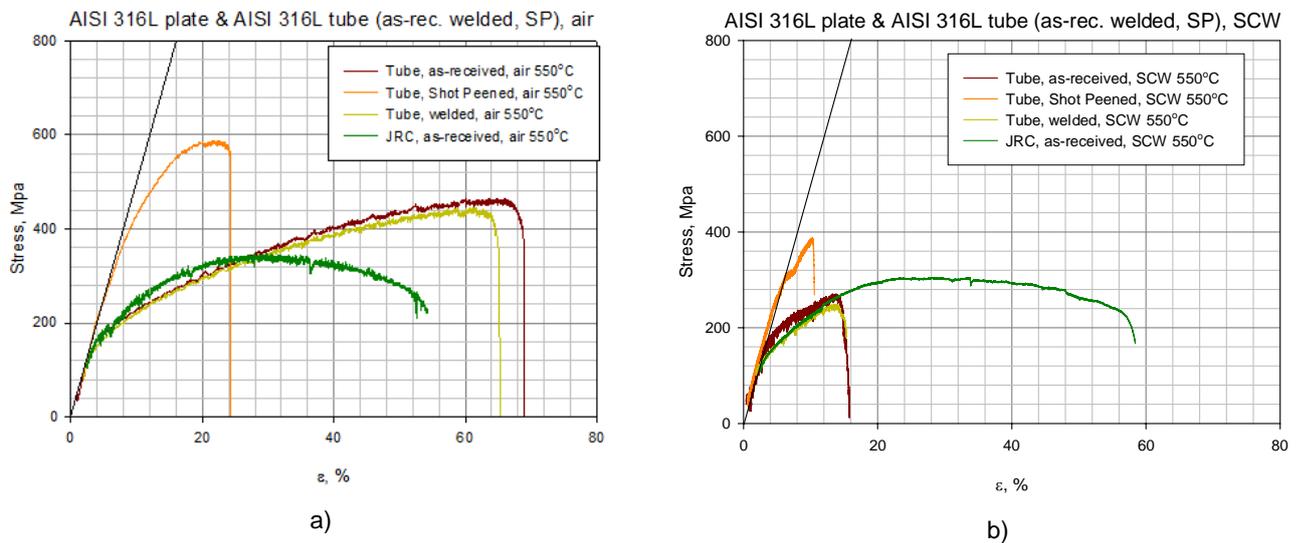
Figure 12. Stress-strain curves of the additional 316L SCWR-FQT steel in air a) and SCW b) at 550°C. Strain rate was 1e-7 1/s in each test. The initial 316L results are also shown for comparison.

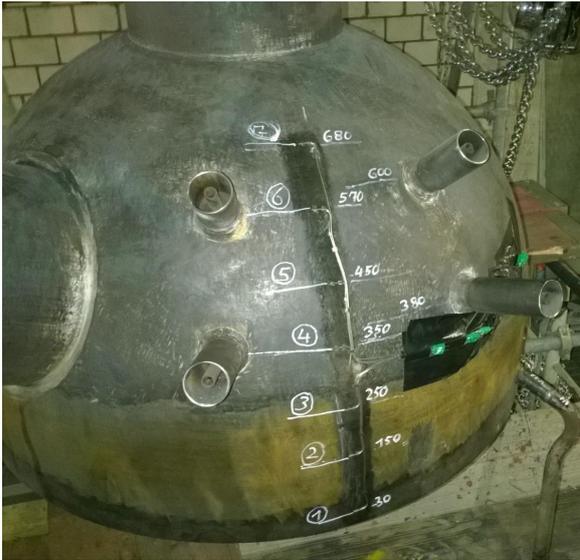
Figure 3. Boiler circulation pump housing with extra temperature measurement positions

To determine the real loads which have led to the crack growing in the replaced end plate and which could lead to possible crack nucleating and growing in the repaired pump, extensive transient measurements and analyses were done. An extra temperature measurement equipment with 7 vertical positions was installed at the external pump housing surface additionally to the since 1994 existing online monitoring system, see Figure 3.

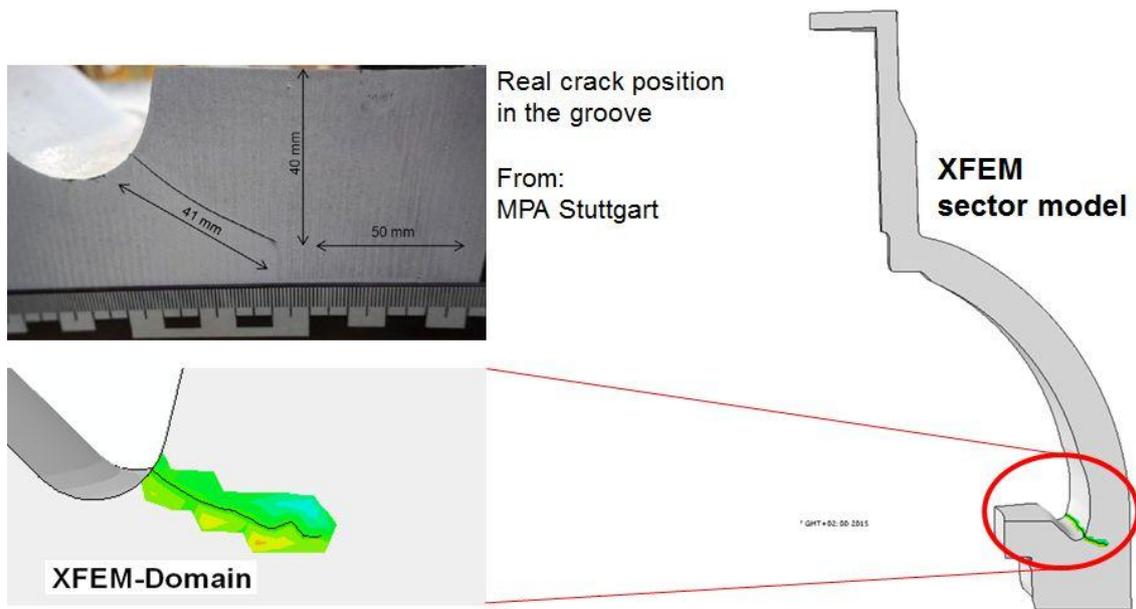
Figure 5. XFEM analysis and comparison with destructive testing results

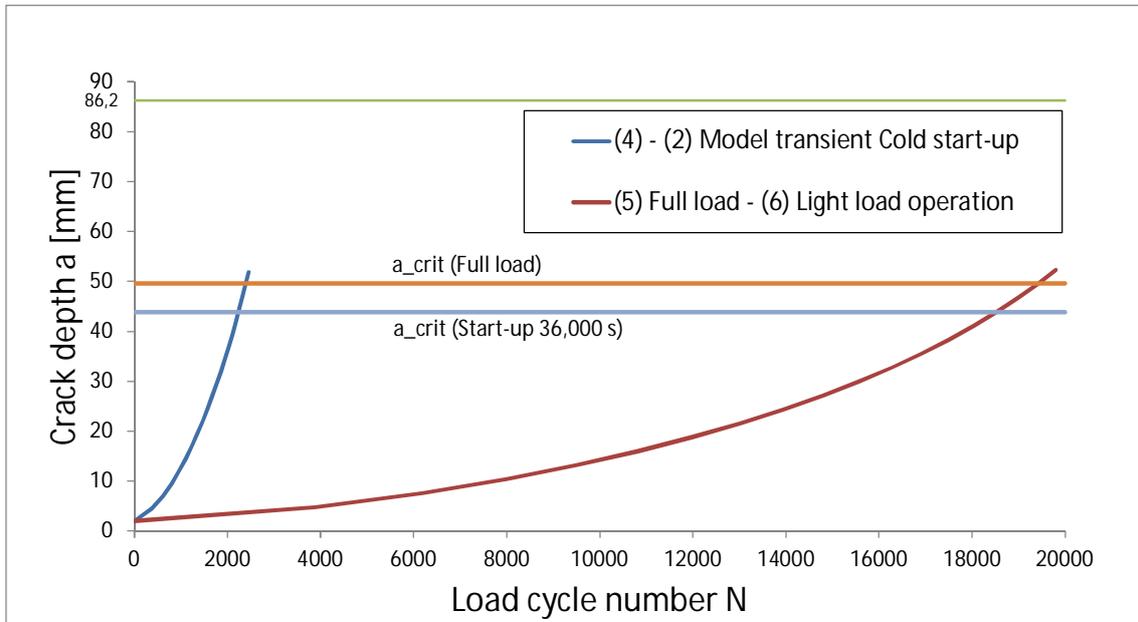
Figure 8. Crack growth diagram on basis of different load ranges

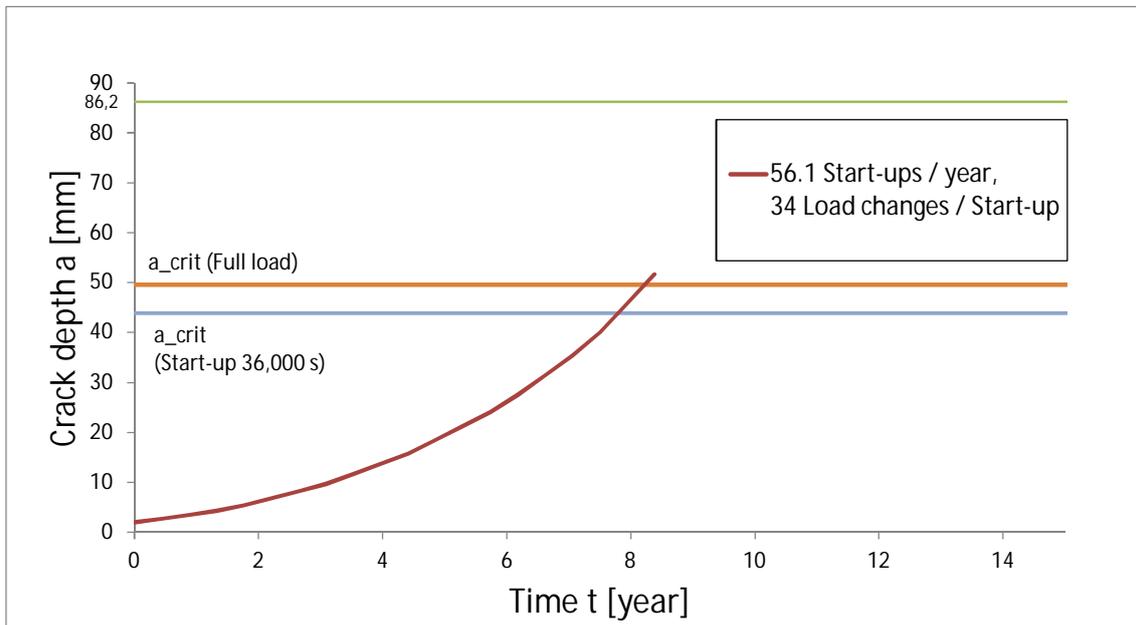
Figure 9. Crack growth diagram (Damage Tolerance diagram)

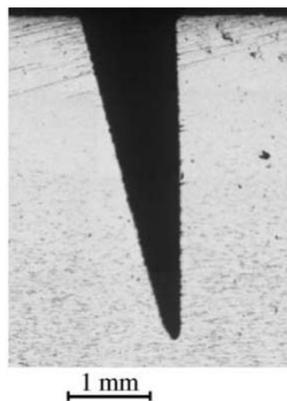
Figure 2. an EDM notch [8]

EDM notches are usually produced in a reference mock-up. Manufacturing process is nonconventional machining process, in which the material is removed very accurately in a controlled environment. Cutting is done with an electrode, which is shaped to resemble the desired flaw, only a bit shorter than the flaw desired. The electrode can either cut or burn the material in order to achieve the desired flaw shape and size. The parameters of a resulted flaw can be easily inspected with cast replica method to ensure that the desired flaw has been achieved. A typical cross-section of an EDM notch can be seen in Figure 2. [7]

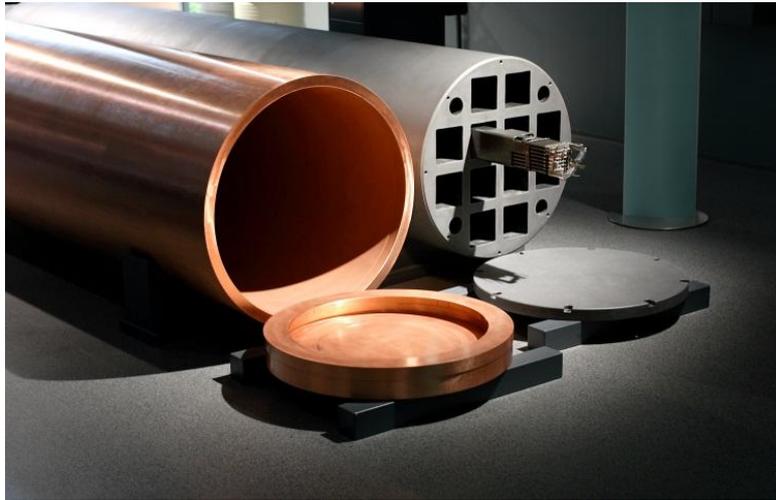
Figure 2. The disposal canister (Posiva Oy).

The disposal canister consists of nodular cast iron insert, copper overpack and copper lid (Figure 2).

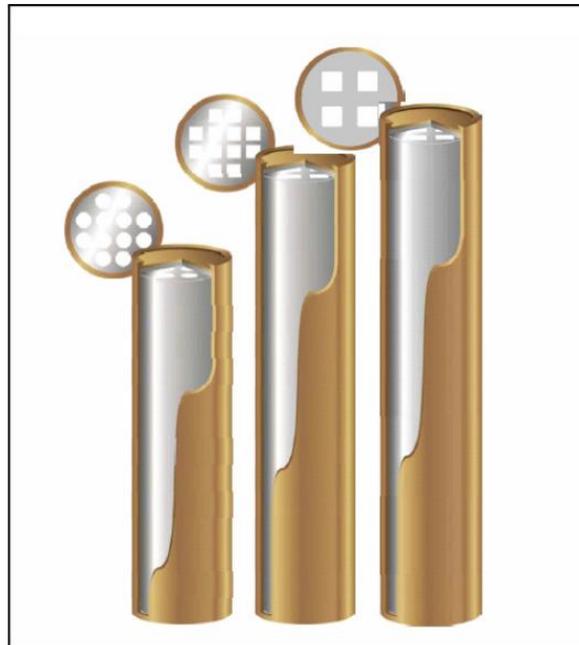
Figure 3. Different types of nodular cast iron inserts for VVER 440, BWR and EPR (from left to right) (Posiva Oy).

The main task for the nodular cast iron insert is to give adequate strength to the structure of the canister to withstand the mechanical stress originating from the bedrock in the underground repository. There are three different types of cast iron inserts (Figure 3), one for Loviisa 1 and Loviisa 2 (VVER 440 type), second one for Olkiluoto 1 and Olkiluoto 2 (BWR type) and third one for Olkiluoto 3 (EPR type).

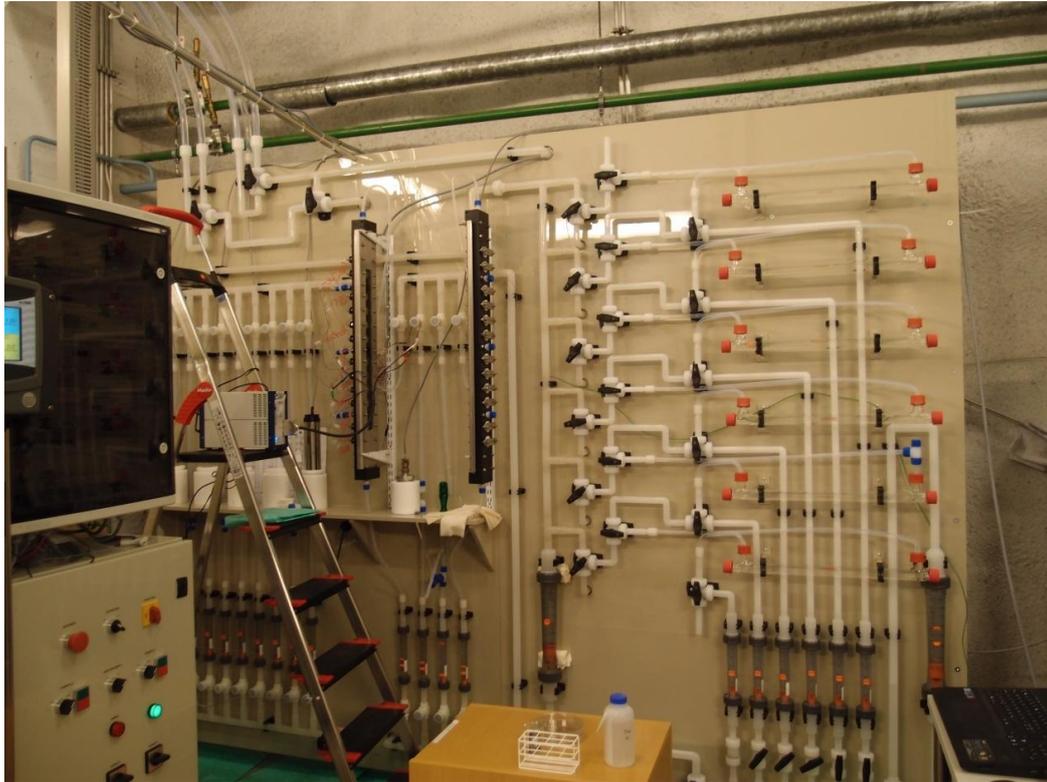
Figure 1. Photograph of the pilot cooling water circle.

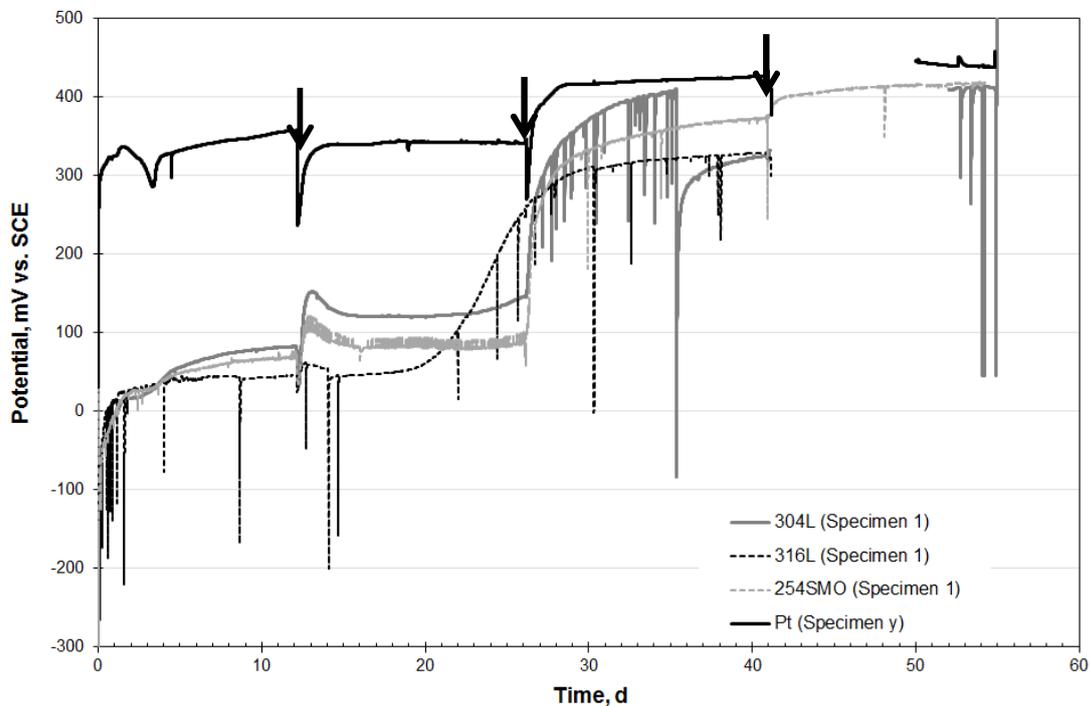
Figure 2. OCP recording of one of the specimen for each material and platinum, time points for renewal of the test water are showed with arrows.

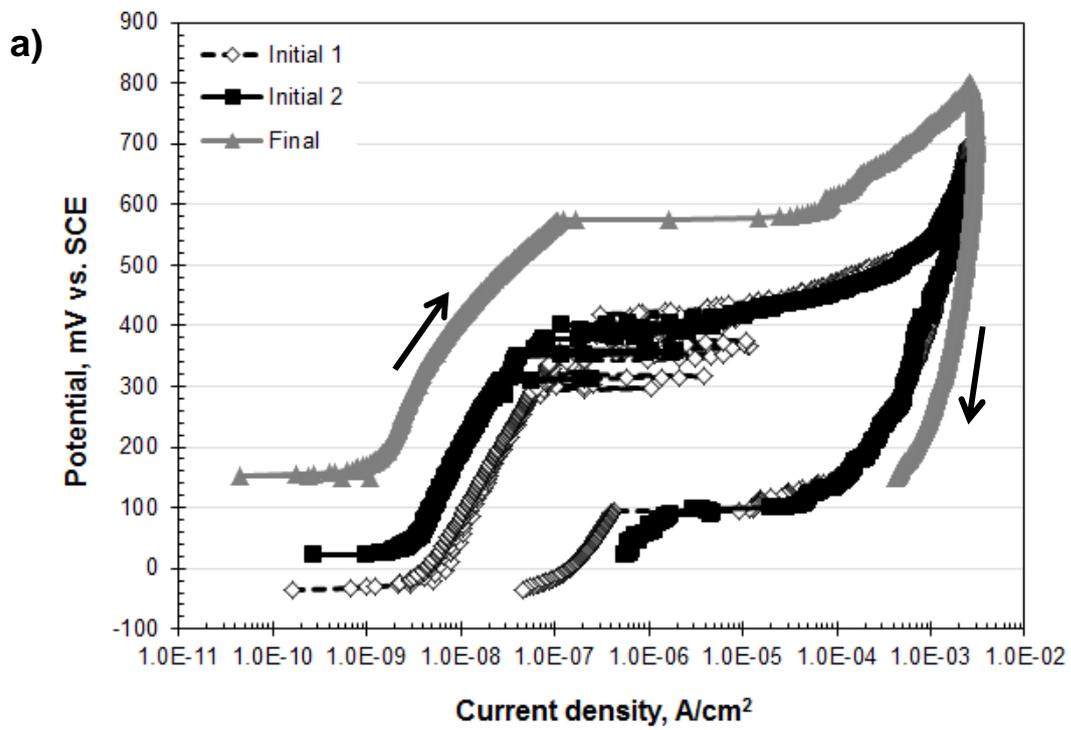
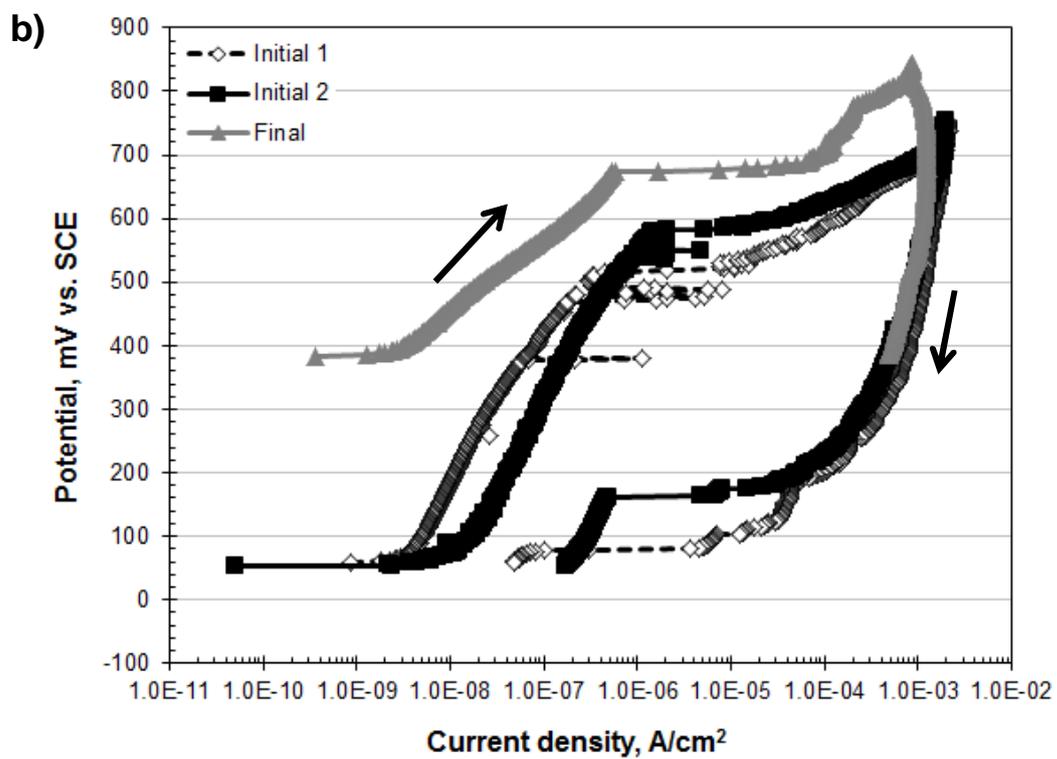
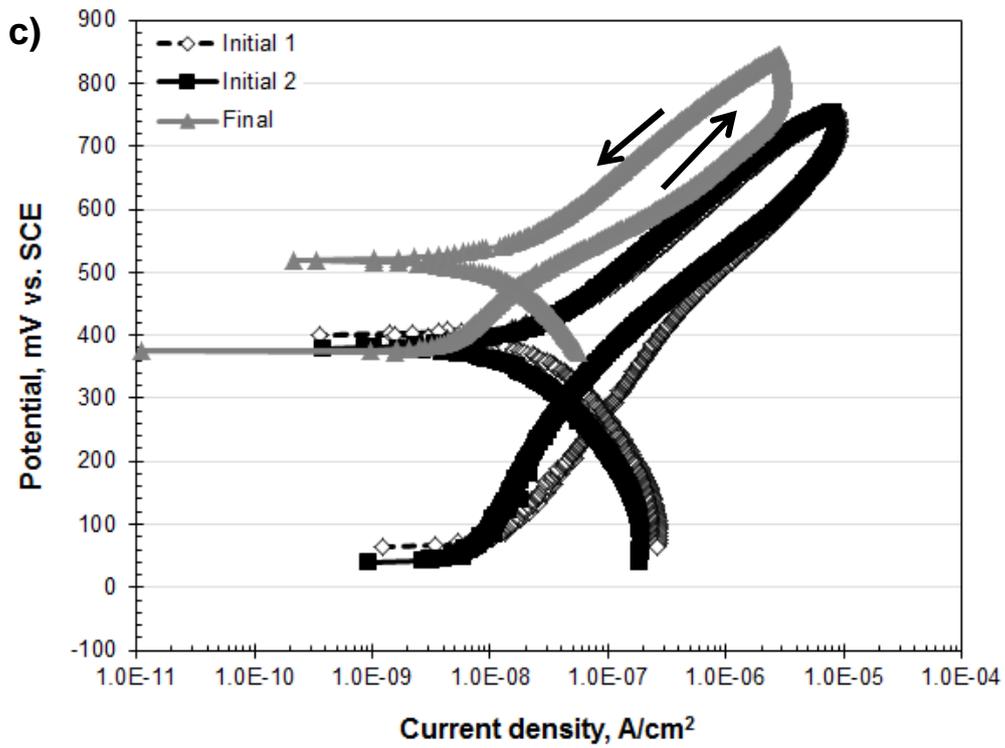
Figure 3. Cyclic anodic polarization curves before and after the experiment for a) AISI 304L, b) AISI 316L and c) 254 SMO.

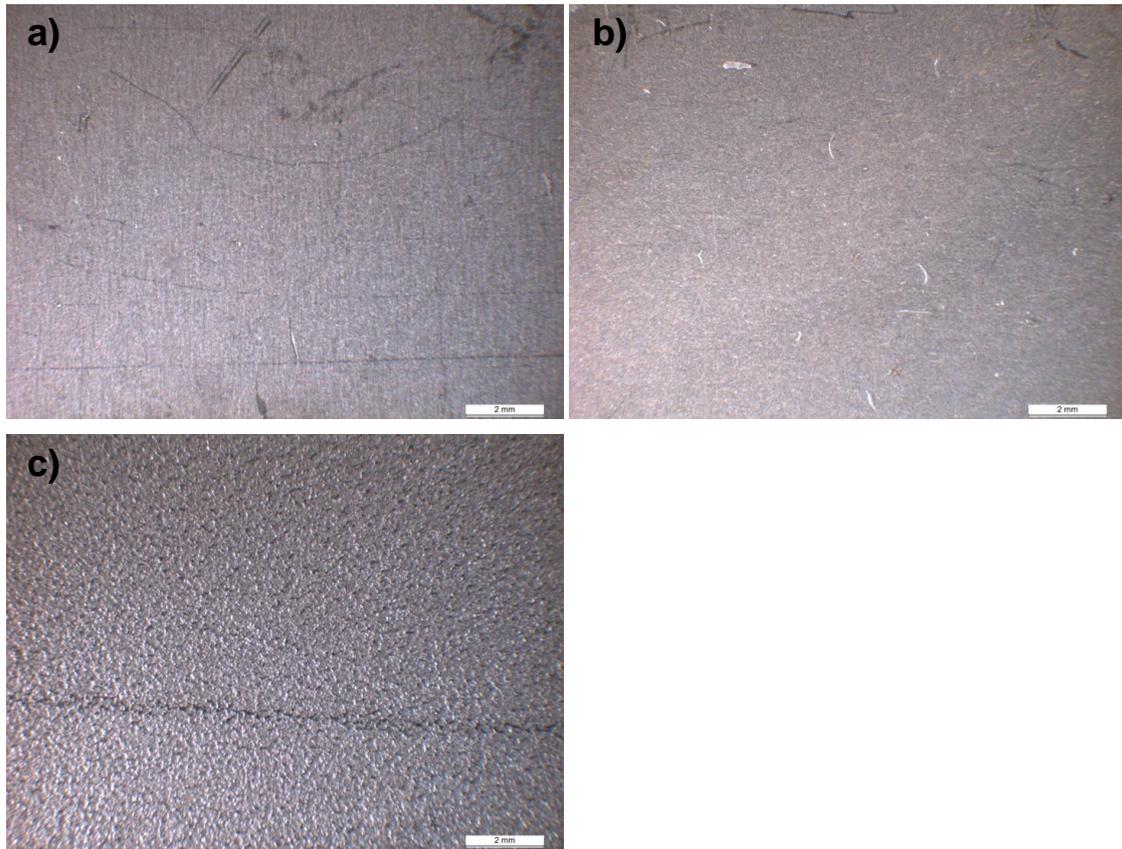
Figure 5. Surfaces of the electrochemical samples after experiment, stereomicroscopic inspection (original samples, no measurements applied): a) AISI 304L, b) AISI 316L and c) 254 SMO. Surfaces appeared similar compared to the initial sample surfaces.

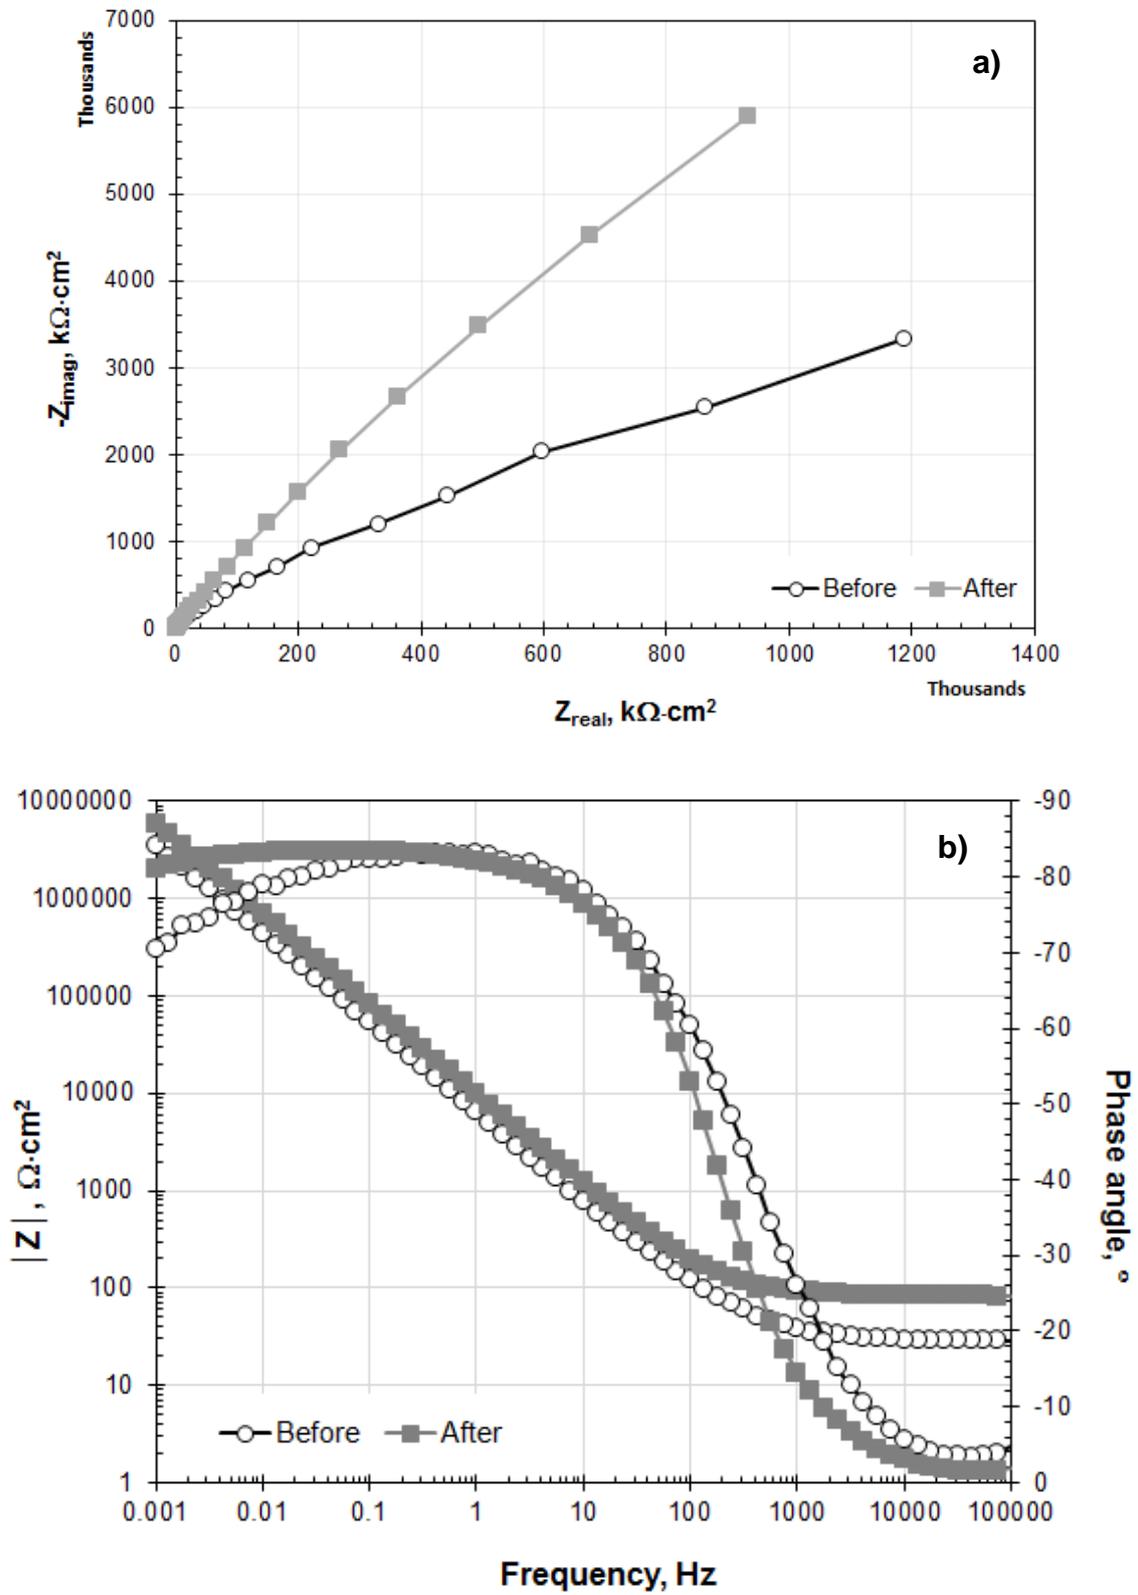
Figure 6. EIS spectra for 304L: a) Nyquist plot, b) Bode plots.
