The impact deformation and wear of thick composite coatings

Richard Peter Waudby

VTT Technology 300

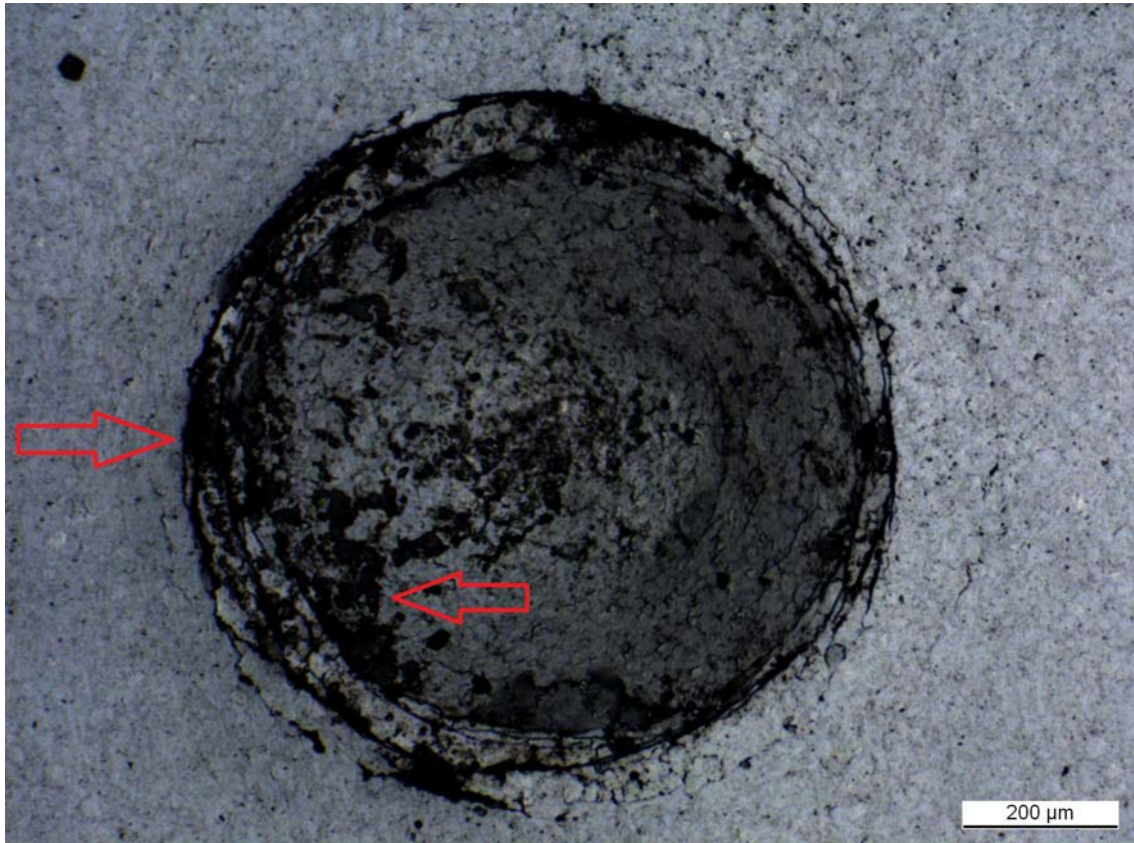
* Note that the regions marked with the red arrows demonstrate material loss due to fatigue and sliding wear

Figure 5.7: Optical micrograph showing a secondary damage caused by a sliding contact in a thermal spray coating (EXP2) after percussive normal impact (1750 N, 10k cycles)

Despite being a minor consideration, damage due to a sliding contact is observed. It is not a major failure mode. Contact between asperities of the counterface and impact specimen surface (i.e. two body abrasion and/or adhesion) and the counterface, impact specimen and wear particles (i.e. three body abrasion) are the key mechanisms responsible. Gouge marks are typically seen on the inside edge of the impact crater, often after a high number of impact cycles. See Figure 5.7.

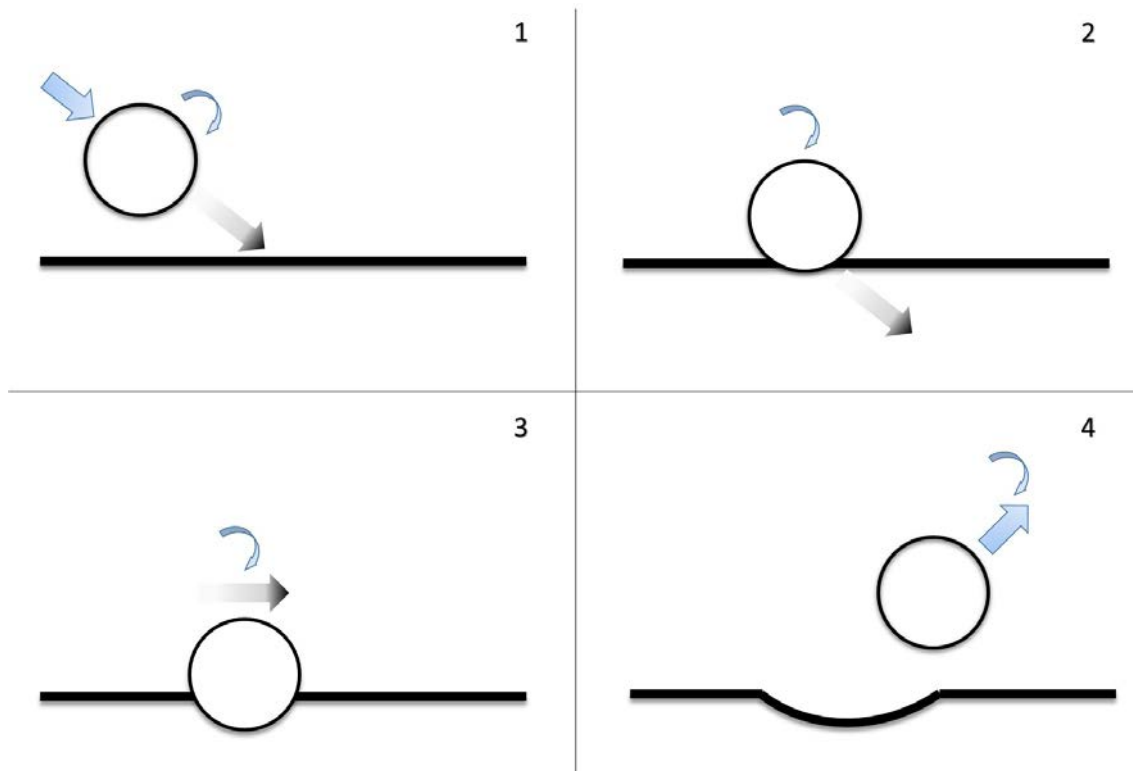
Figure 6.1: Schematic diagram describing the evolving contact between the target specimen and project for a single , compound sliding impact investigation

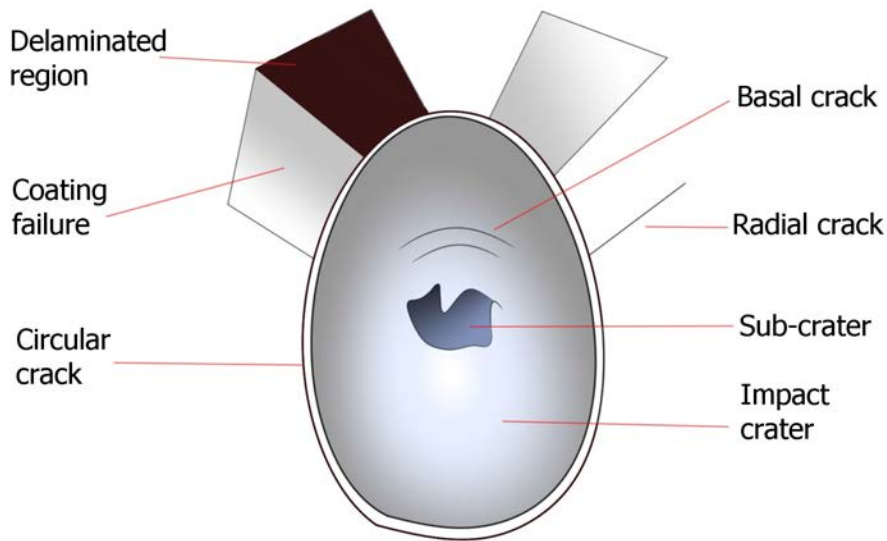
Figure 6.2: Schematic diagram showing the typical failures observed for the investigated thick, composite coatings after single body compound sliding impact testing

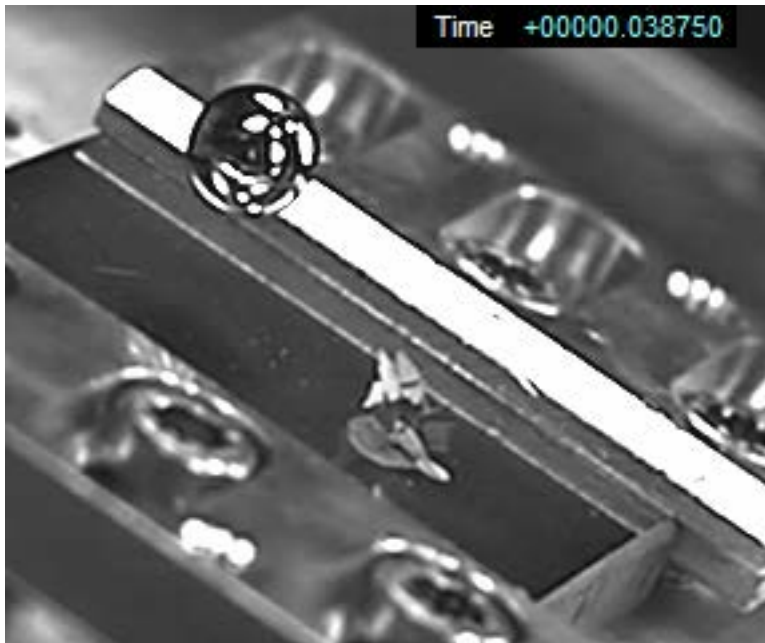
Figure 6.7: High speed video frame of an impact event showing the ejection of debris due to a compound impact sliding event for a spherical steel projectile against COMM3
